Runway Incursions and Airfield Lighting

NTSB Aviation Accident Investigation

*2019 IES Aviation Lighting Committee
Technology Meeting
Monterey, CA*

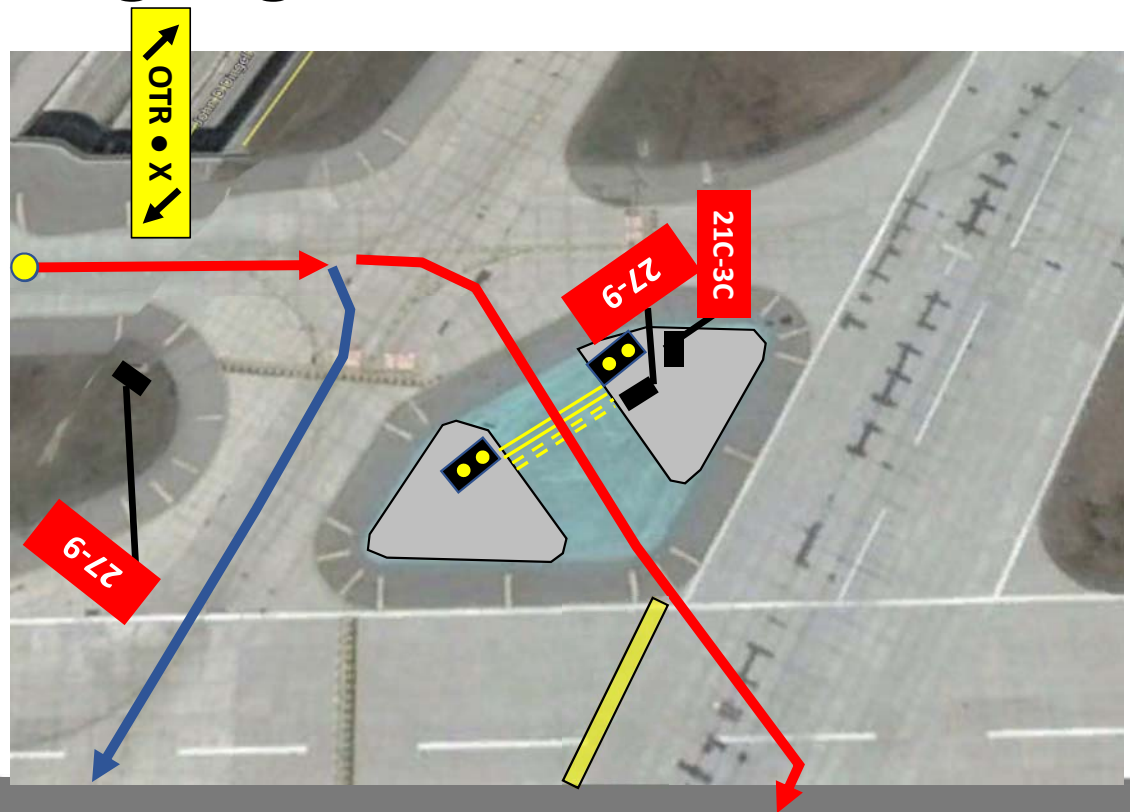
Airfield Lighting and Signage

Runway Centerline Lights

- Centerline Lights were not operable?
- Rotary Switch needed Replacement

Missing Runway Edge Lights

- No Inpavement lights Through Crosswind RW
- “Wig Wag”
 - No L-804 FAA specification
 - New Technology in 1990
 - Not required by FAA Criteria

- Close Island
- Implement Signage Per FAA AC 150/5340-18A
 - Dedicated Sign Circuits
 - Rename Taxiways
- Install Wig Wags
- Install Inpavement Runway Edge Lights
- Revise Rotary Switch on Control Panel
- Complete New Lighting Vaults
 - New CCRs
 - New Generators
 - New Computer (CPU) based Controls System

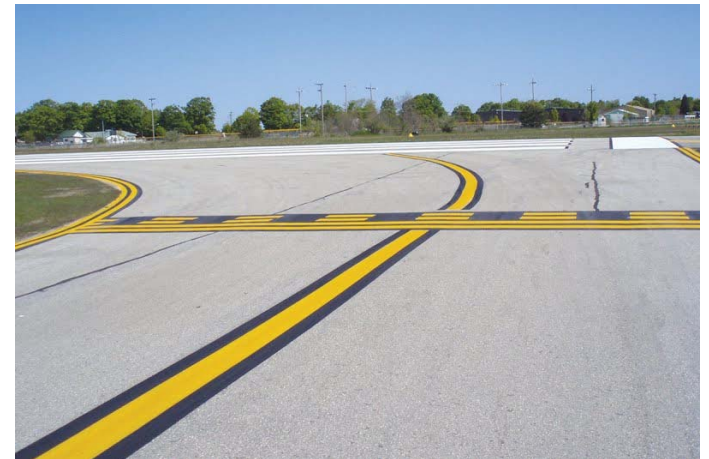
Signage, Lighting and Marking

Paint Markings

- Reported Initially as poor in TW Oscar 6 area
- NTSB noted good paint markings in field investigation

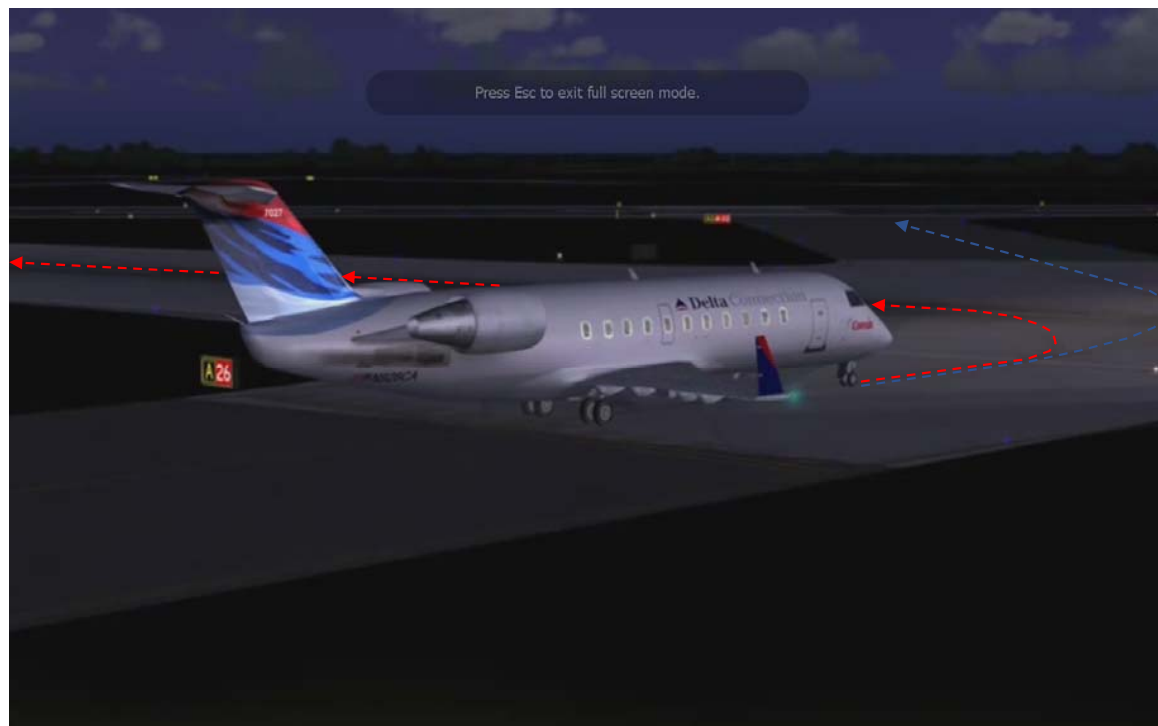
Aircraft Entering Runway

Runway 26

- Hold Position Sign Visible
- RW “26” Paint Marking was visible from the Right of Aircraft

Runway 22

- RW 22 Hold Position Sign was Visible
- Taxiway CL markings were visible

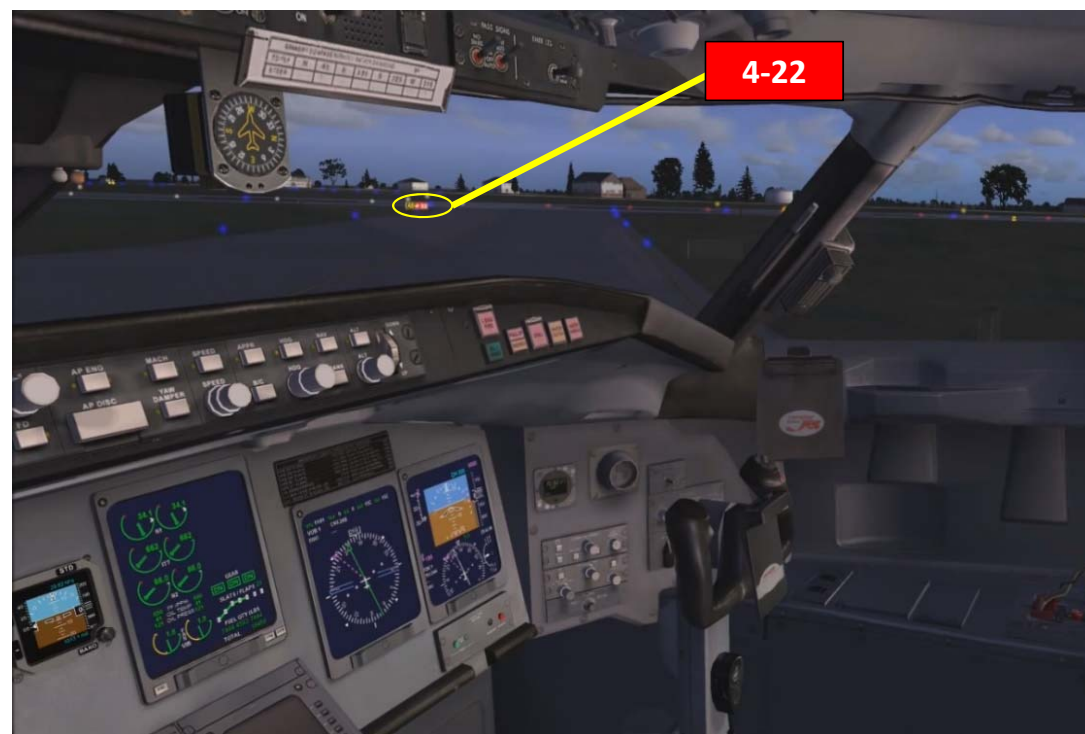
Runway 26 Threshold

Runway 26

- RW Edge and CL Markings were Visible
- RW "26" Paint Marking were not visible
- RW 22 Hold Position Sign and White Edge Lights were Visible
- 2000-feet RDR Sign was not Visible
- RW 8 End not visible due to Dark Horizon
- TW Edge Lights were Visible

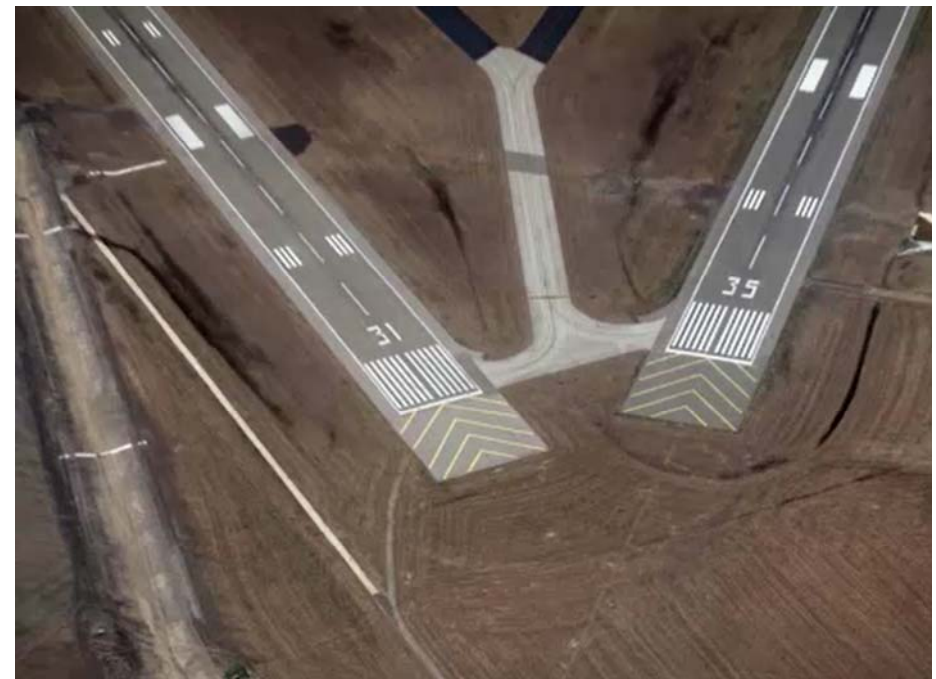
RIM Example No. 1

- Runway Ends to Close Together
- Non-Standard Geometry

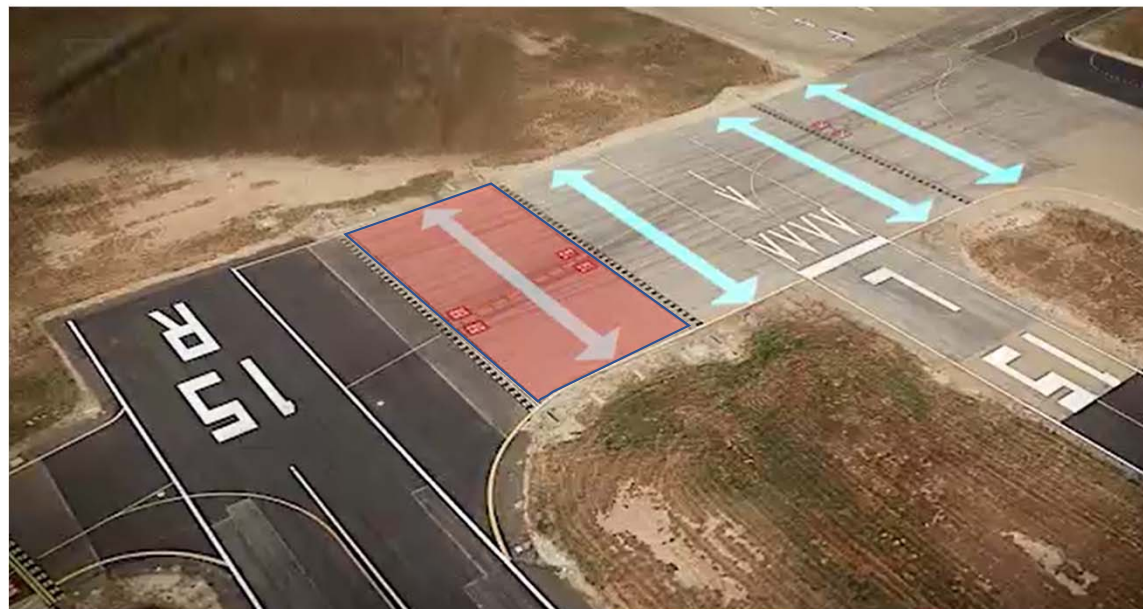
RIM Example No. 2

- Nine Runway Incursions in 6 Years
- Challenges
 - Wide Expanse of Taxiway near a Runway
 - Short Taxiway Stubs between Runways
 - Non-Standard Marking and Signage
