# IES-2011

## Airport Lighting Cans Load Transfer

**Daniel E Geary**

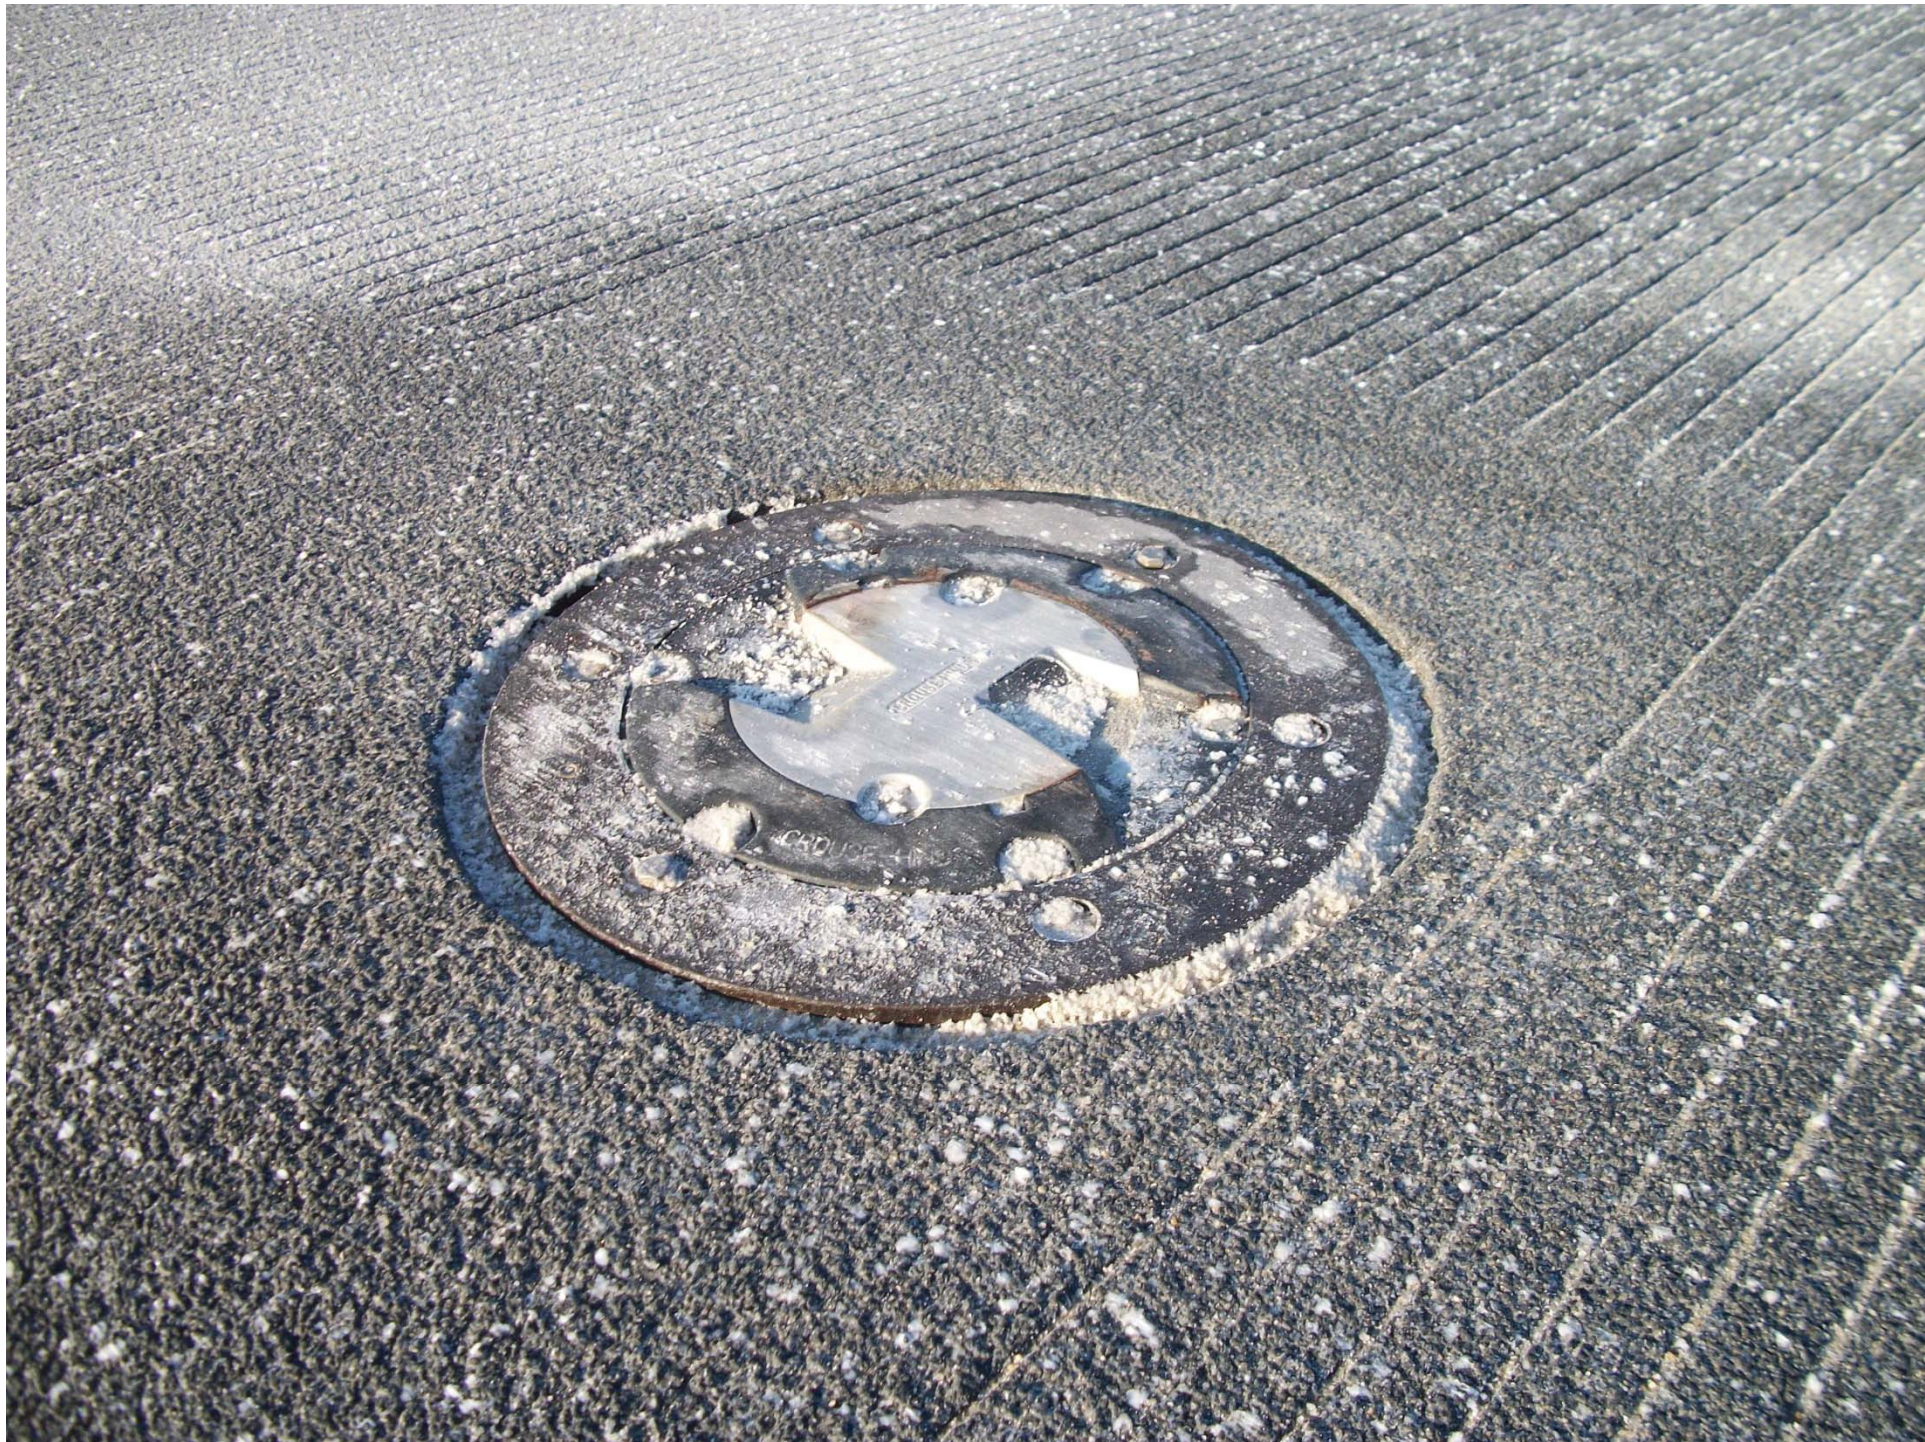
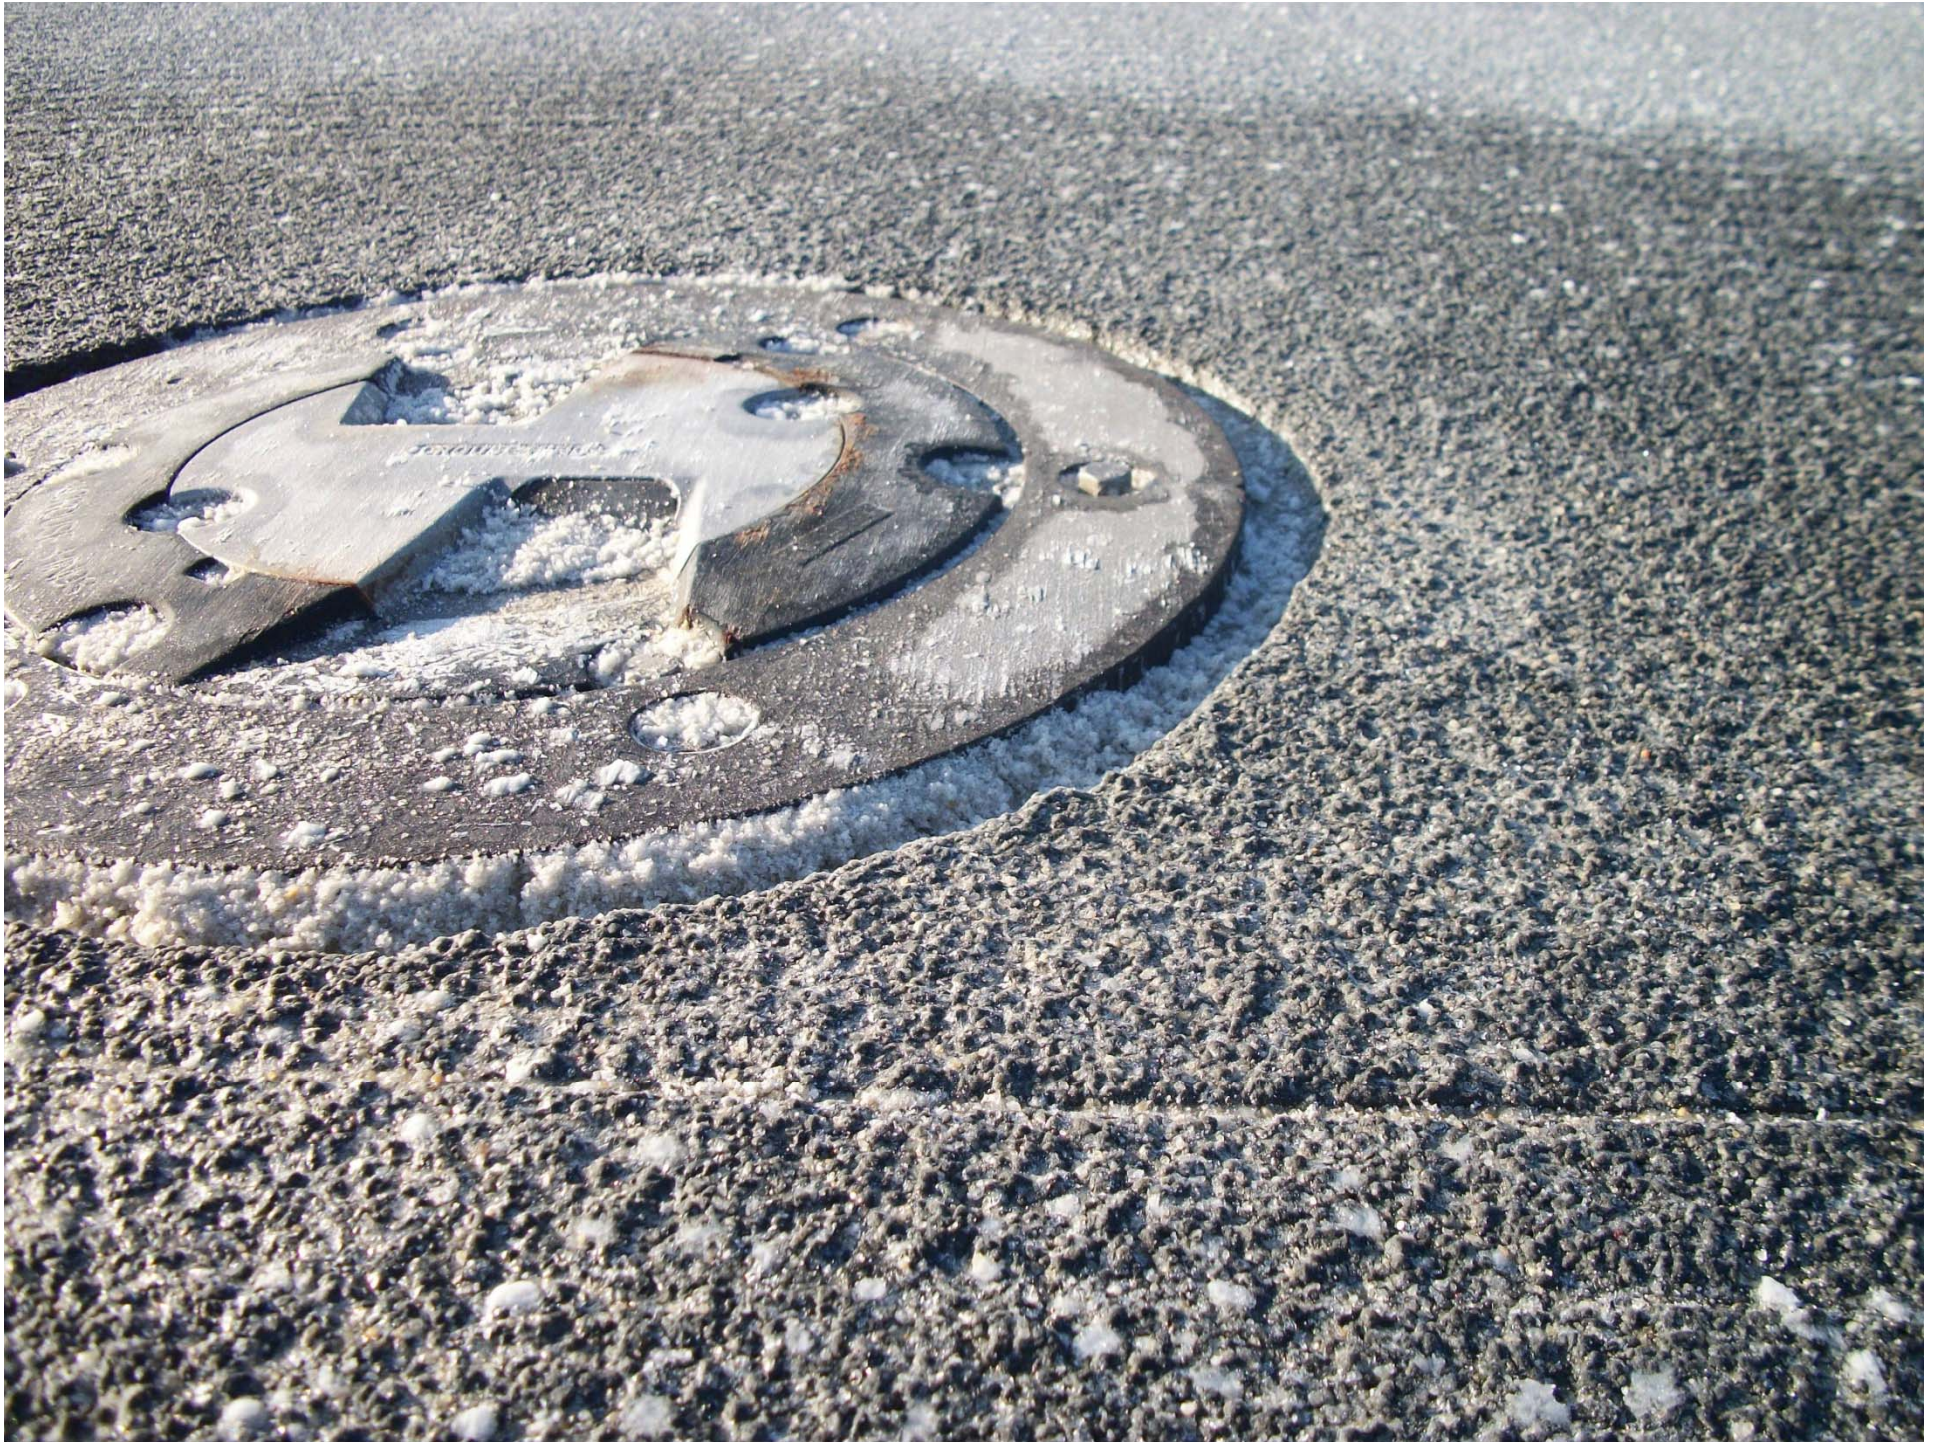
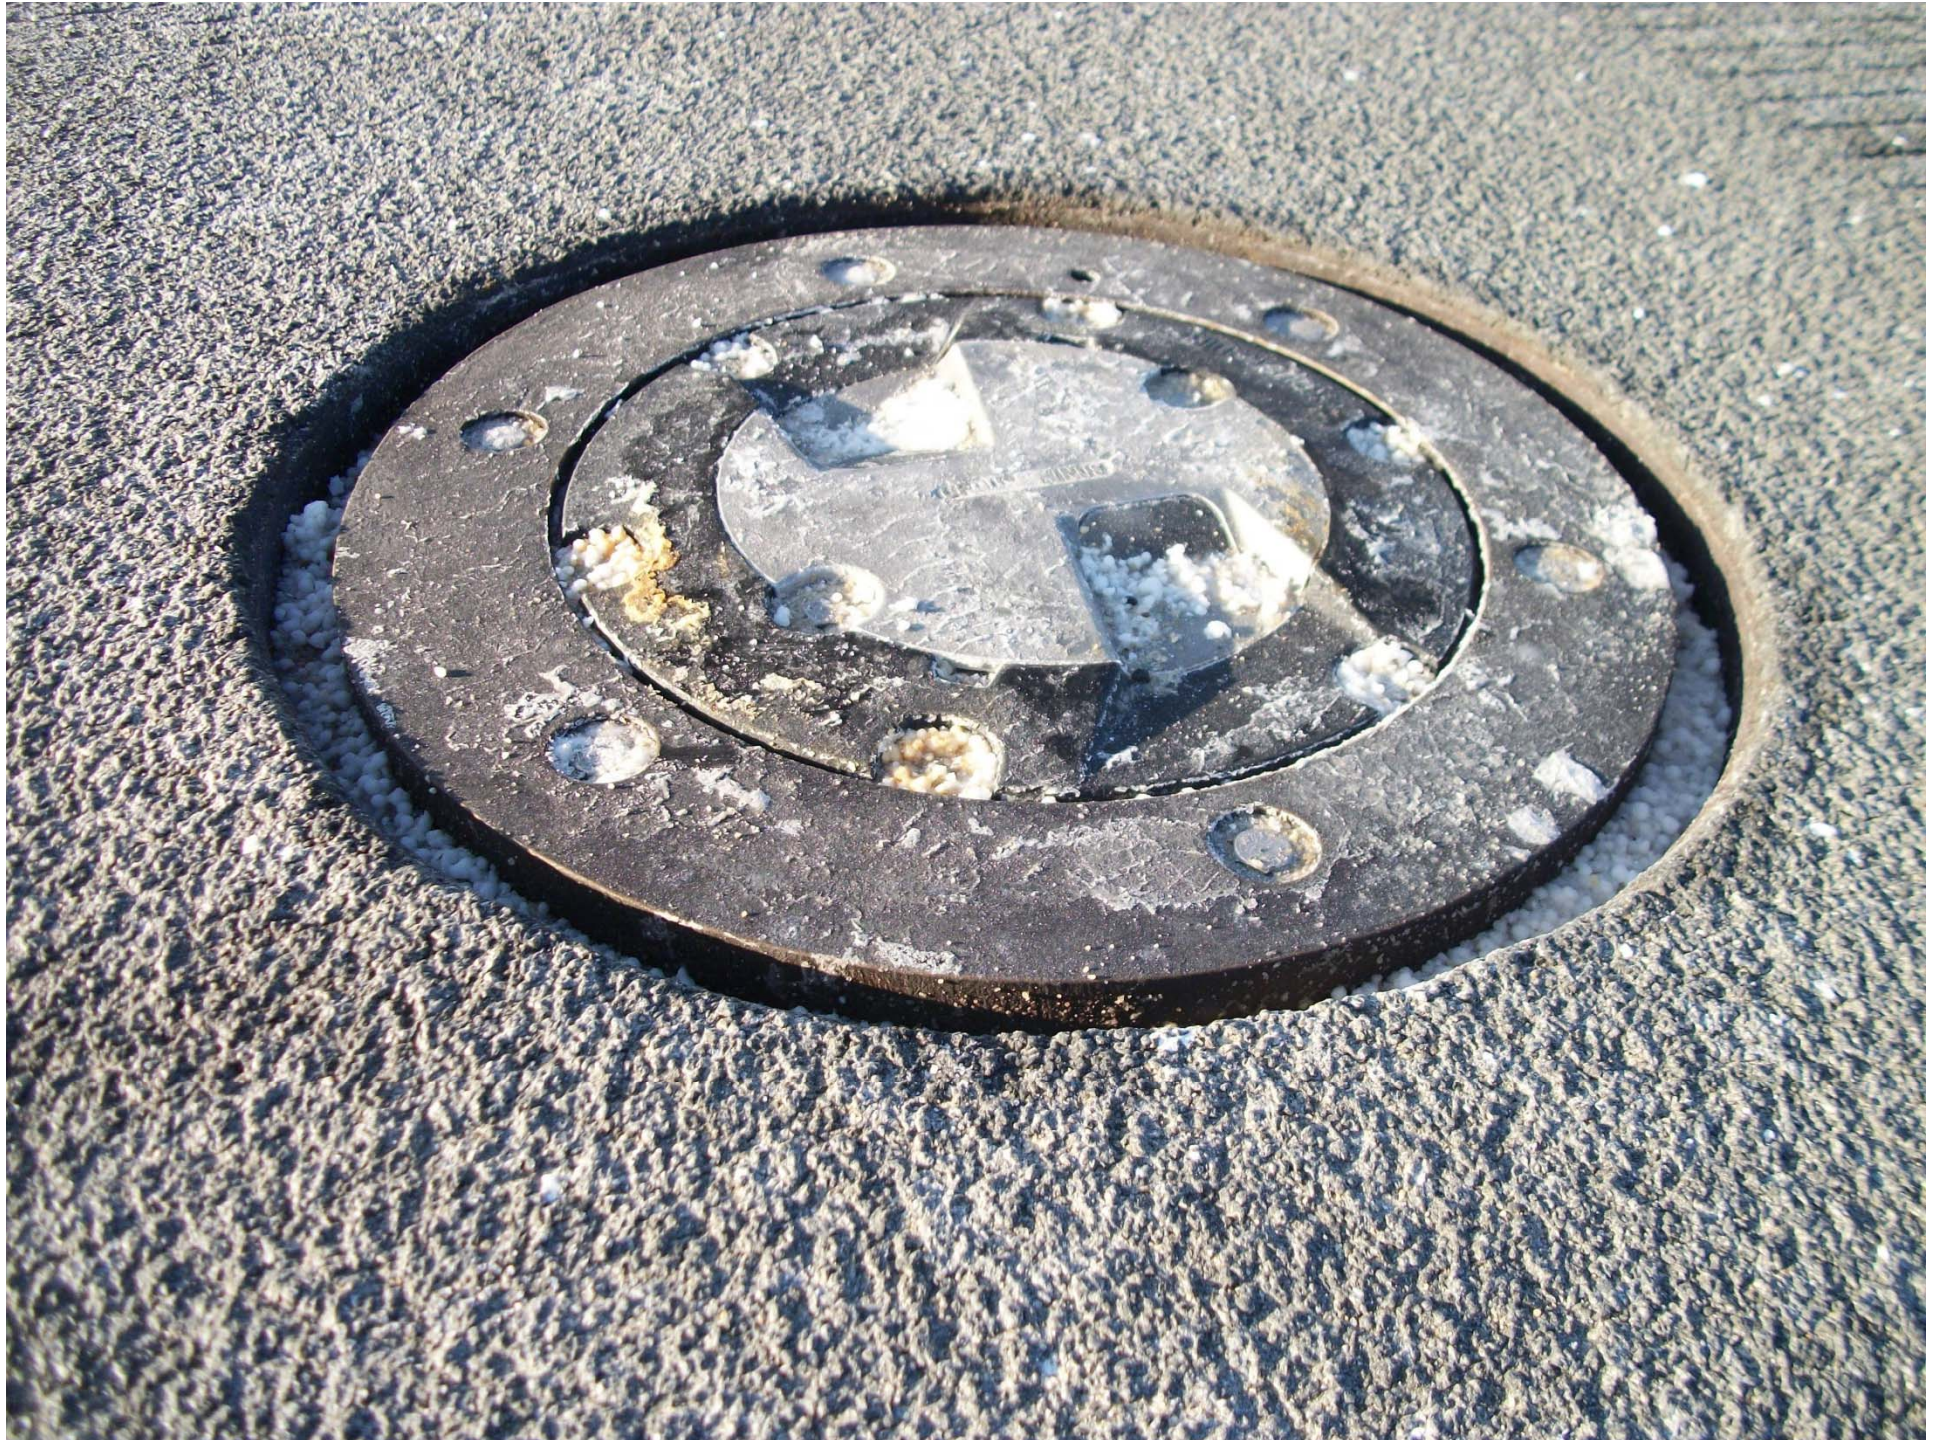
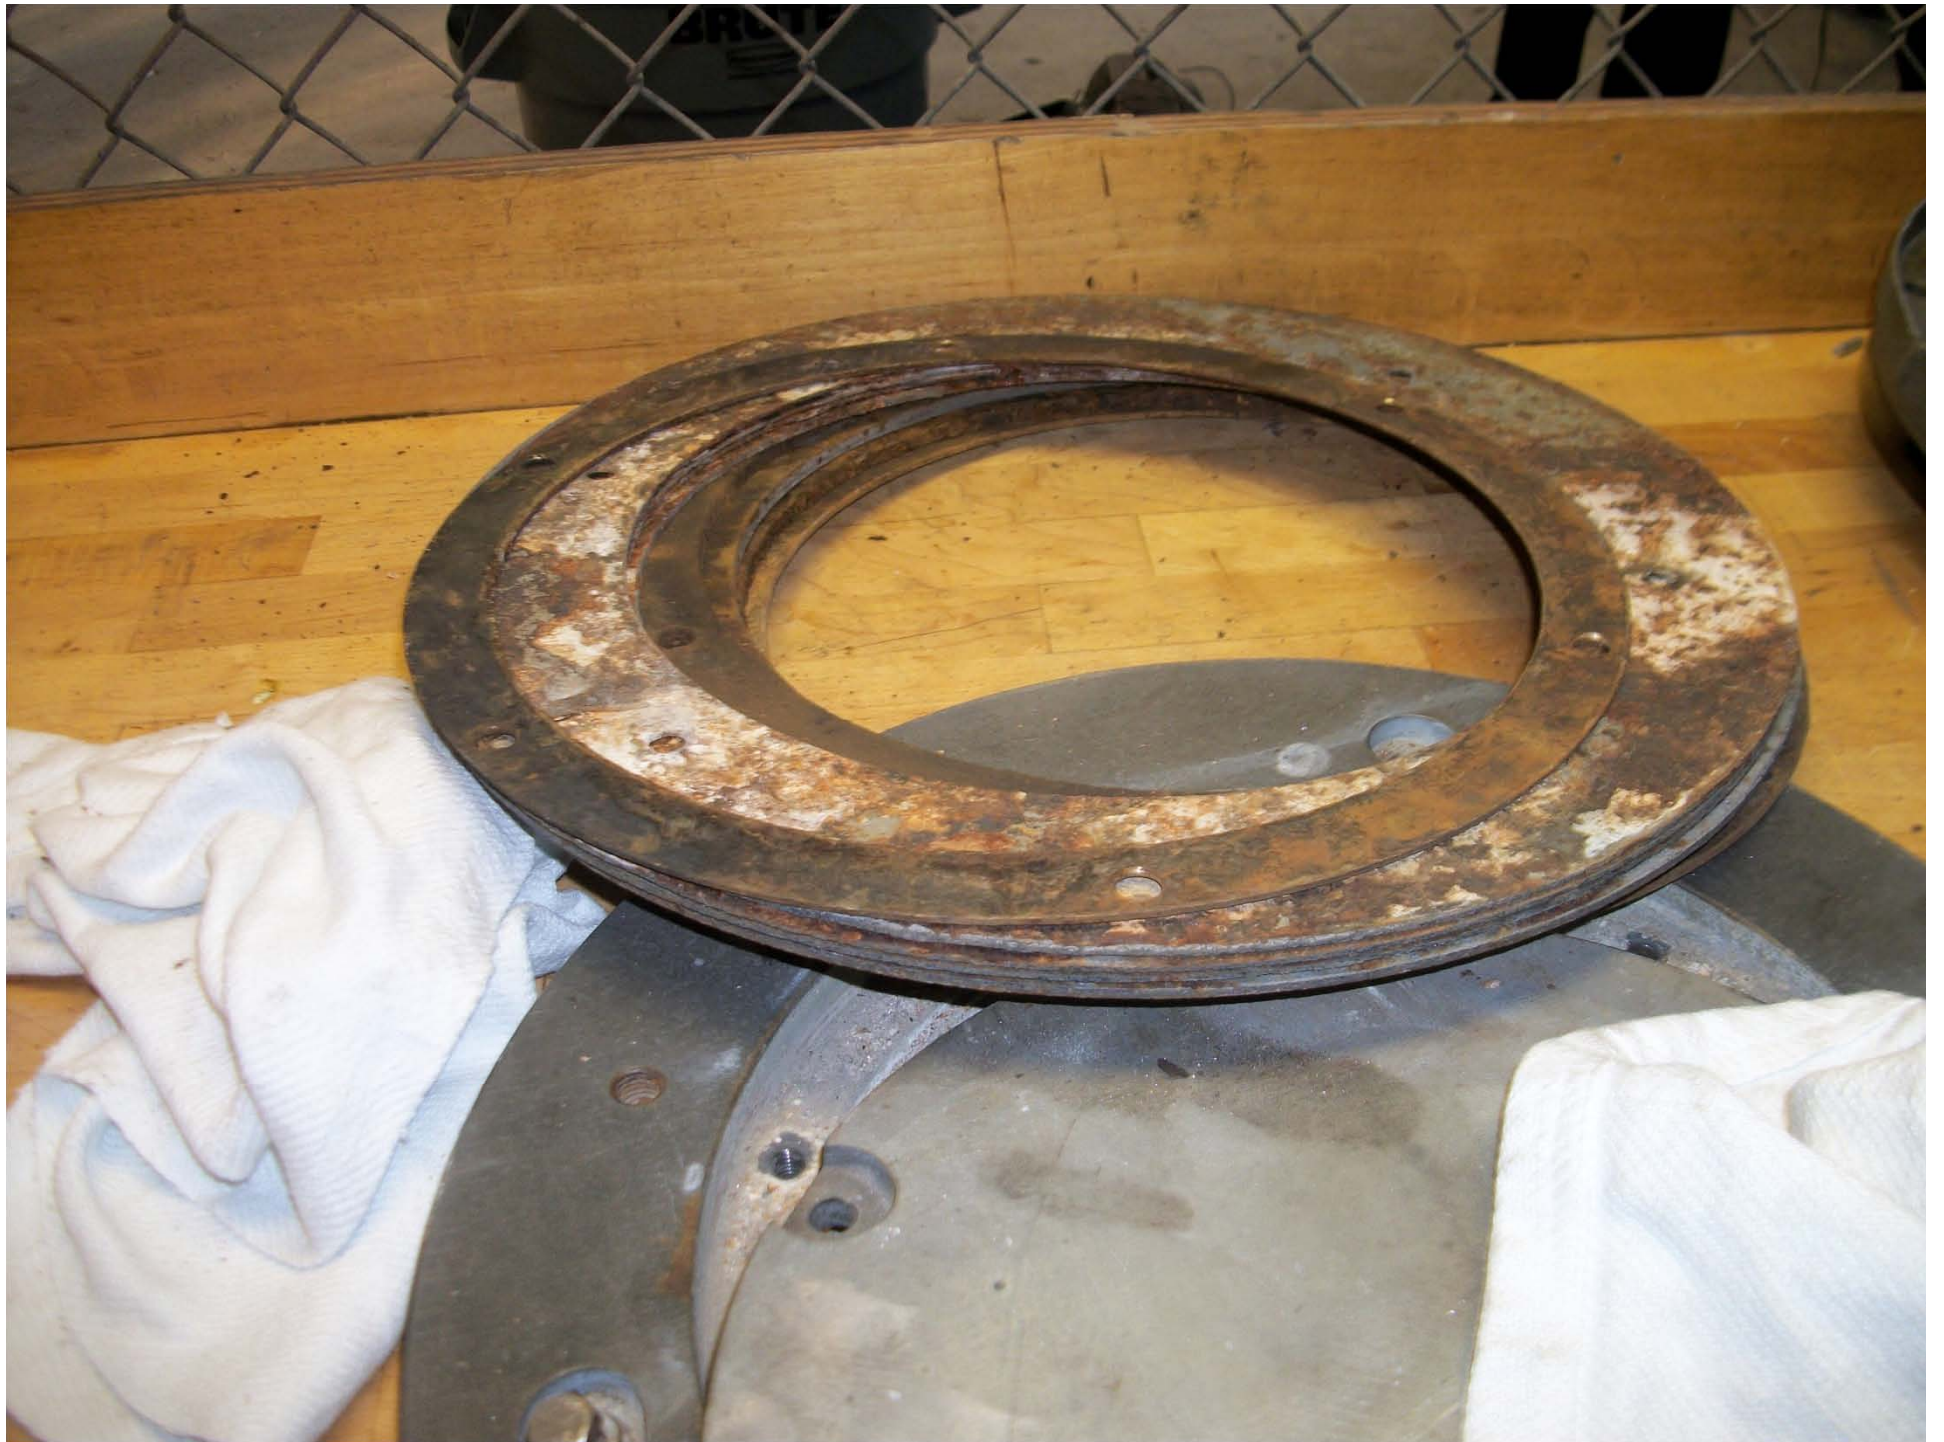
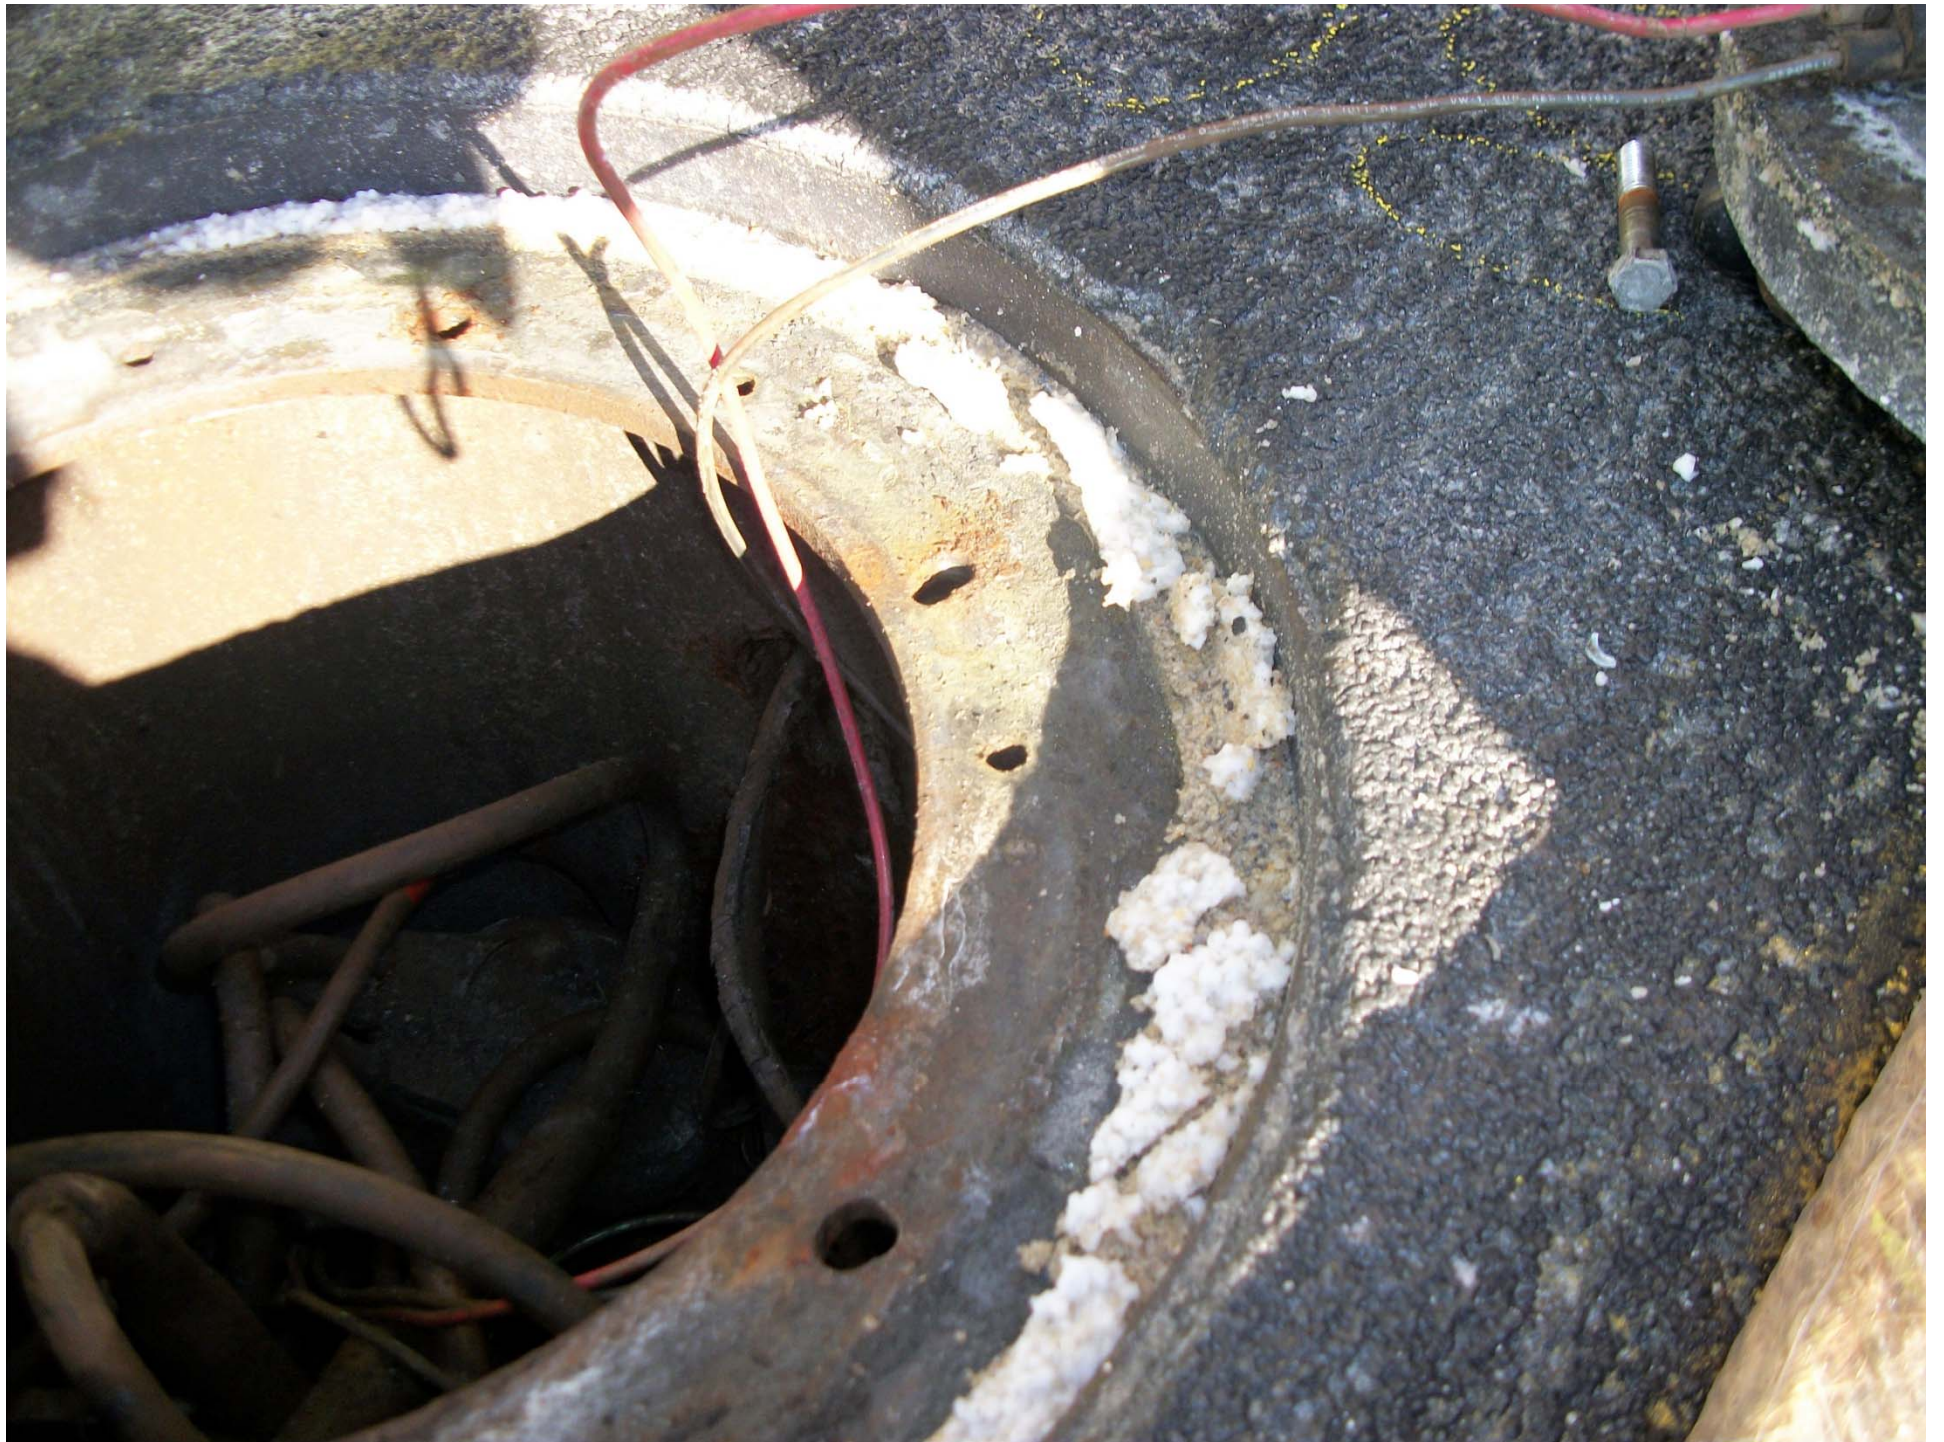
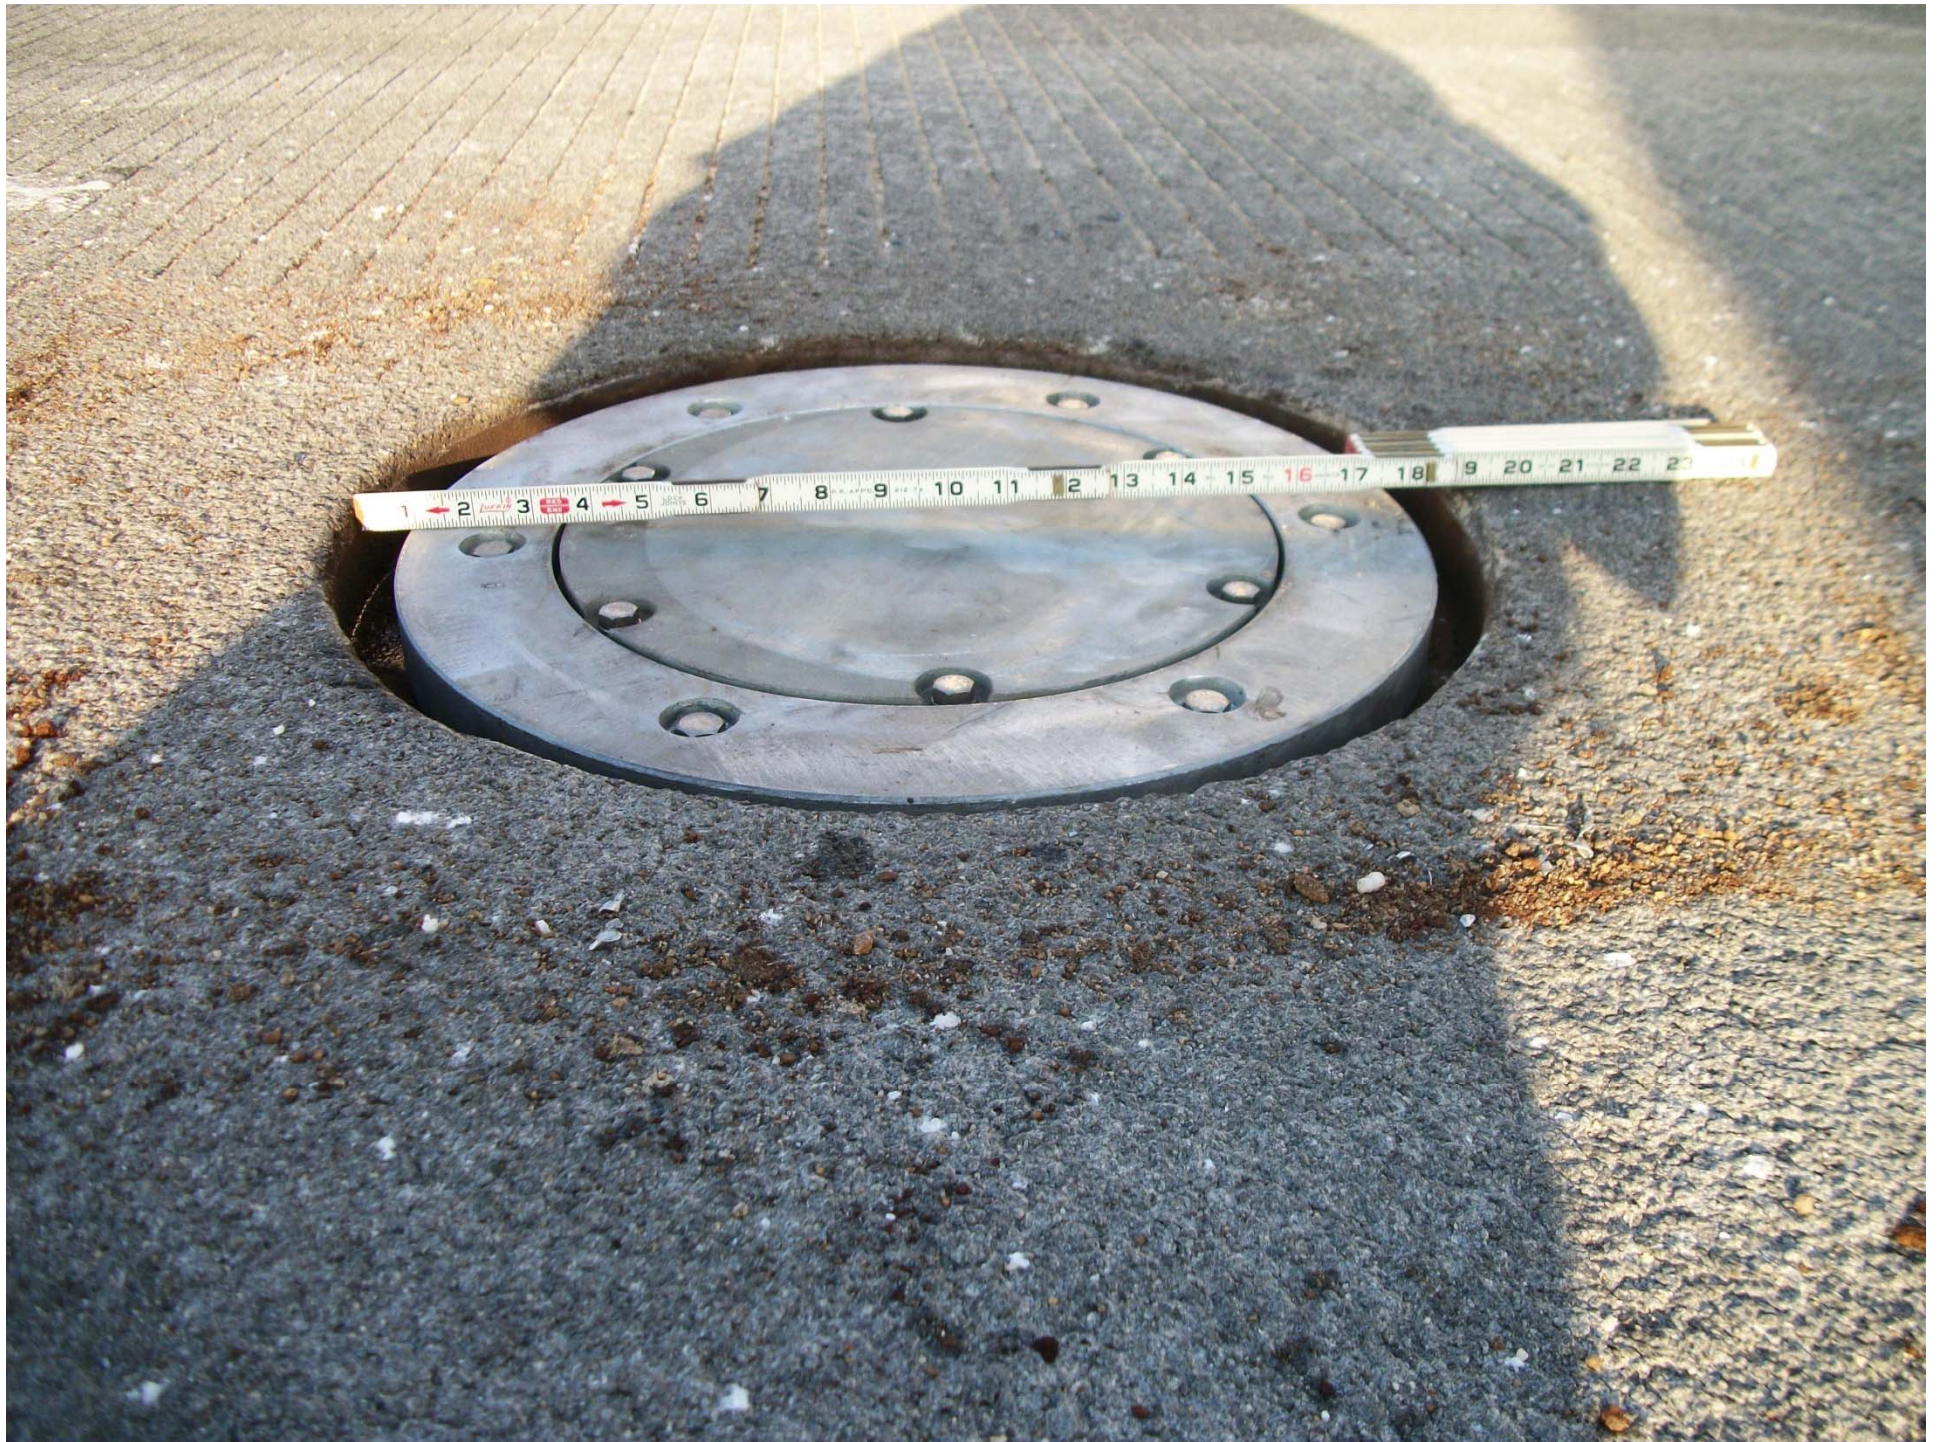
# Bolt Failure

- If the 6 3/8" bolts are used solely to take the shear load they can fail

- Adapter ring was not tied to the pavement
- Adapter ring was not indented into the can
- Shim rings compounded the problem

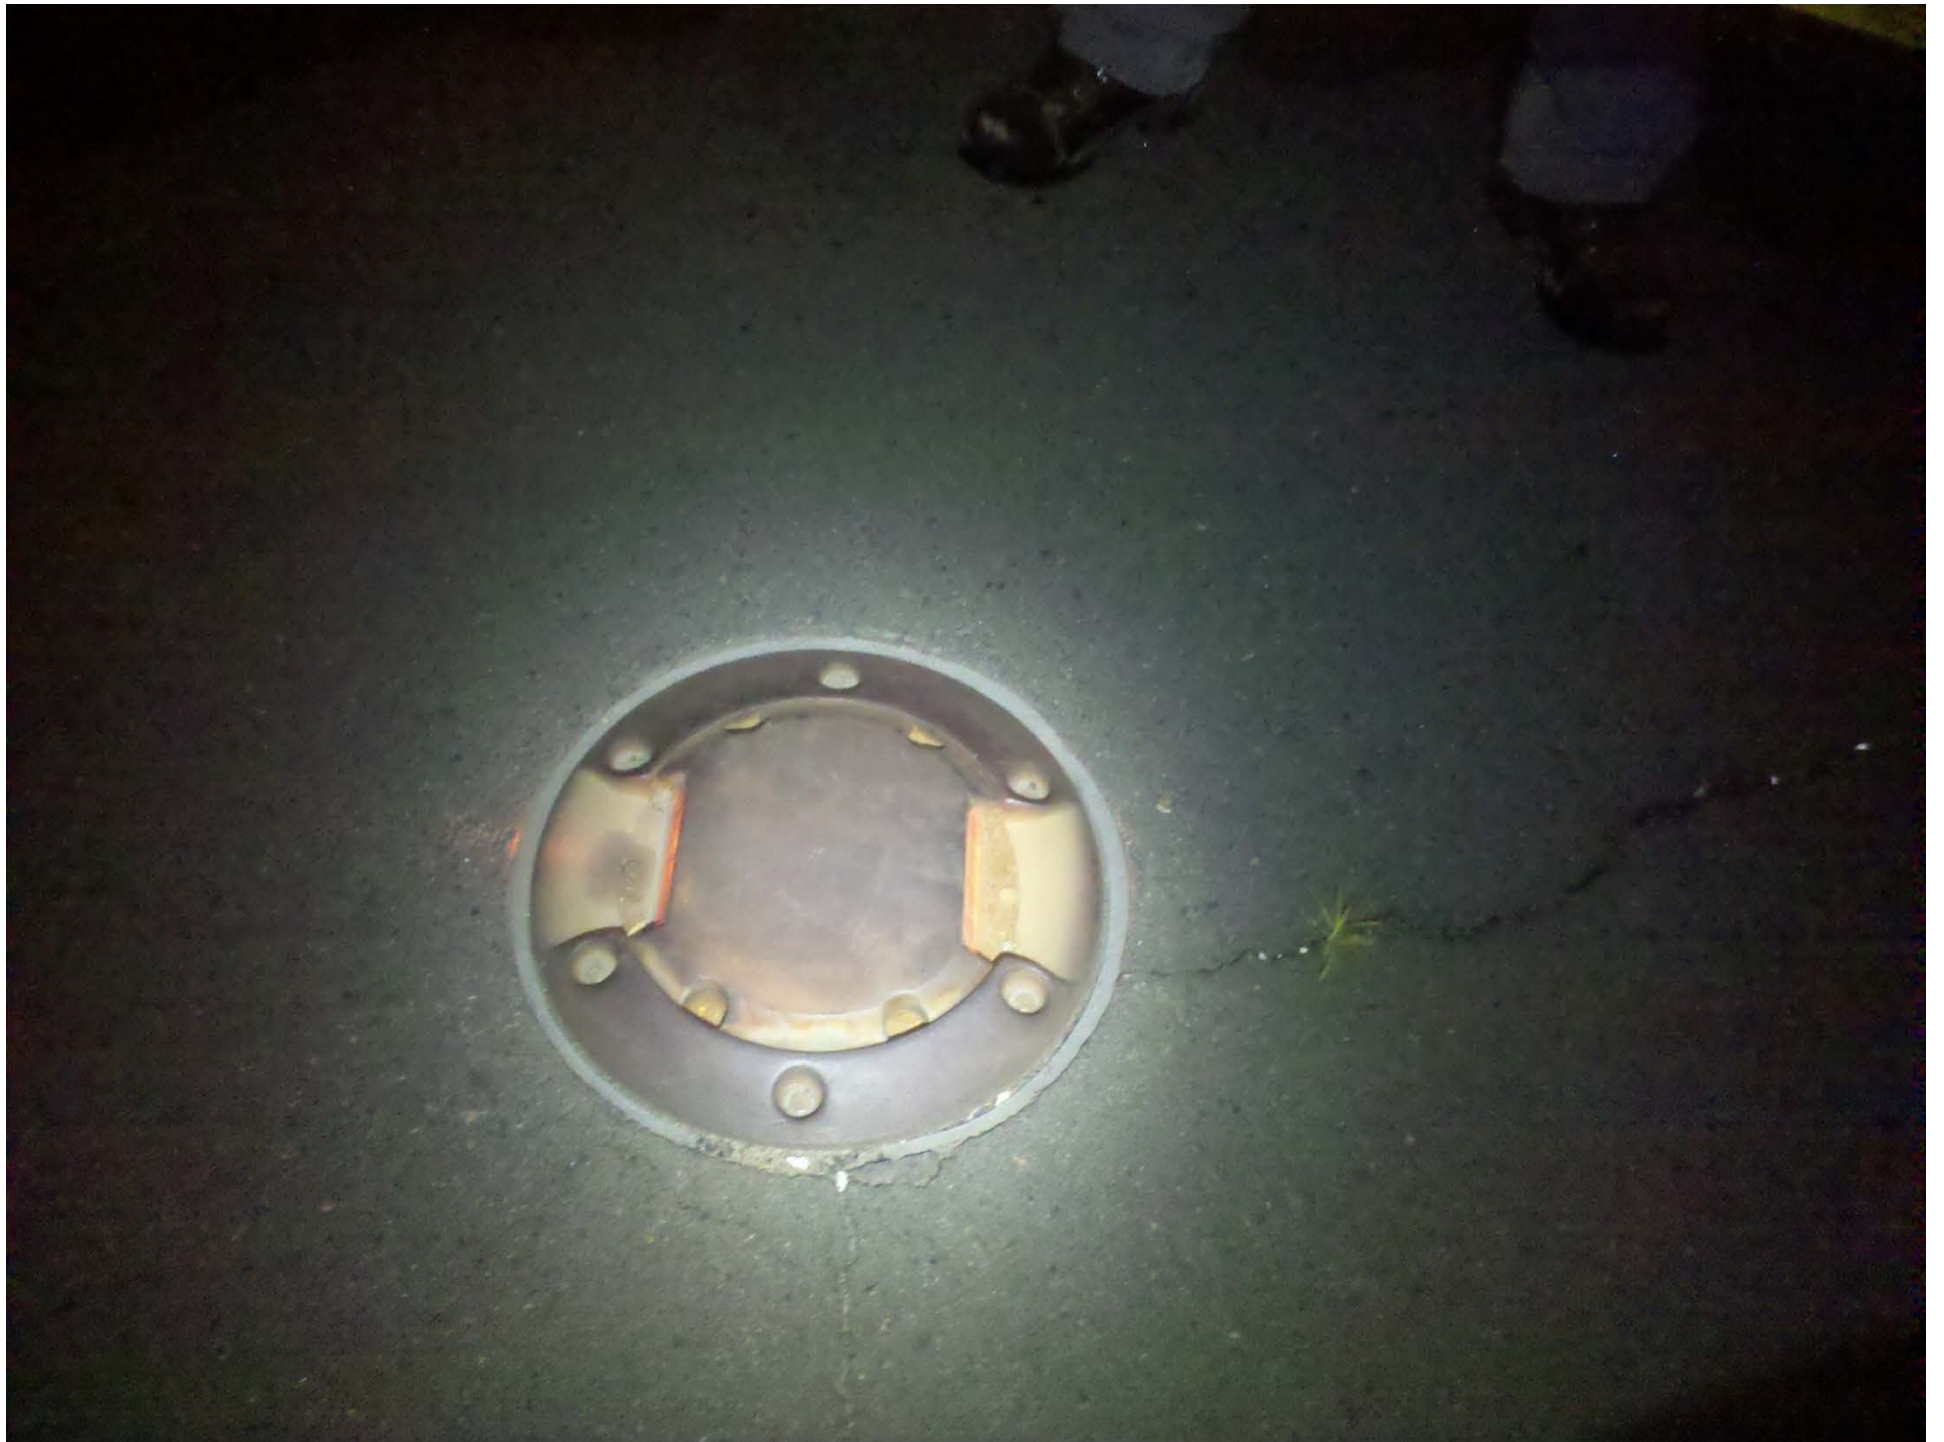
# Adapter Rings

- We have used adapter rings for a long time
- Many have been installed for a long time
- No problem
