# IES-2011

## Airport Lighting Cans Load Transfer

**Daniel E Geary**

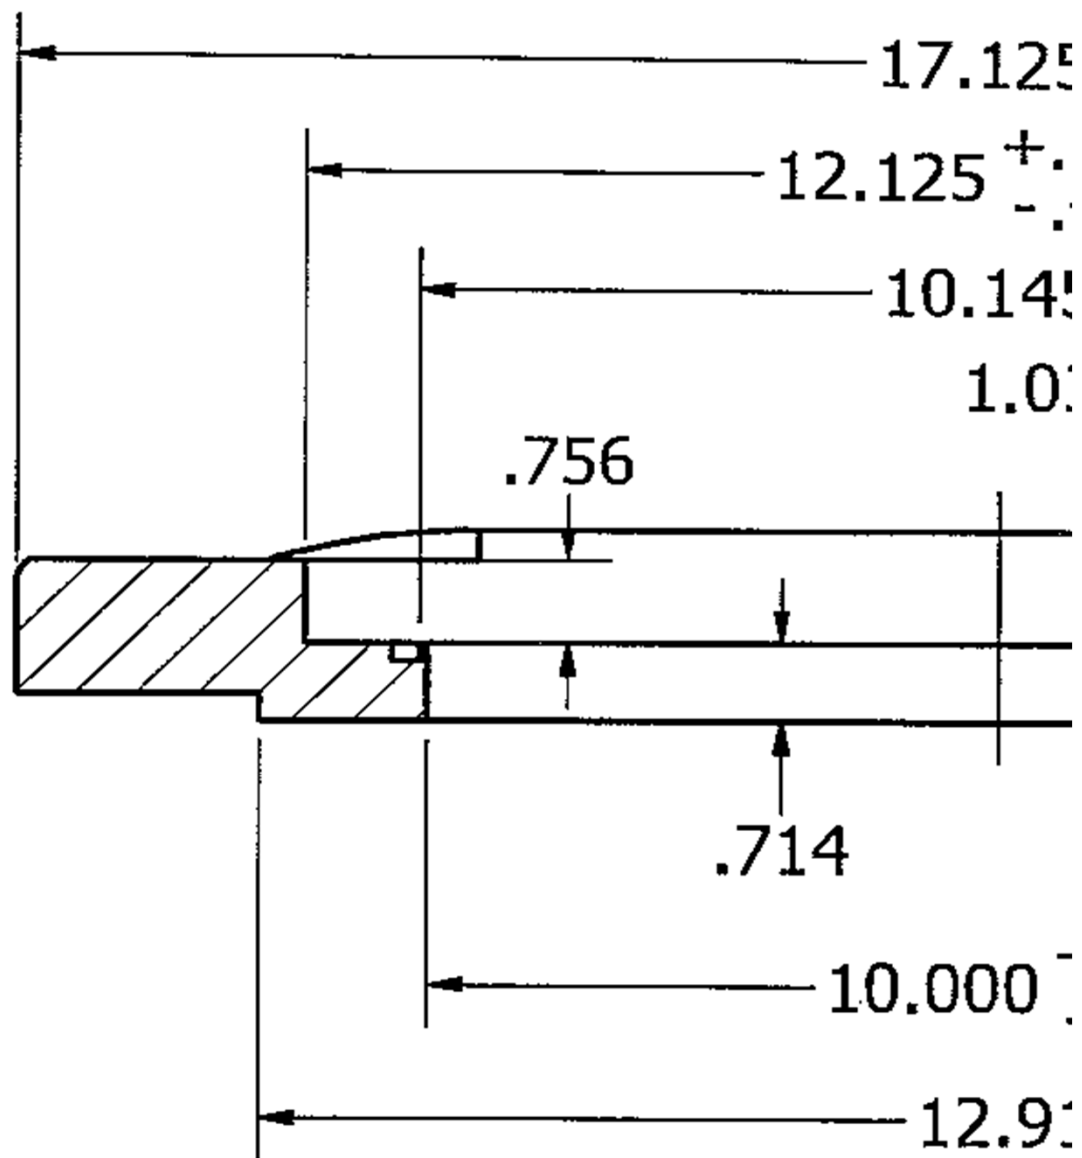
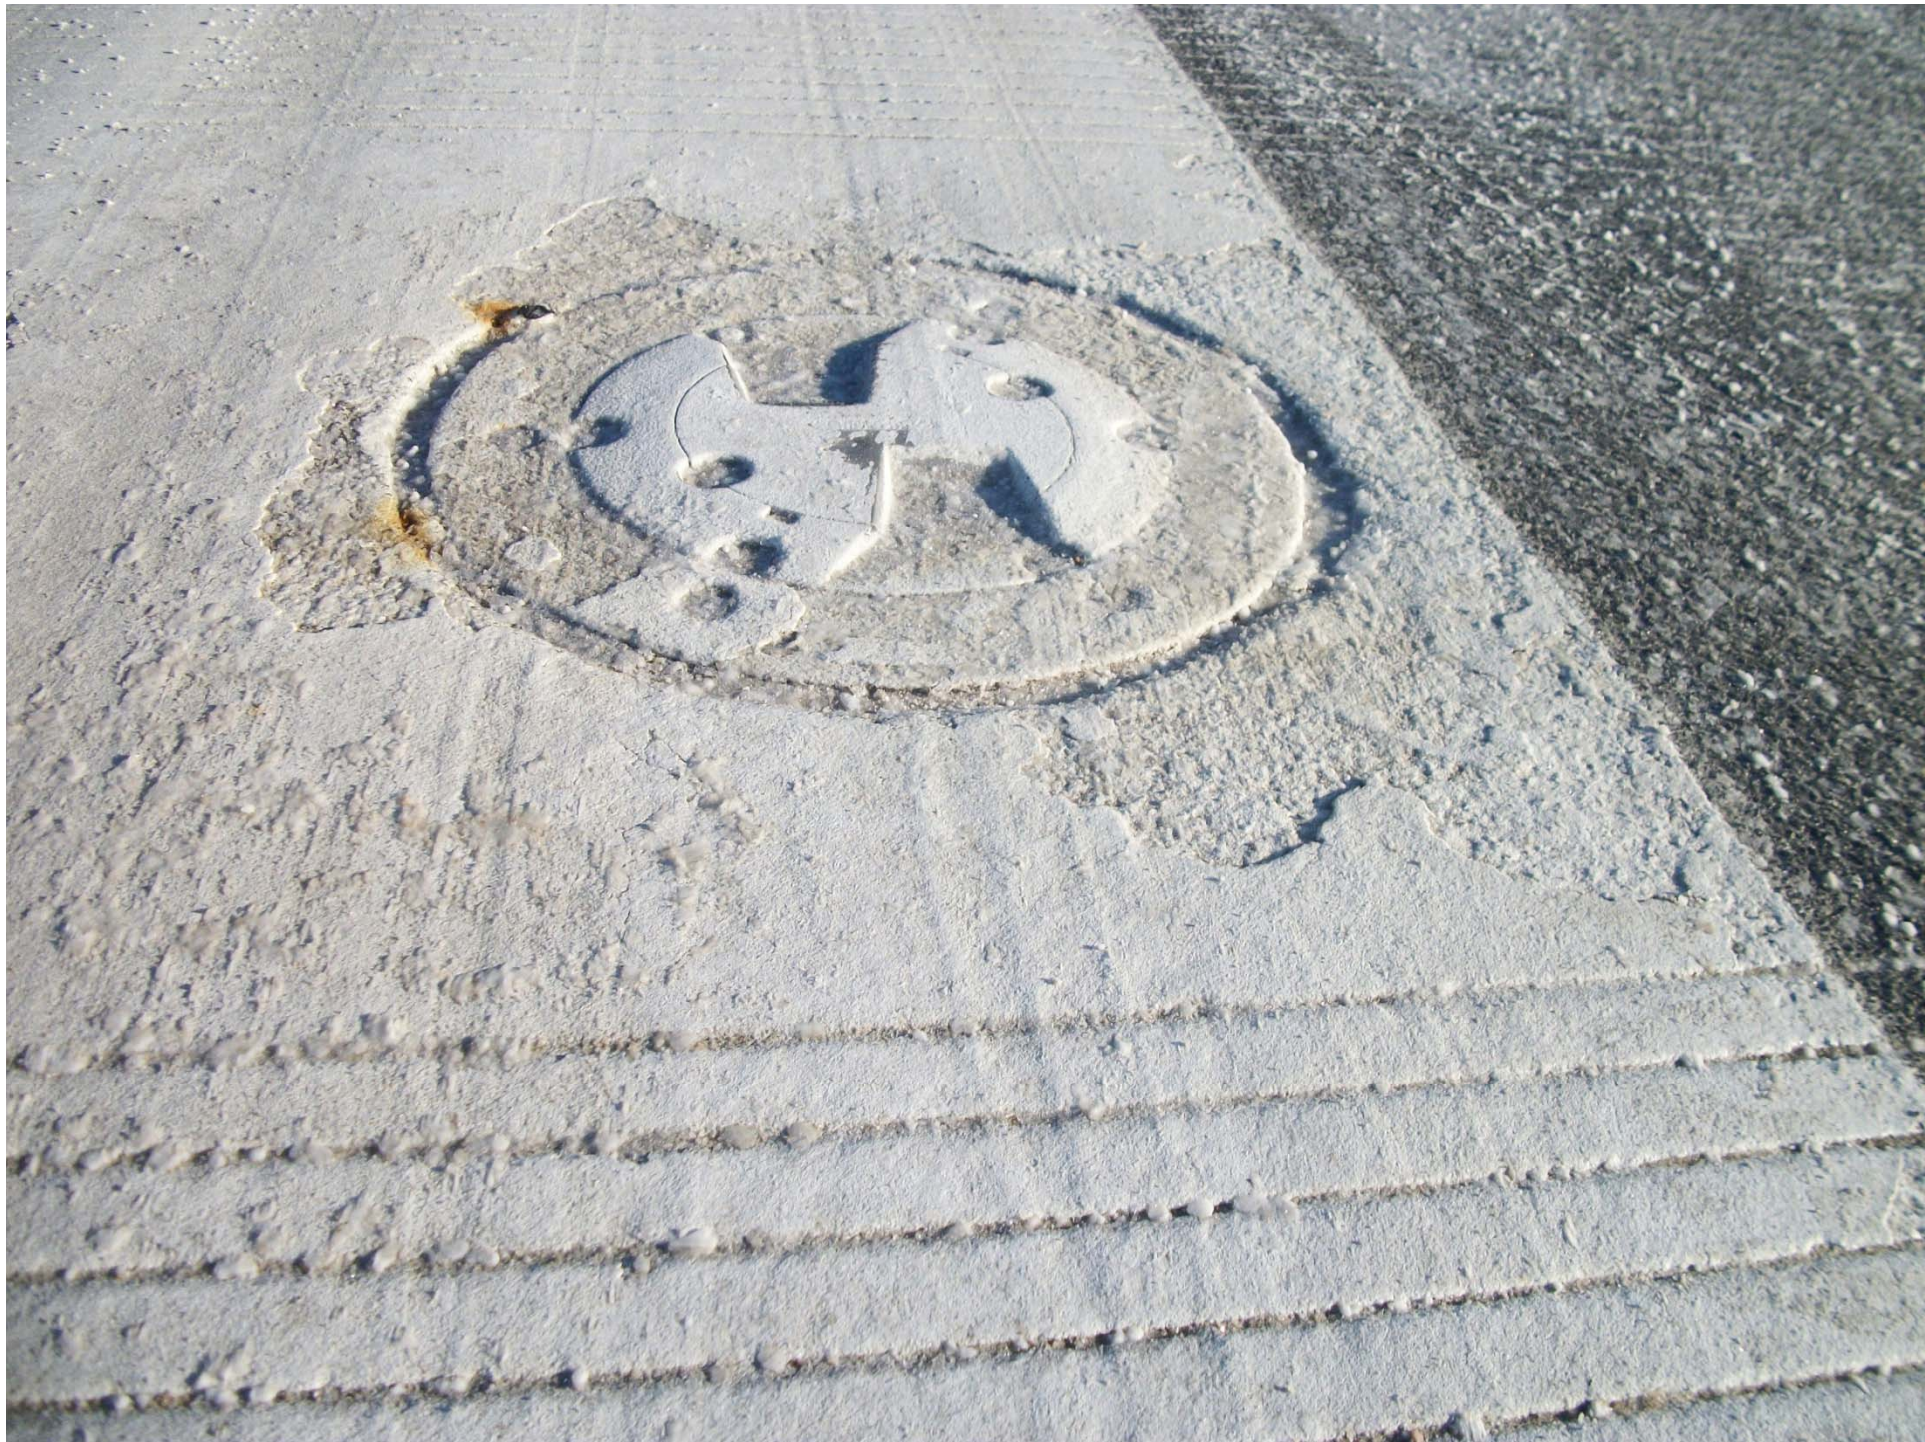
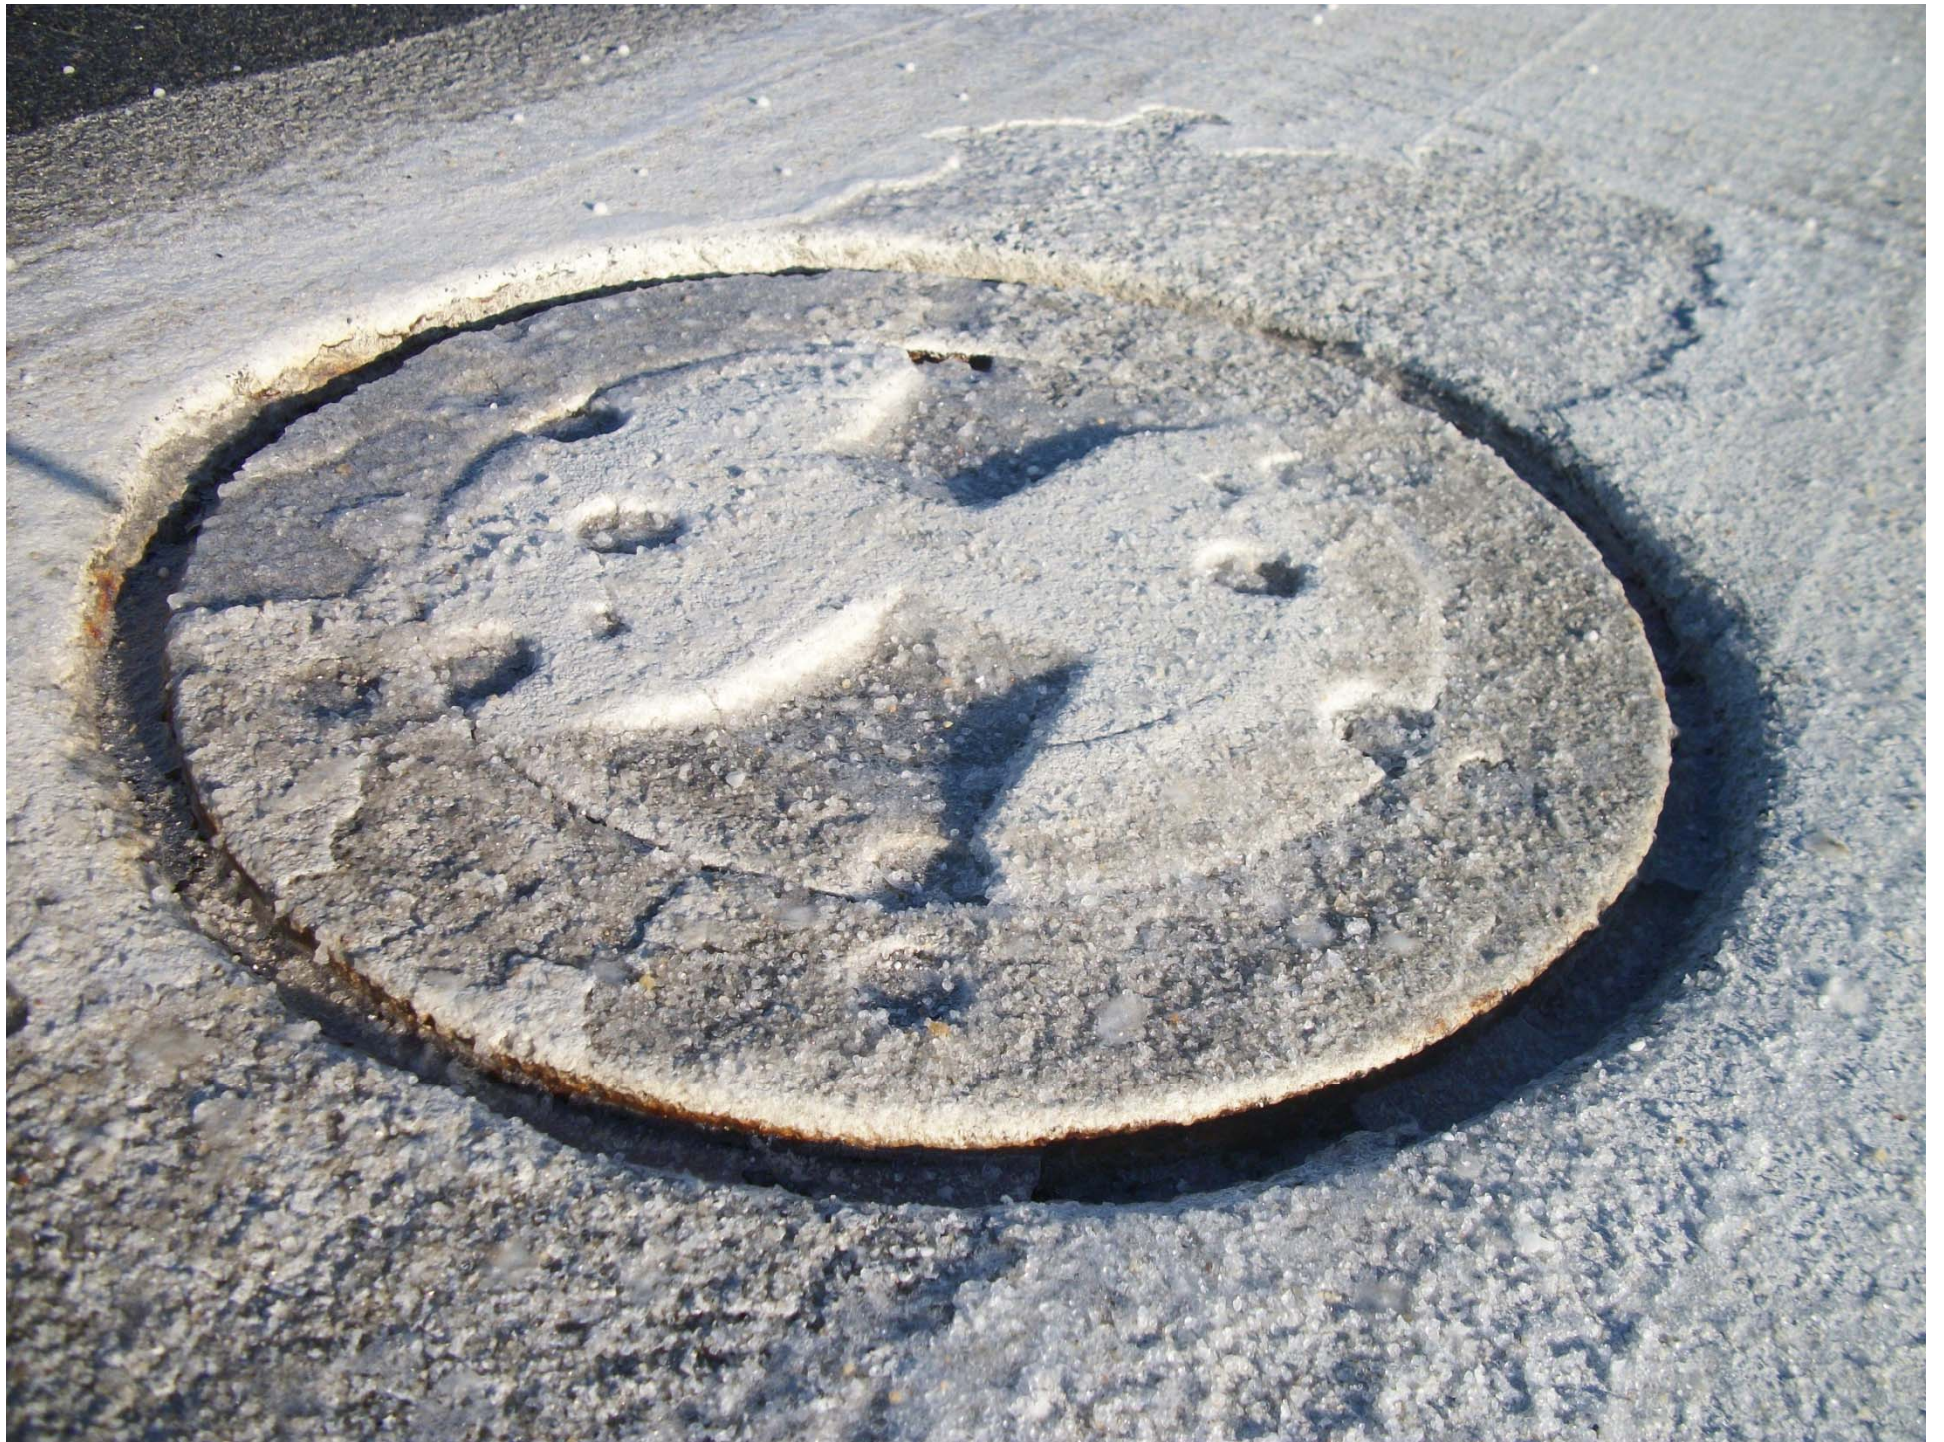
# Correct Installation

- Adapter ring was machined with a indent that matched the top of the can
- When installed the adapter ring set down inside the can and locked the ring to the can
- The bolts held the can down but the shear load was carried by the can
- Also note there is one set of bolts to hold the ring to the can and another set to hold the fixture to the ring

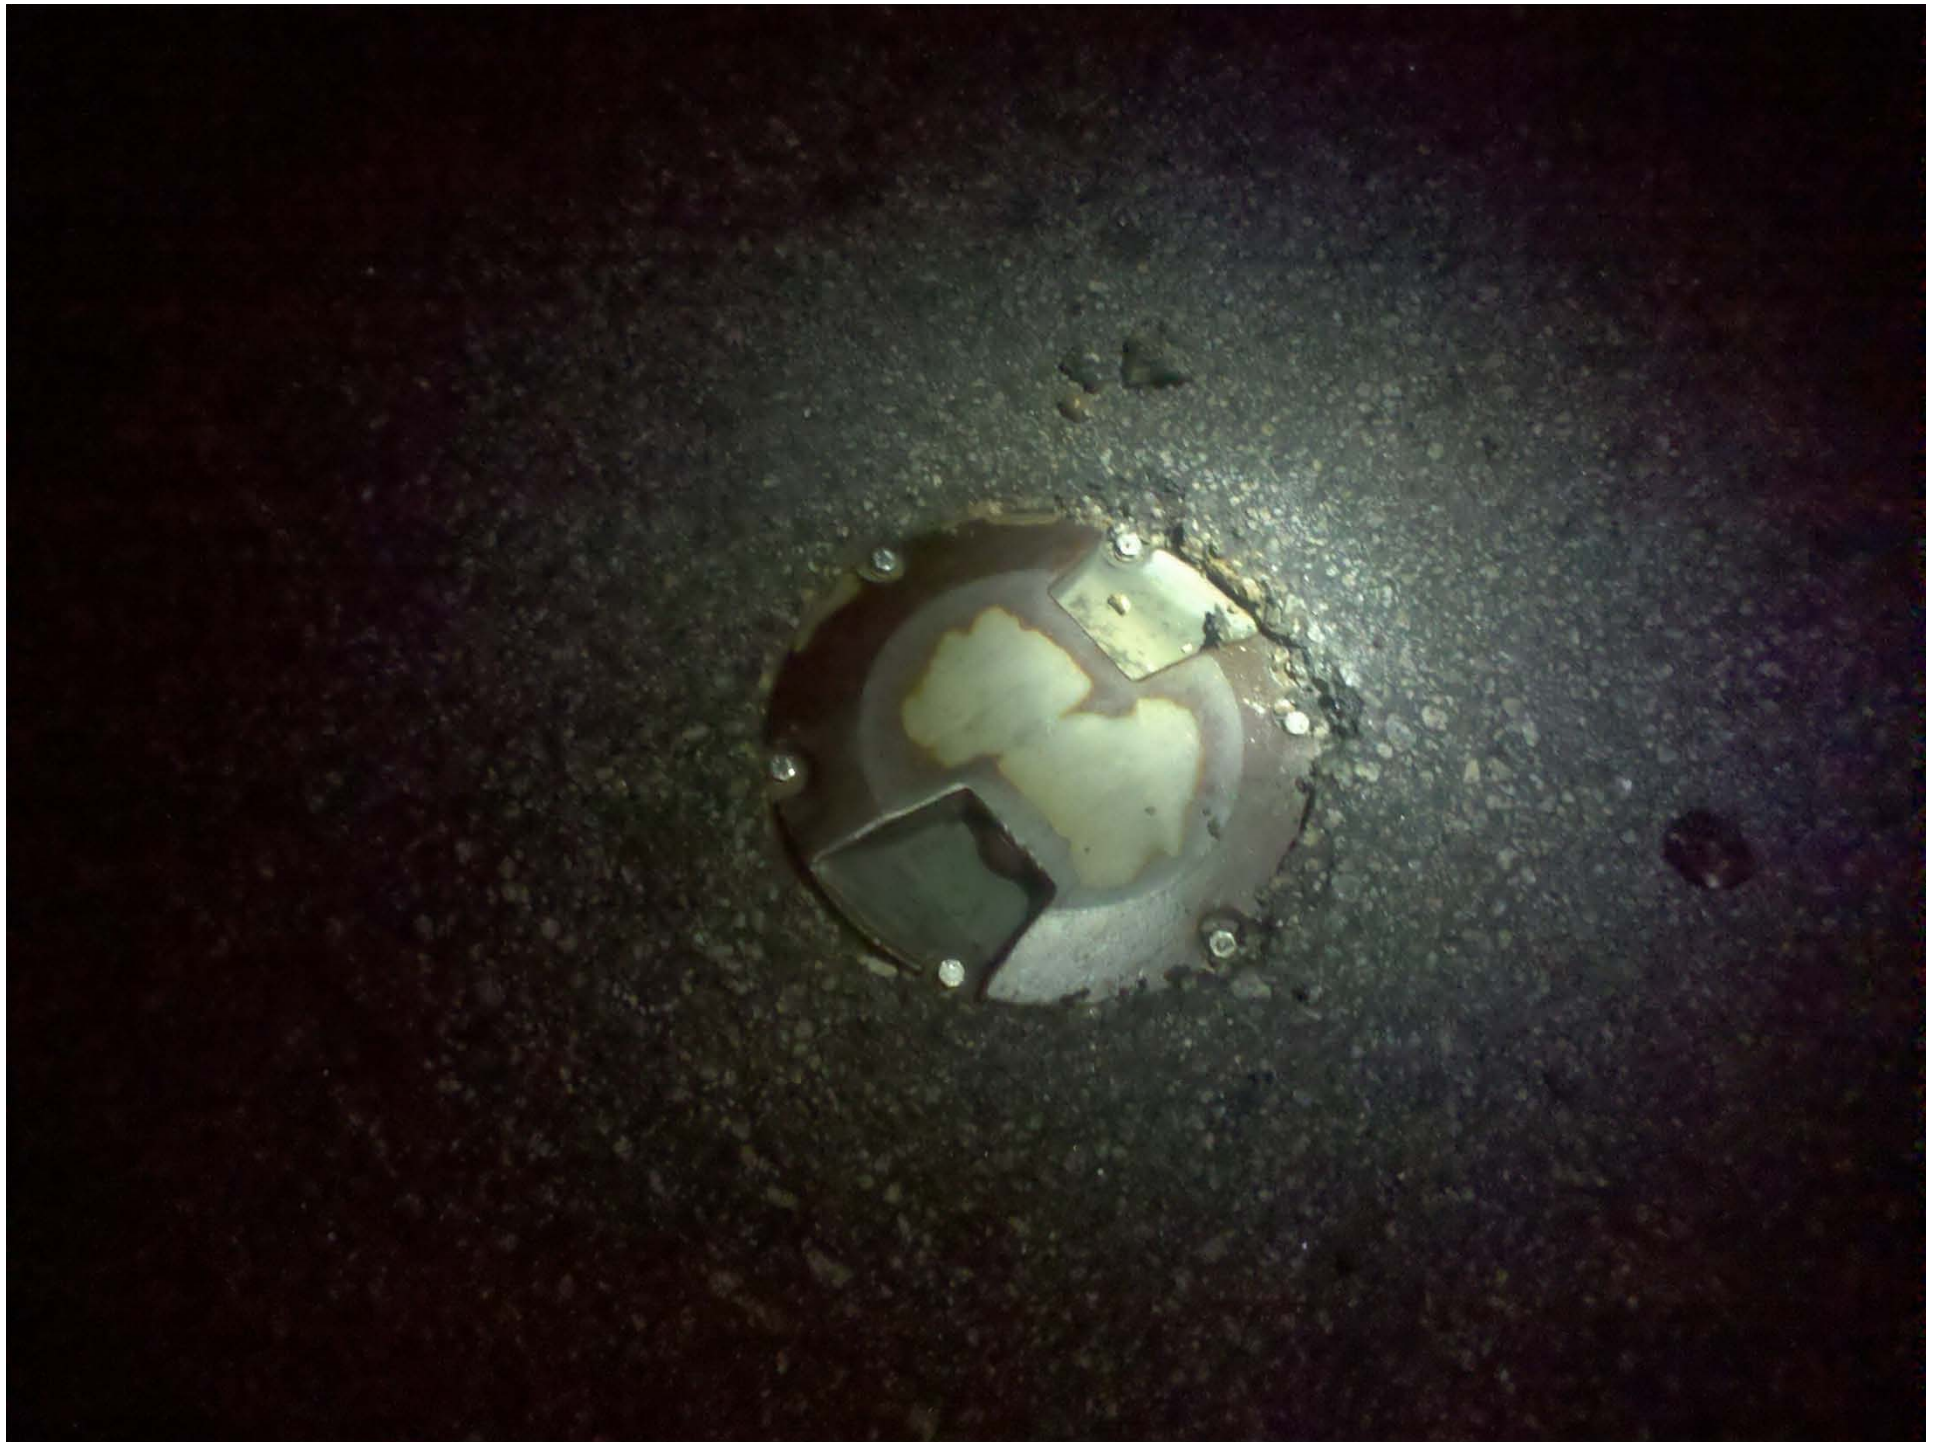
# Top Section Failure

- Fixtures slowly sinking into the pavement
- Some down far enough they were patched over with asphalt
- Some were repaired by drilling under the can and injecting grout

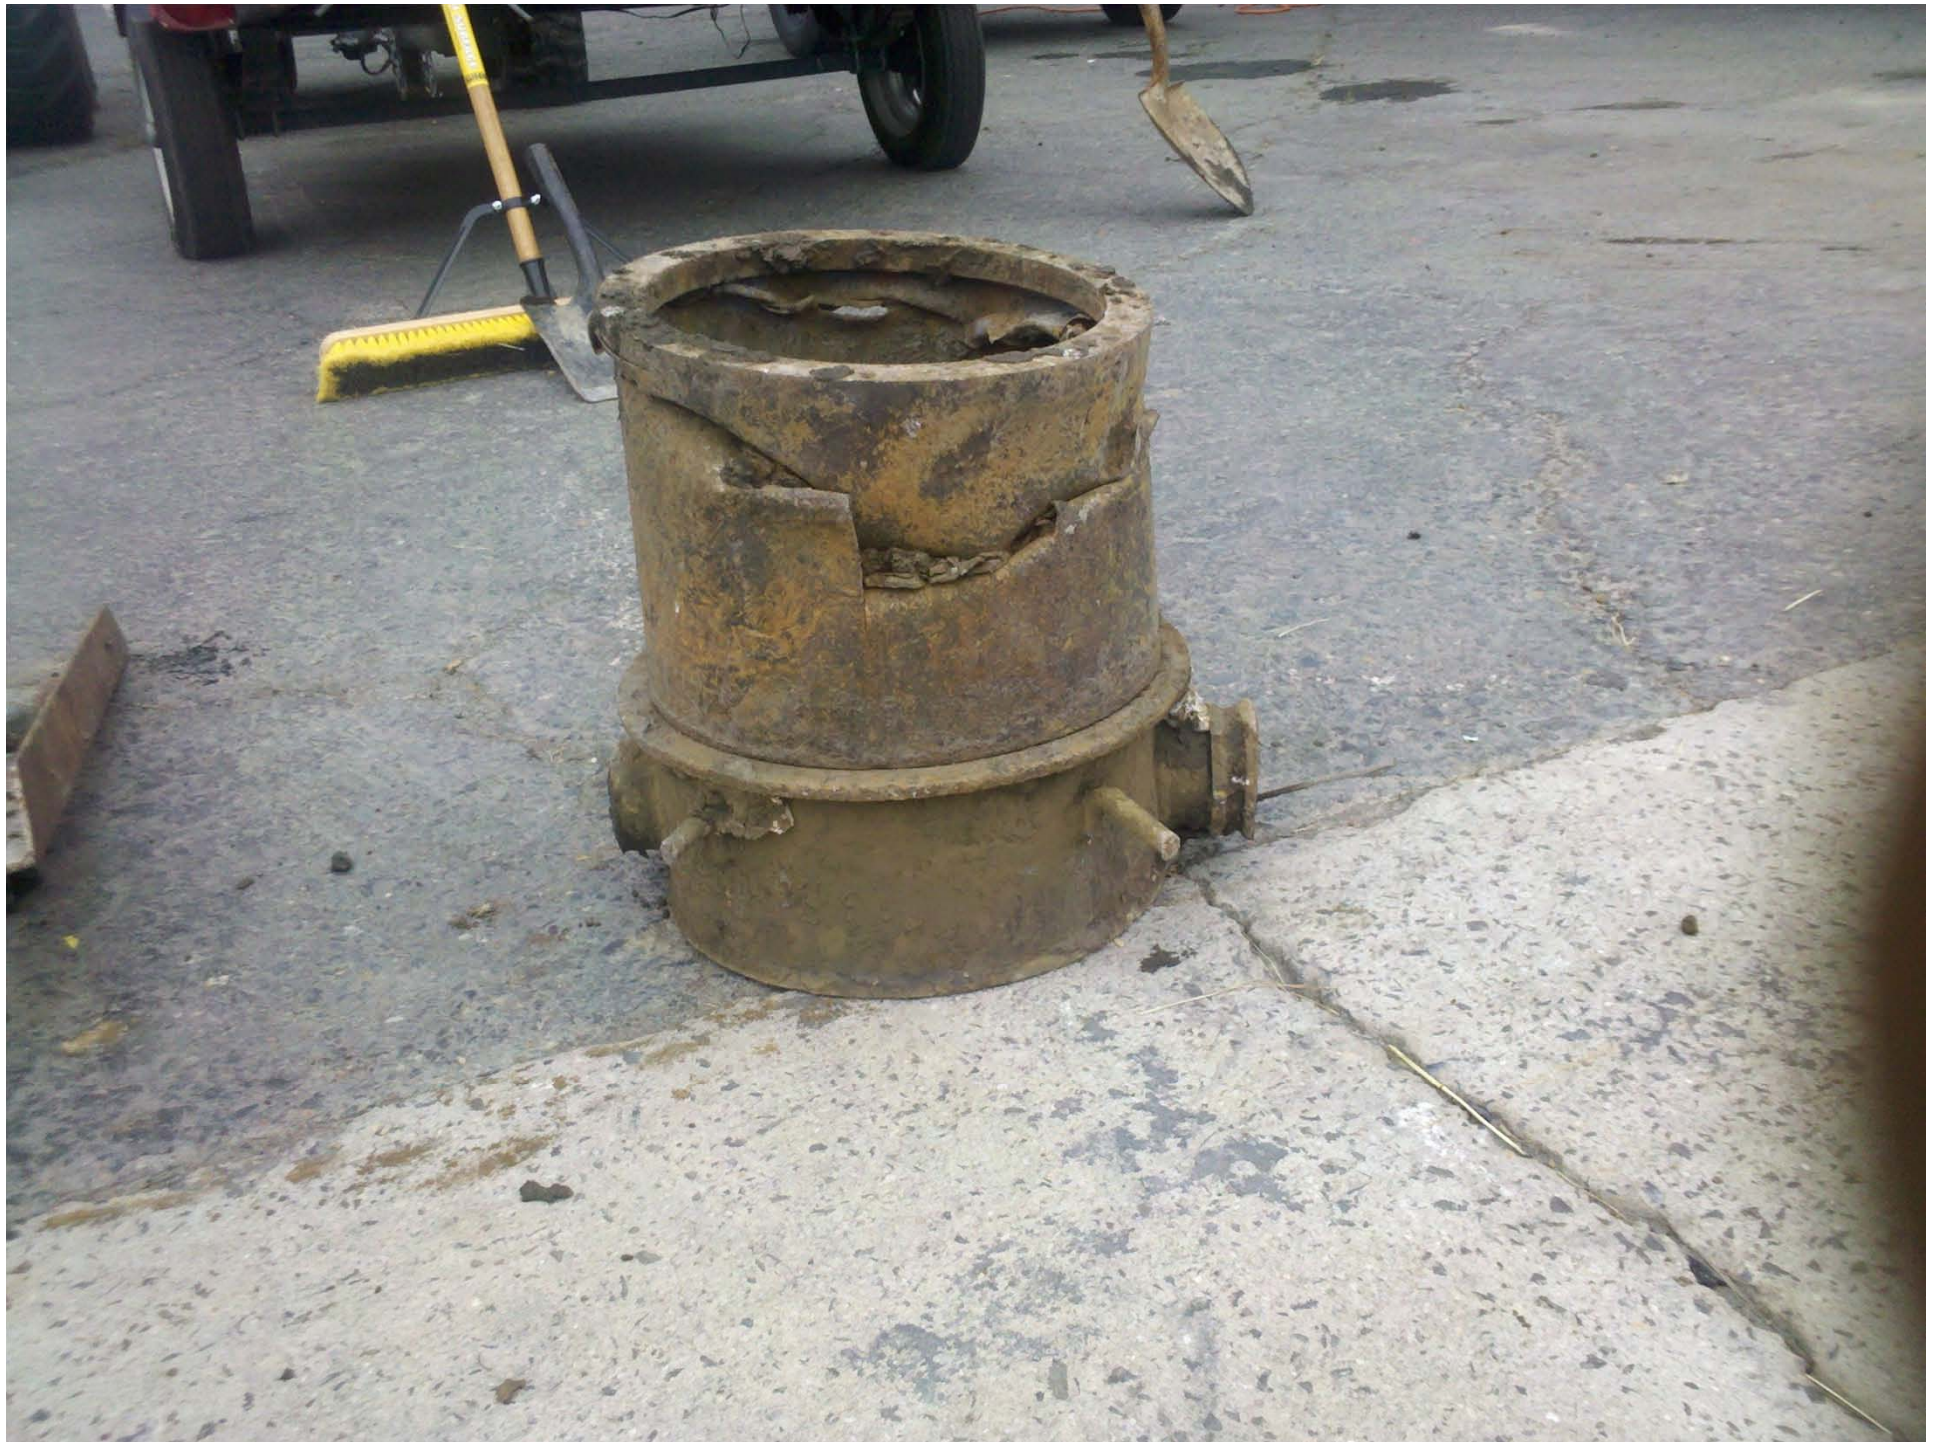
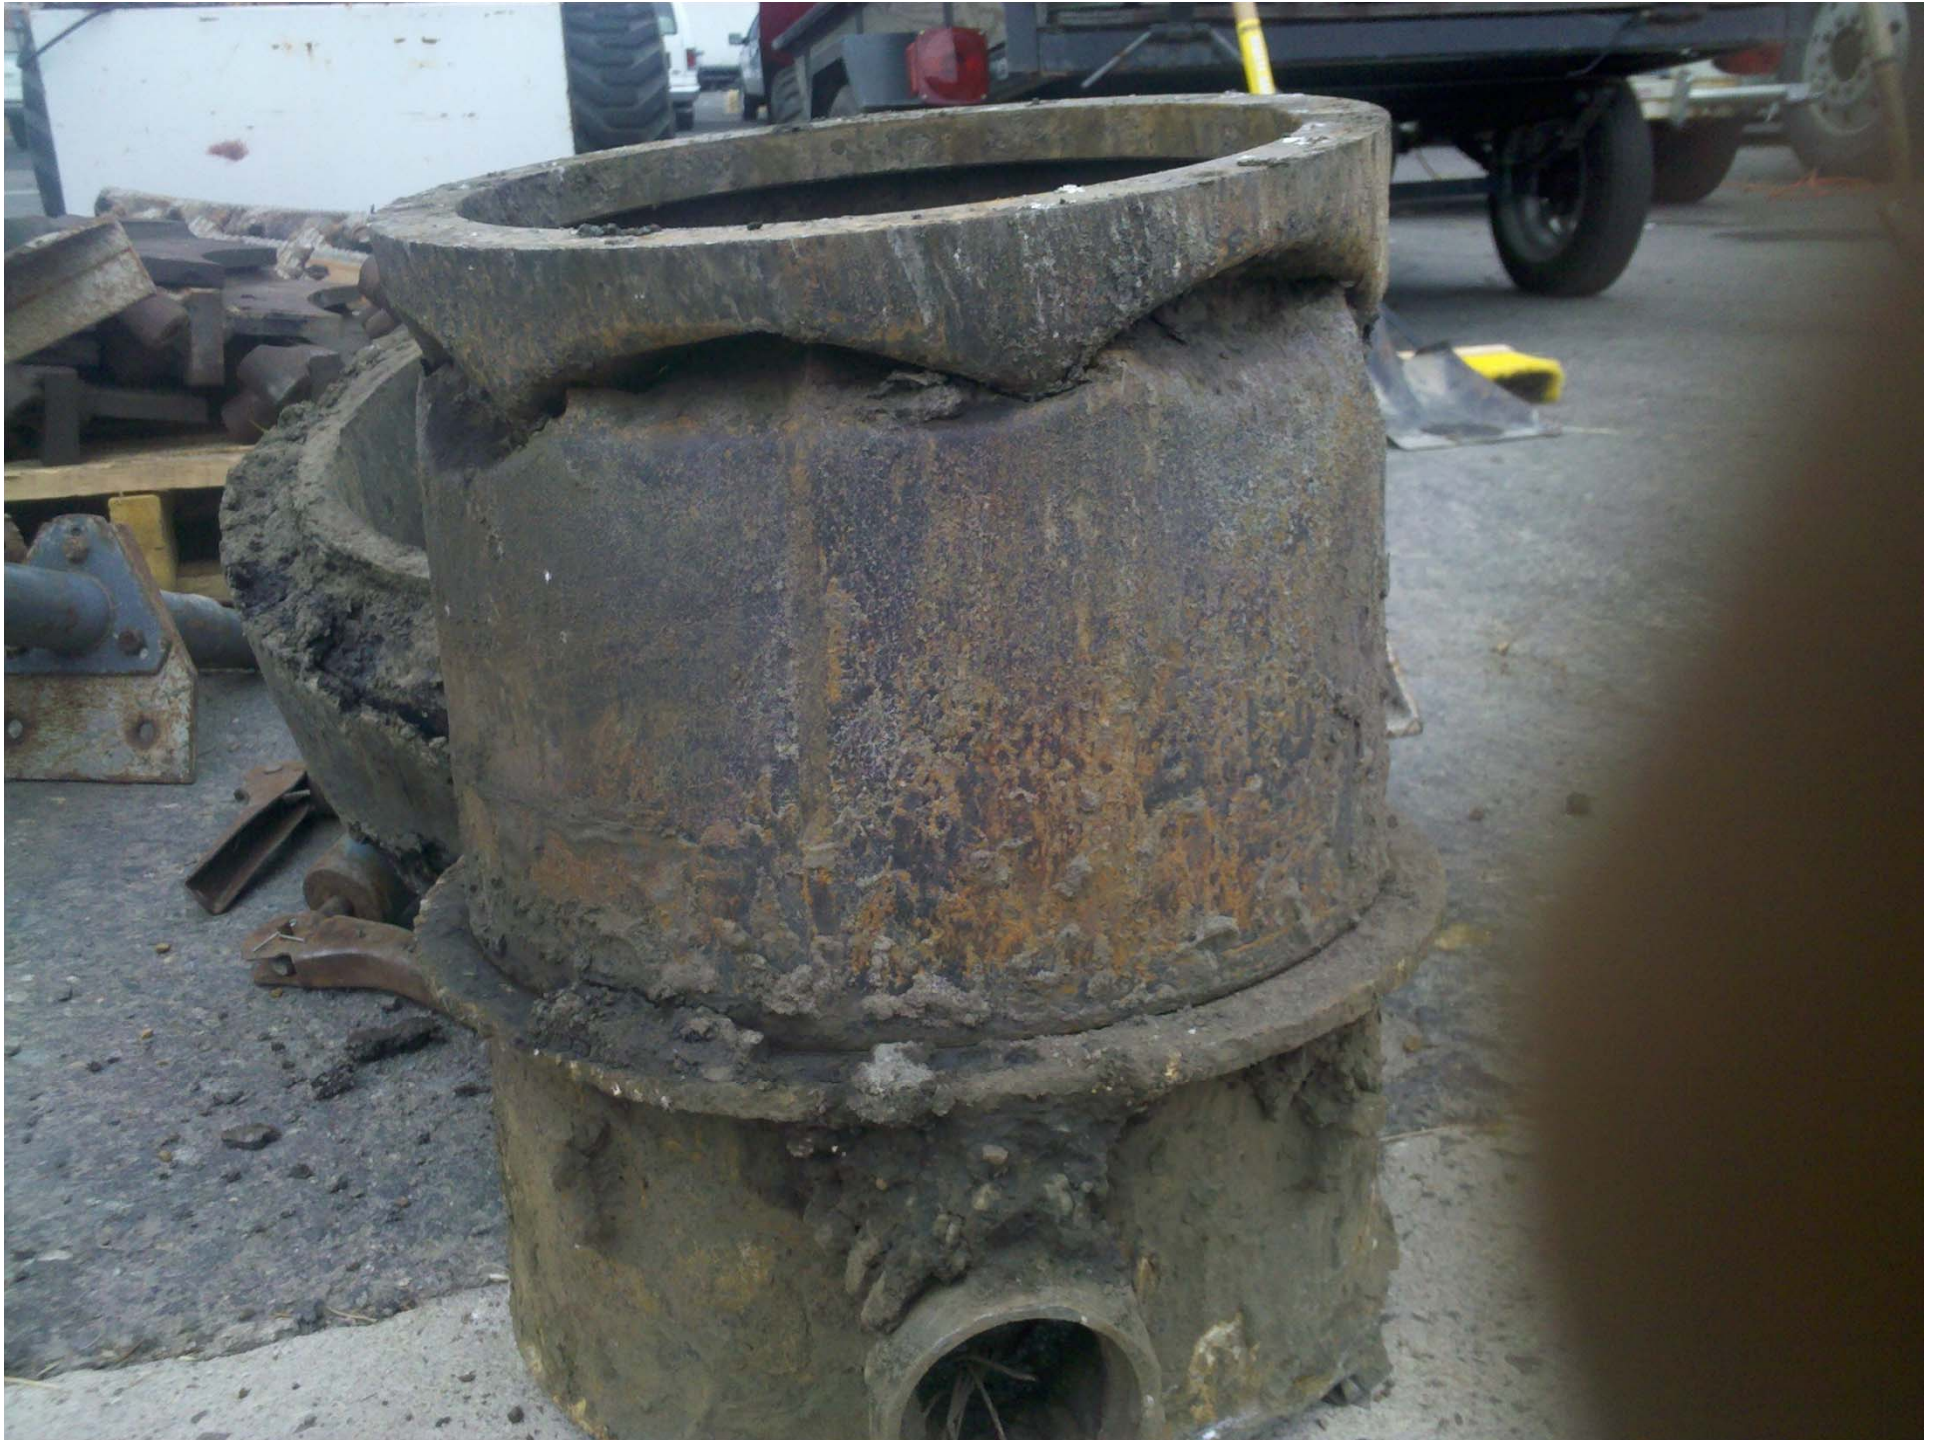
# Observation

- Asphalt type paving
- No flange ring
- Fixture going down
- Asphalt breaking off the edge
- Fixture 1" below paving no light could get out

- Can extension or top can was up to 16" long
- Question ? How long can a top section be?
- Normally the bottom can is concreted in and is only 6" to 7" max to top of paving finish surface
- Most asphalt installations the concrete of the bottom can is within 4" to 5" of the finish surface

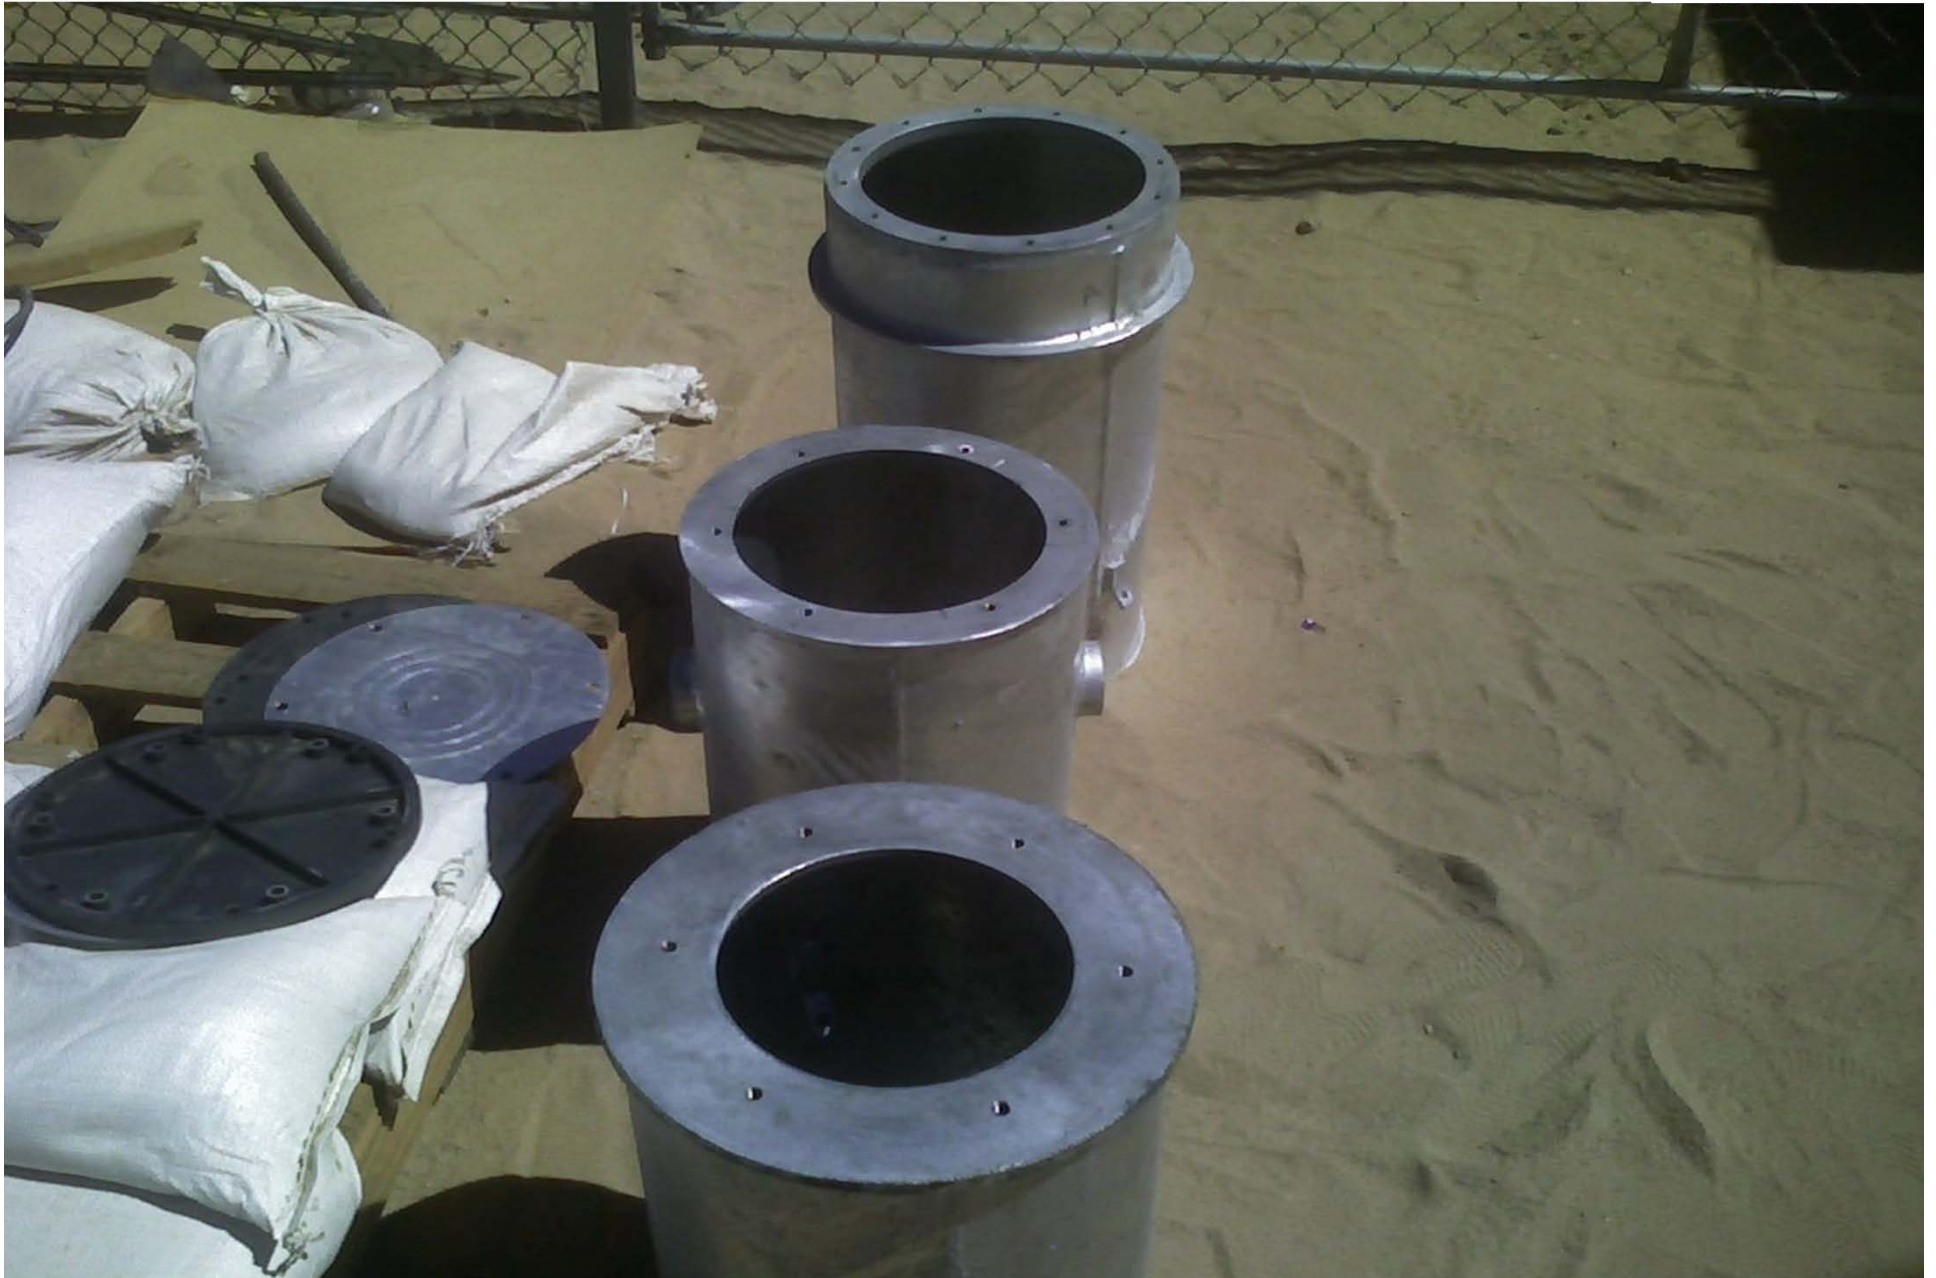
# Airfield Cans

- L-868 can has a load bearing ring near the top of the can to transfer the can load to the pavement
