# IES-2011

## Airport Lighting Cans Load Transfer

**Daniel E Geary**

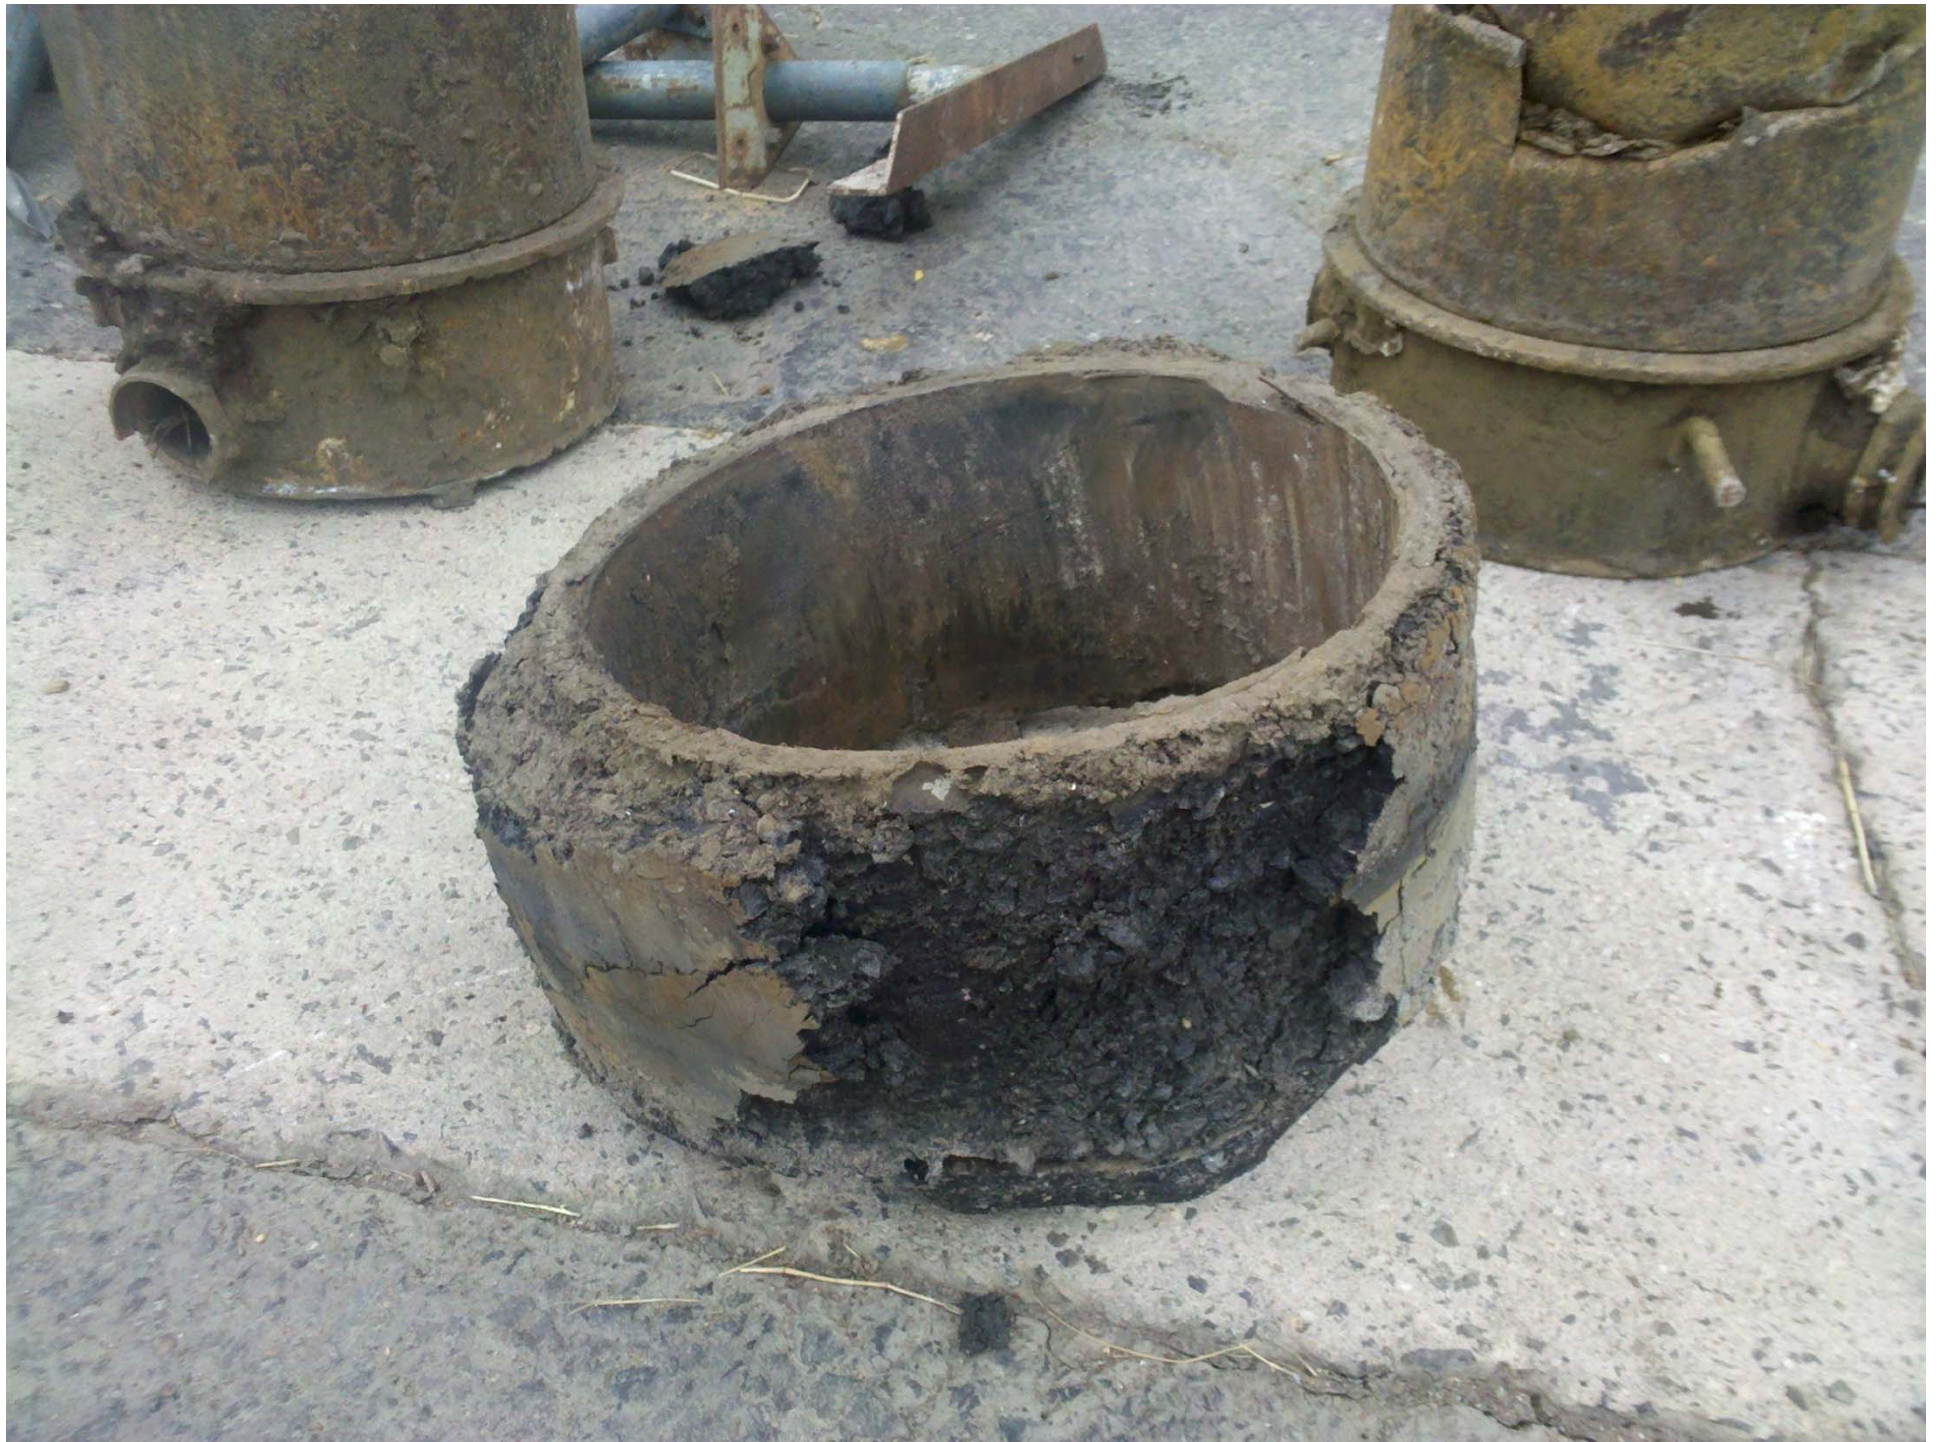
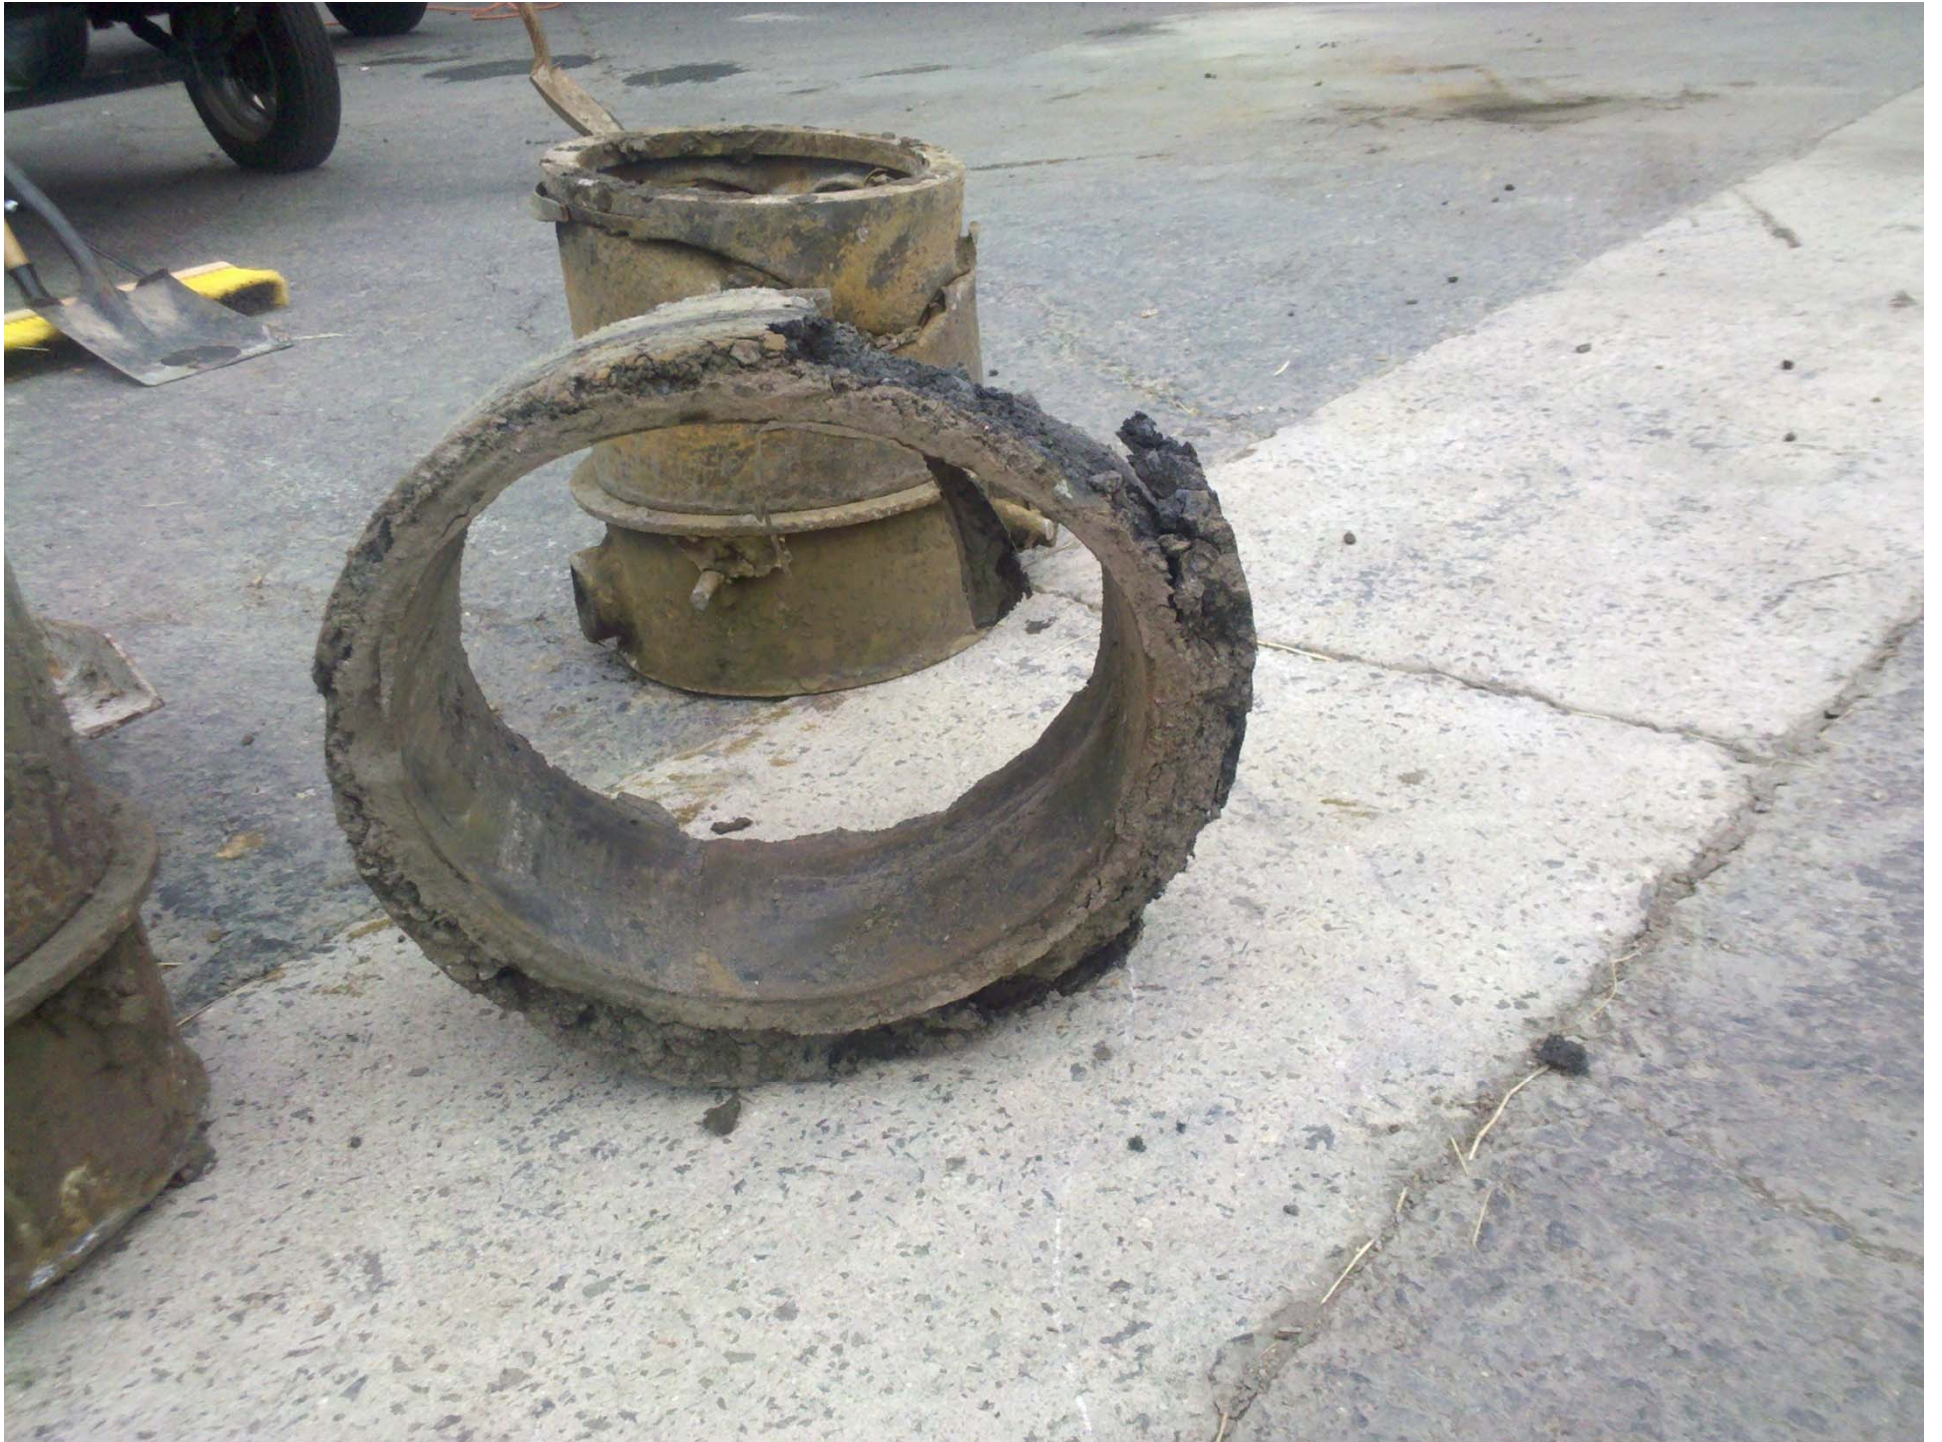
# Other Problem

- Can extension was installed with a flexible sealer

- Too long of extension
- Extension not tied into the pavement
- Load was not transferred to the pavement
- Can failed
- Possible if the can extension had a load bearing ring and the sealant had been a rigid rather than flexible the installation might have worked

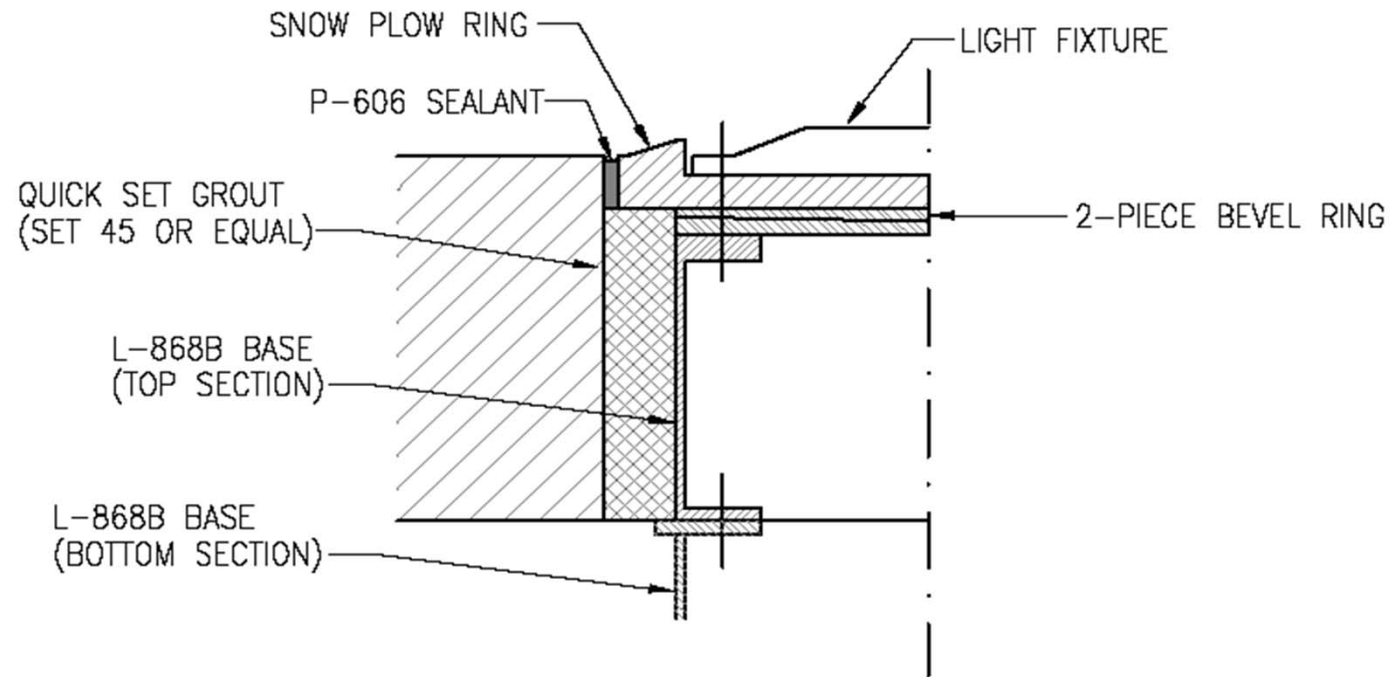
**DETAIL A**  
NOT TO SCALE

# New Installation – Asphalt Overlay

- Detail is not in proportion
- Snow plow ring is 15.75" in diameter
- Can is a 12" can
- Cored hole is 16.25"
- Space on each side of top section is 2.125"

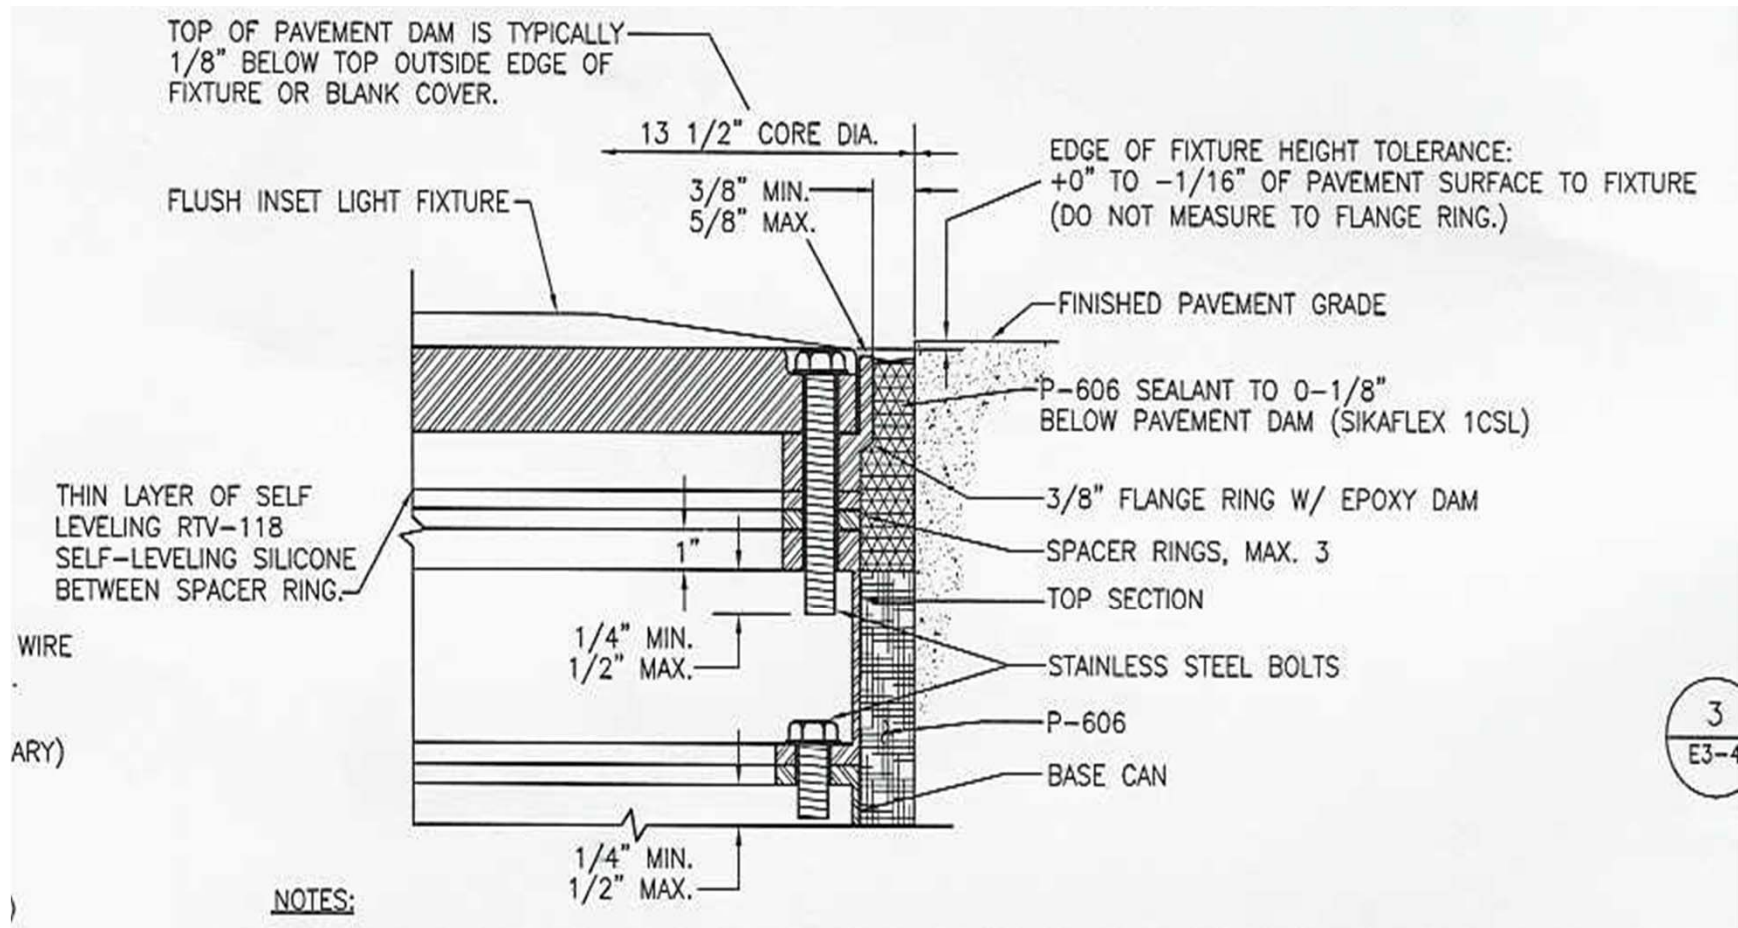
# Stainless Steel Bolts

- .5" bolt length for fixture
- .5" bolt length for snow plow ring
- .75" bolt length for Bevel ring
- .75" bolt length for up to 3 spacer rings
- .75" bolt length to screw into can
- 3.25" bolts
- 2.5" of bolt that could have shear load

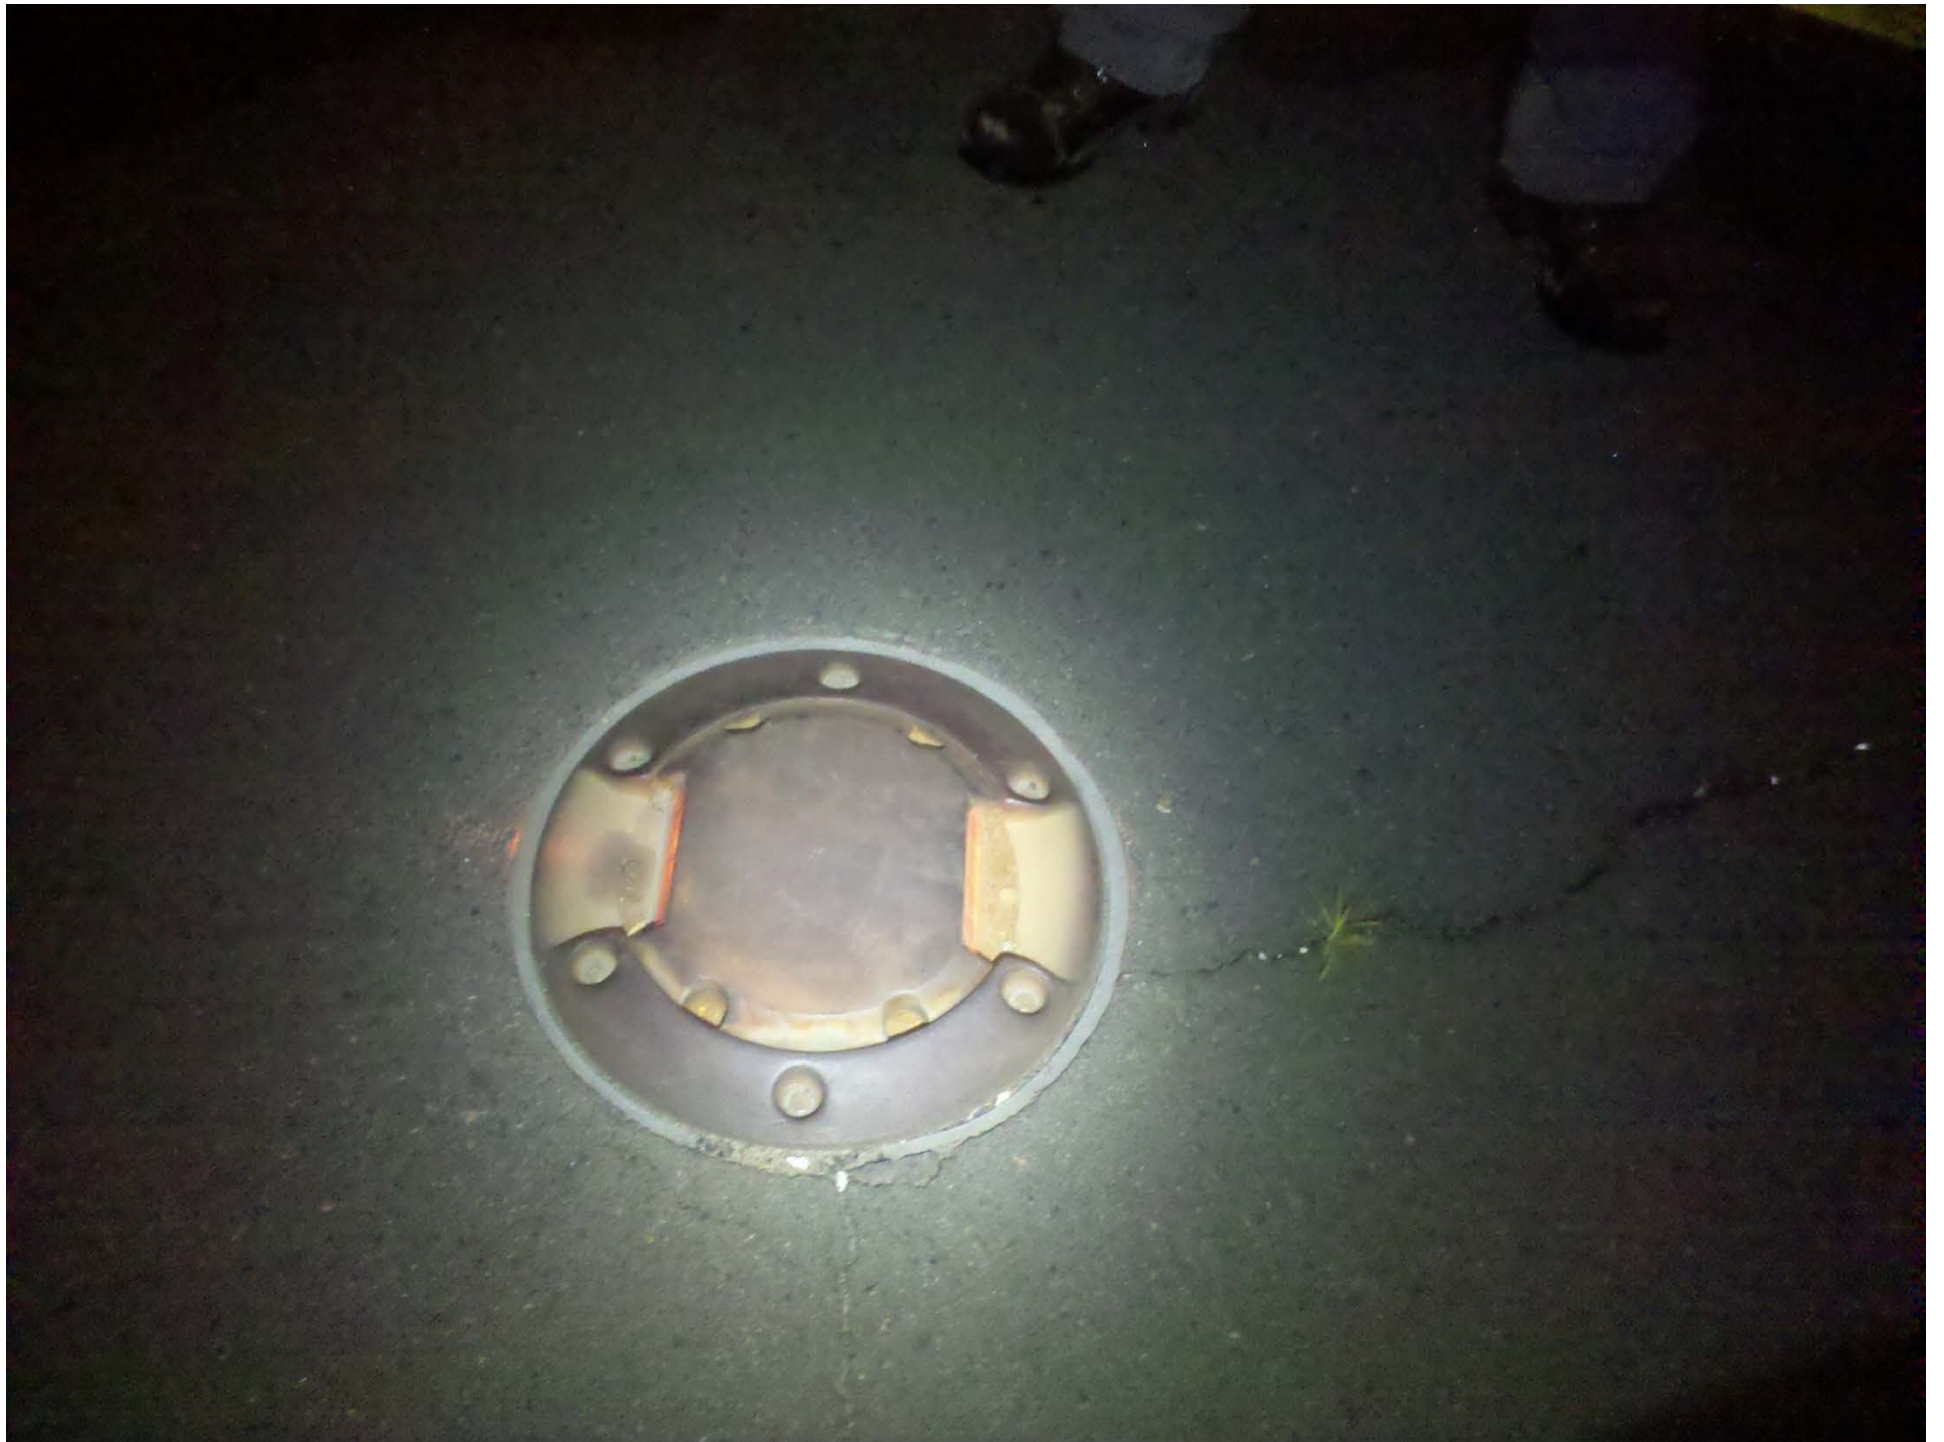
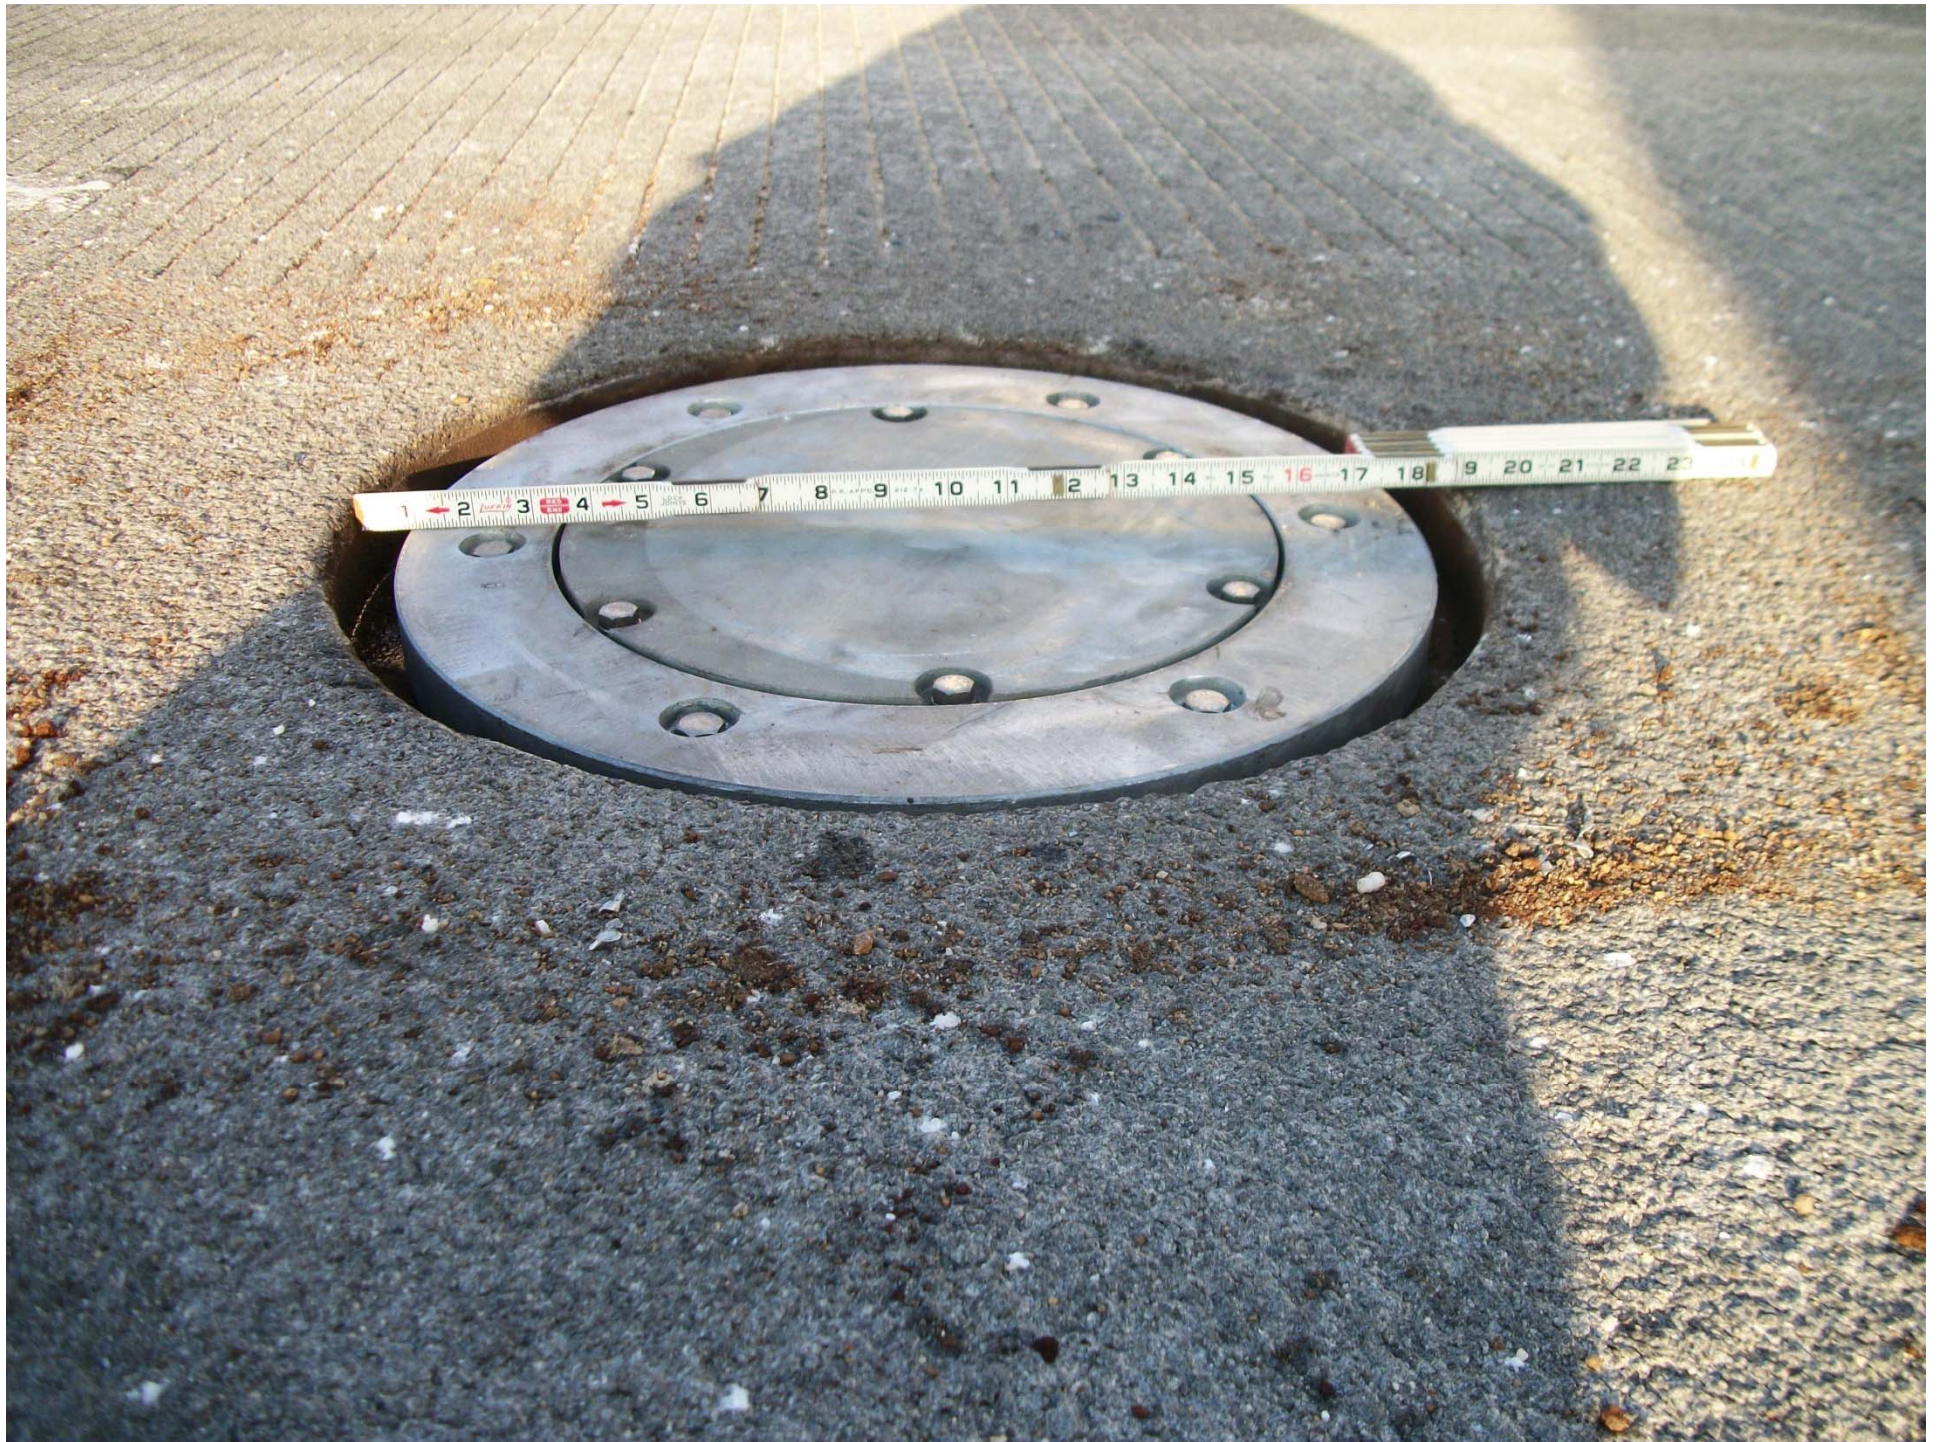
# What We Learned

- Only one set of bolts to hold both the snow plow ring and the fixture

- We could have a bolt failure problem if the top can, spacer rings and snow plow ring are not properly tied into the pavement

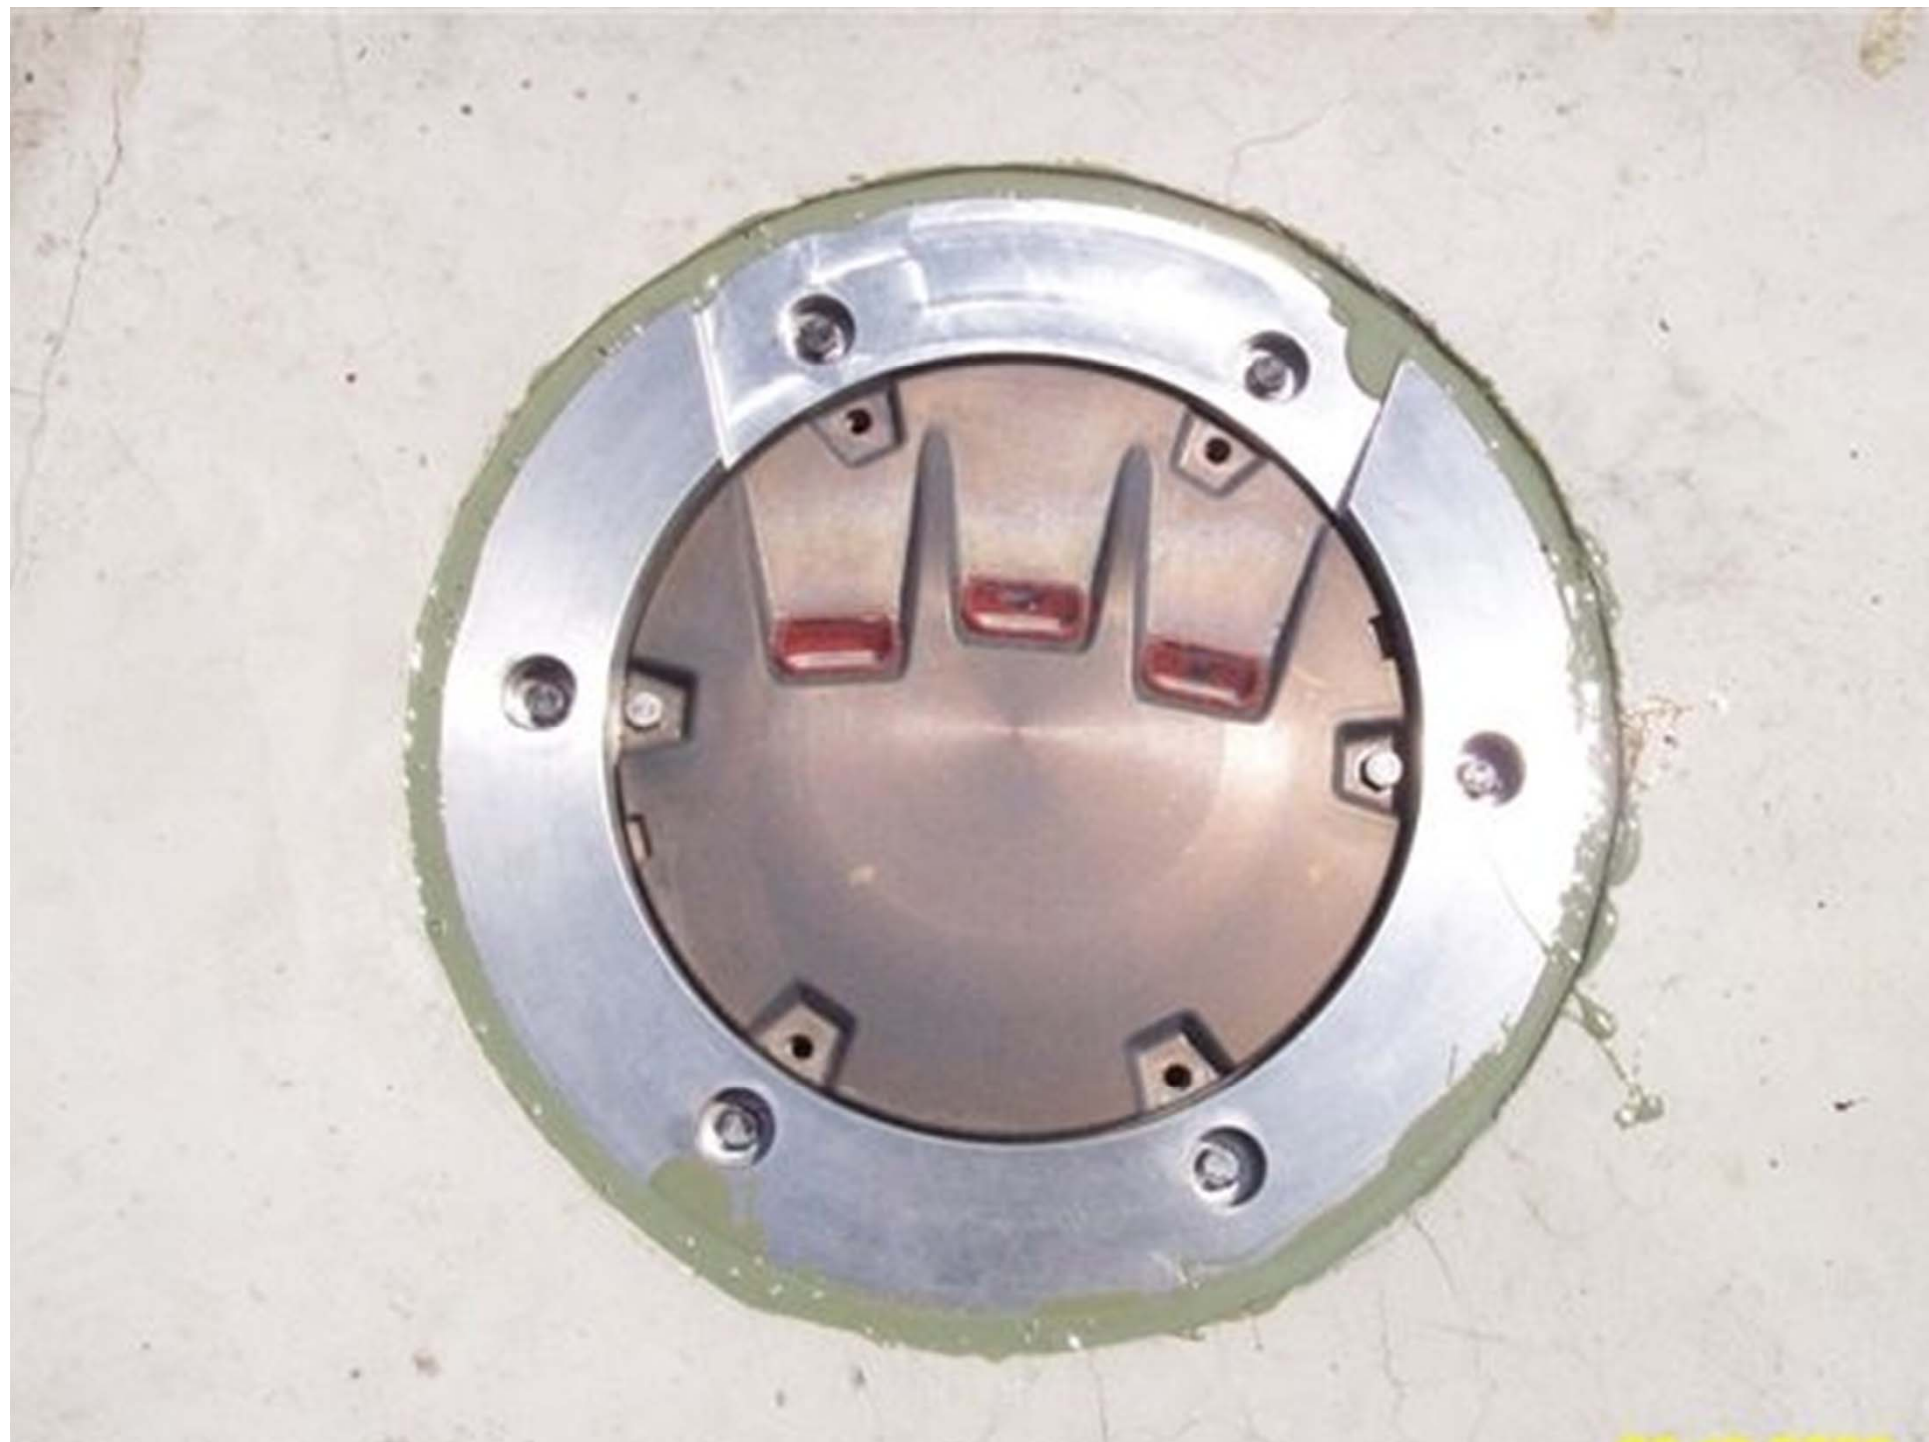
- The annular space between the snow plow ring and the pavement is filled with P-605 which is a flexible sealant
