# Apron Lighting Evaluation

Mai Yeung | Senior Associate - Airports

IESALC

24 October 2013

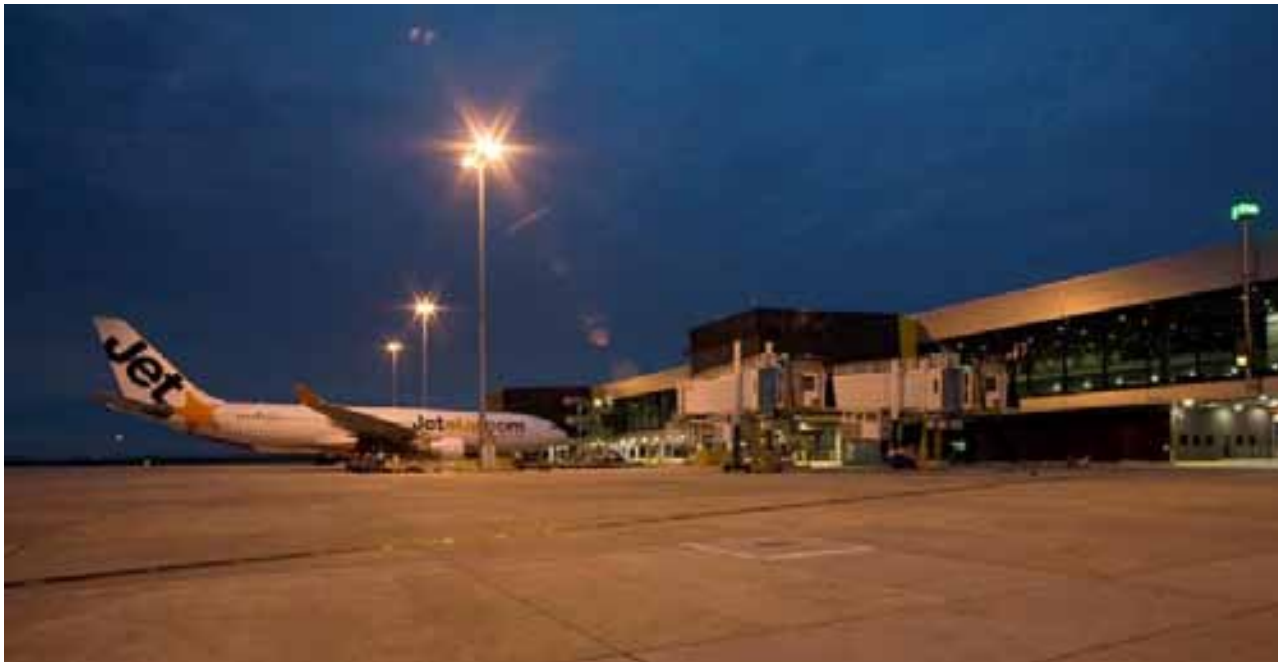
# Example: grid size determination

- A330 – 200/300 apron, aircraft parking position 60 x 64m, 30m high mast
  - Maximum grid size using AS 2560.1 is 2m
  - Maximum grid size using EN 12464-2 formula is 3.6m
  - Maximum grid size using AS 1680.5 is 5m
