Runway Safety Area (RSA) Program Runways 1L-19R and 1R-19L

IES Presentation

San Francisco International Airport

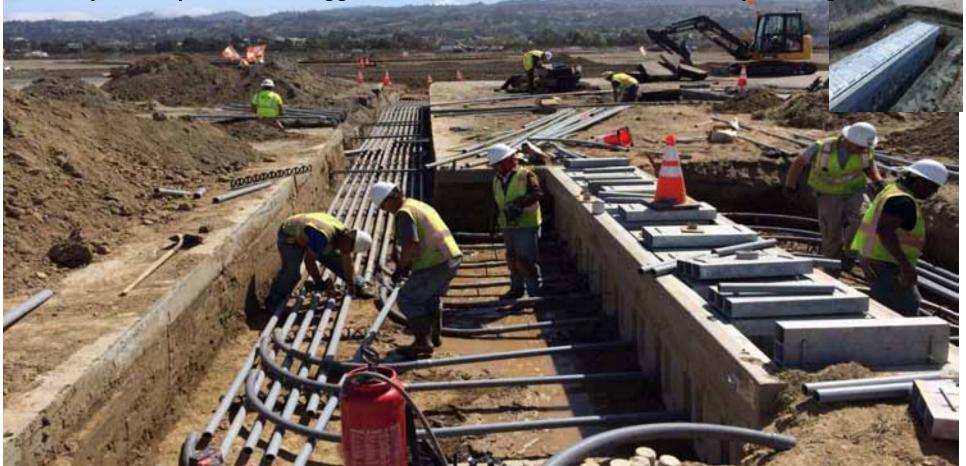
Red concrete allowed us to understand what was new vs. old

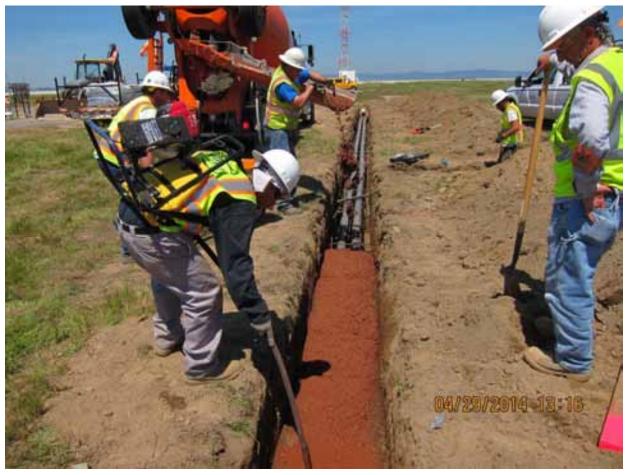
Duct bank installation

Transformer Housing Plaza

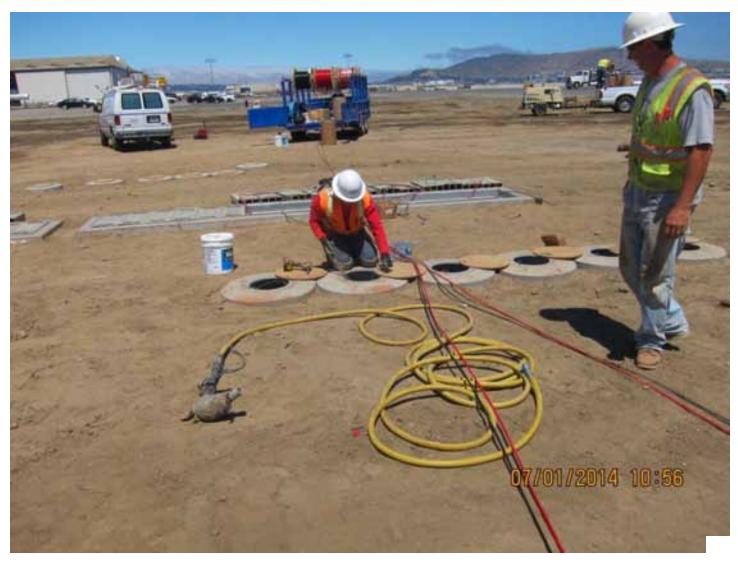
Sectionalizer cable installation

Sectionalizer

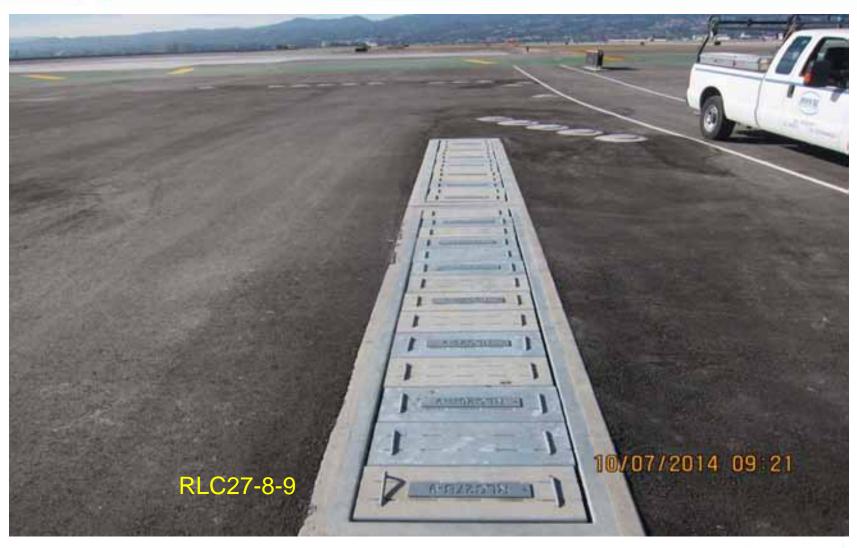
Completed sectionalizer

T/W CTL Kerf

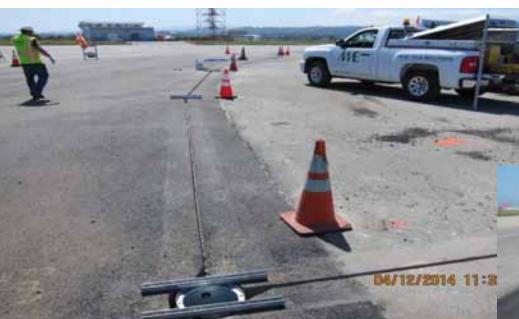
Taxiway Centerline Light installation

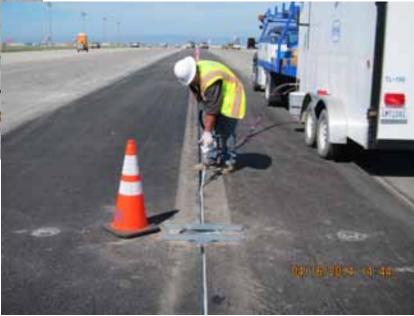
Taxiway Centerline light Kerf installation

Typical T/W Kerf Installation

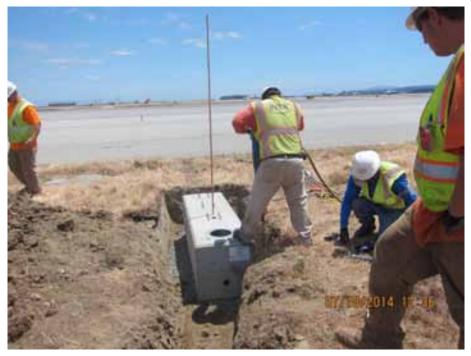
Ground rod installation for precast sign pad

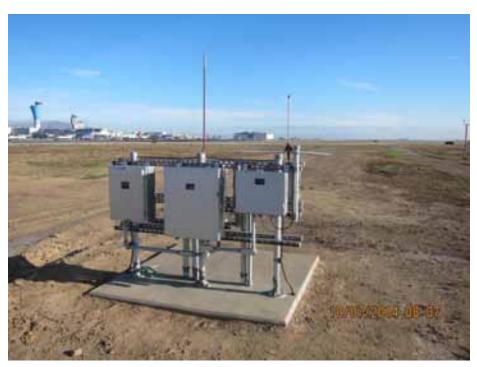
REIL Power and control rack

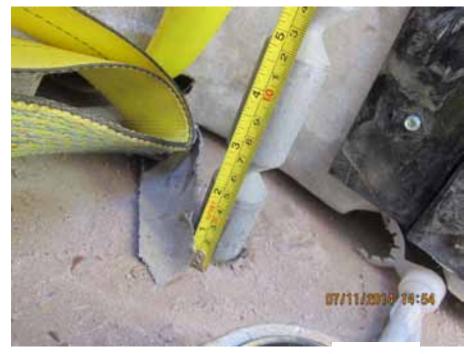
MALSF Sta 2 frangible coup

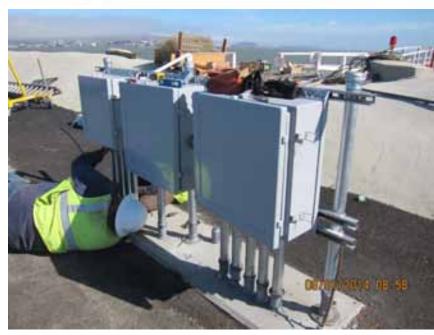
MALSF Distribution panel

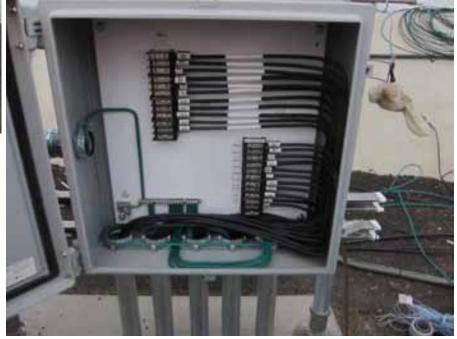
MALSF Dist Panel

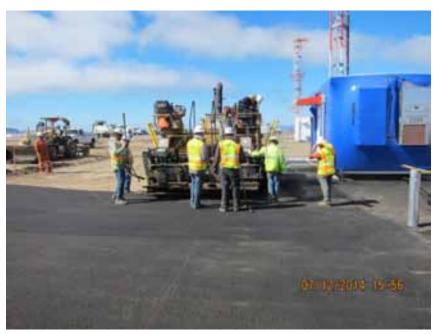
Paving around Glideslope

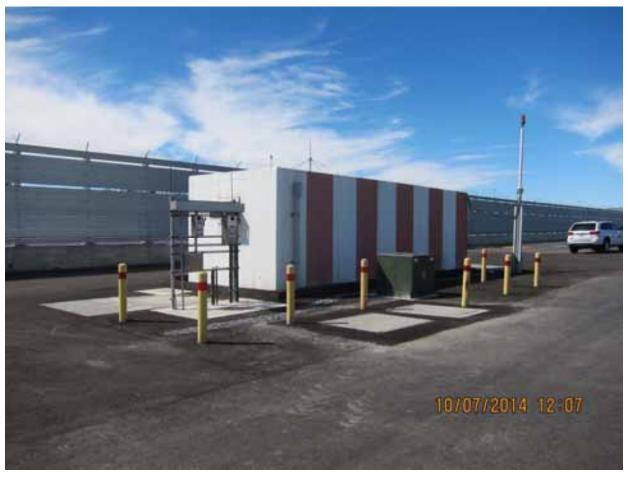
19L Localizer Shelter
