# ***Implementing a Comprehensive Plan for In-pavement Lighting Reliability Improvements***

# Regional Transportation System – Port Authority of New York and New Jersey

# Performance of In-pavement Runway Light Fixture Assemblies

# Aircraft Loading Effects on Load-bearing Inset Lights

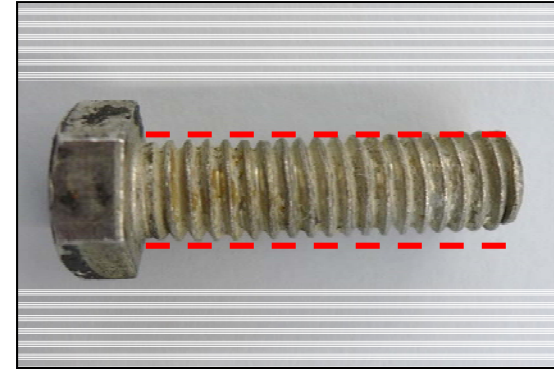
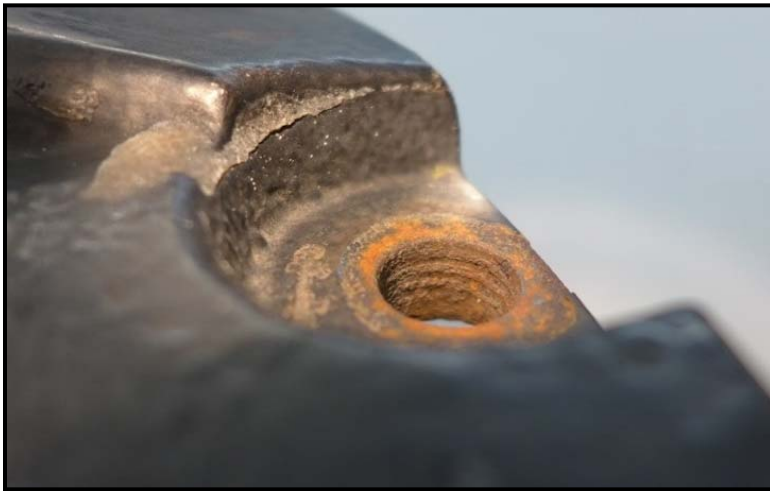
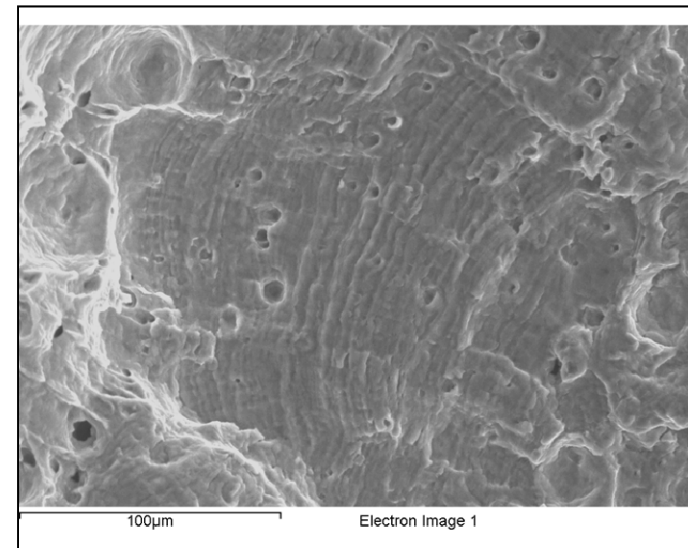
# Light Fixture Failure Analysis

- Thread impressions in fixture clearance holes
- Bent bolts and bolt fatigue failures

Evidence of repeated excessive lateral movement of light fixture

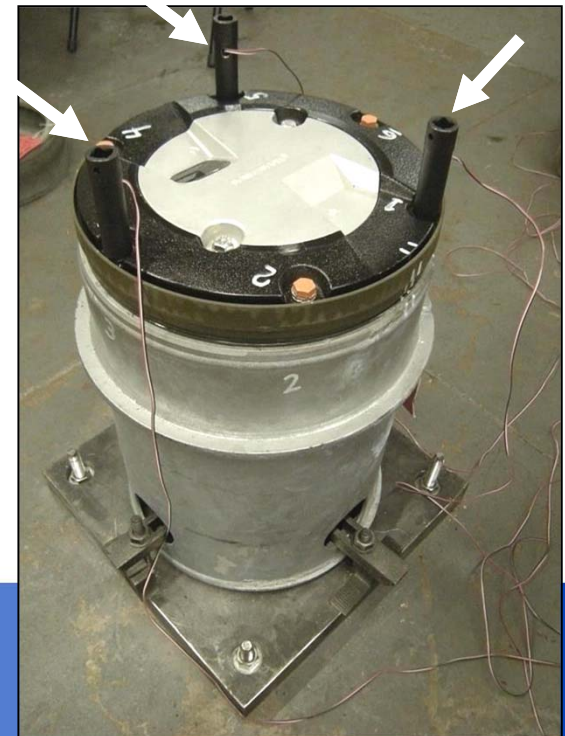
# Bolt Torque Testing

- Bolt torque vs. bolt preload testing performed utilizing instrumented bolts
- Recommended manufacturer torque values do not ensure bolt is at ~75% of proof load
- Documented that scatter is inherent in achieved preload

$$T_{in} = F_P \times D \times K$$

where  $T_{in}$  = input torque (in.-lb)  
 $F_P$  = achieved preload (lb)  
 $D$  = nominal diameter (in.)  
 $K$  = nut factor

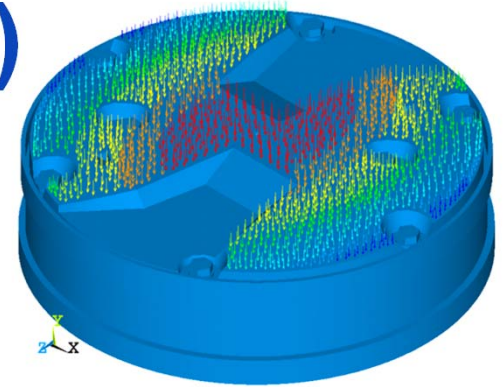
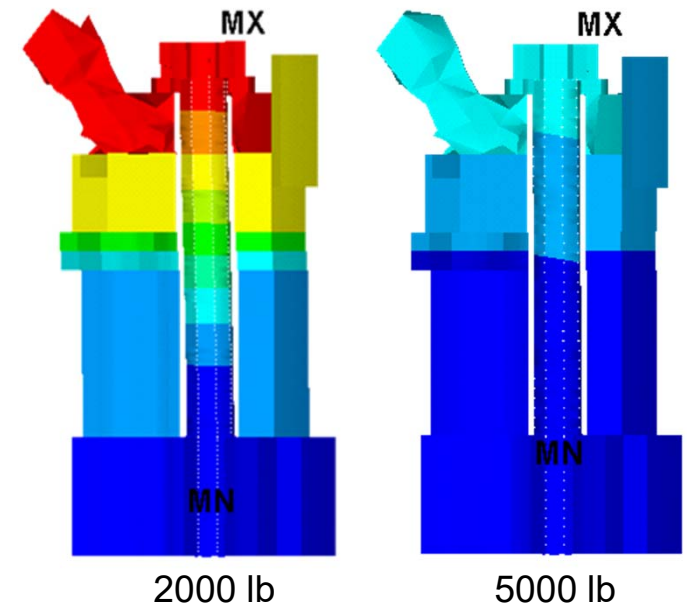
# Finite Element Analysis (FEA)

- Evaluate aircraft wheel roll-over
- Loads derived from Aircraft Characteristics documents
- Low preload allows slip at Support Ring / Flange Ring / Spacer Ring interfaces and bending of bolts

<i>Bolt Preload (lb) →</i>	<u>2000</u>	<u>5000</u>
<u>Bending Stress [ksi]</u>	181.2	33.6
<u>Bolt Lateral Disp. [in.]</u>	.0398	.0070

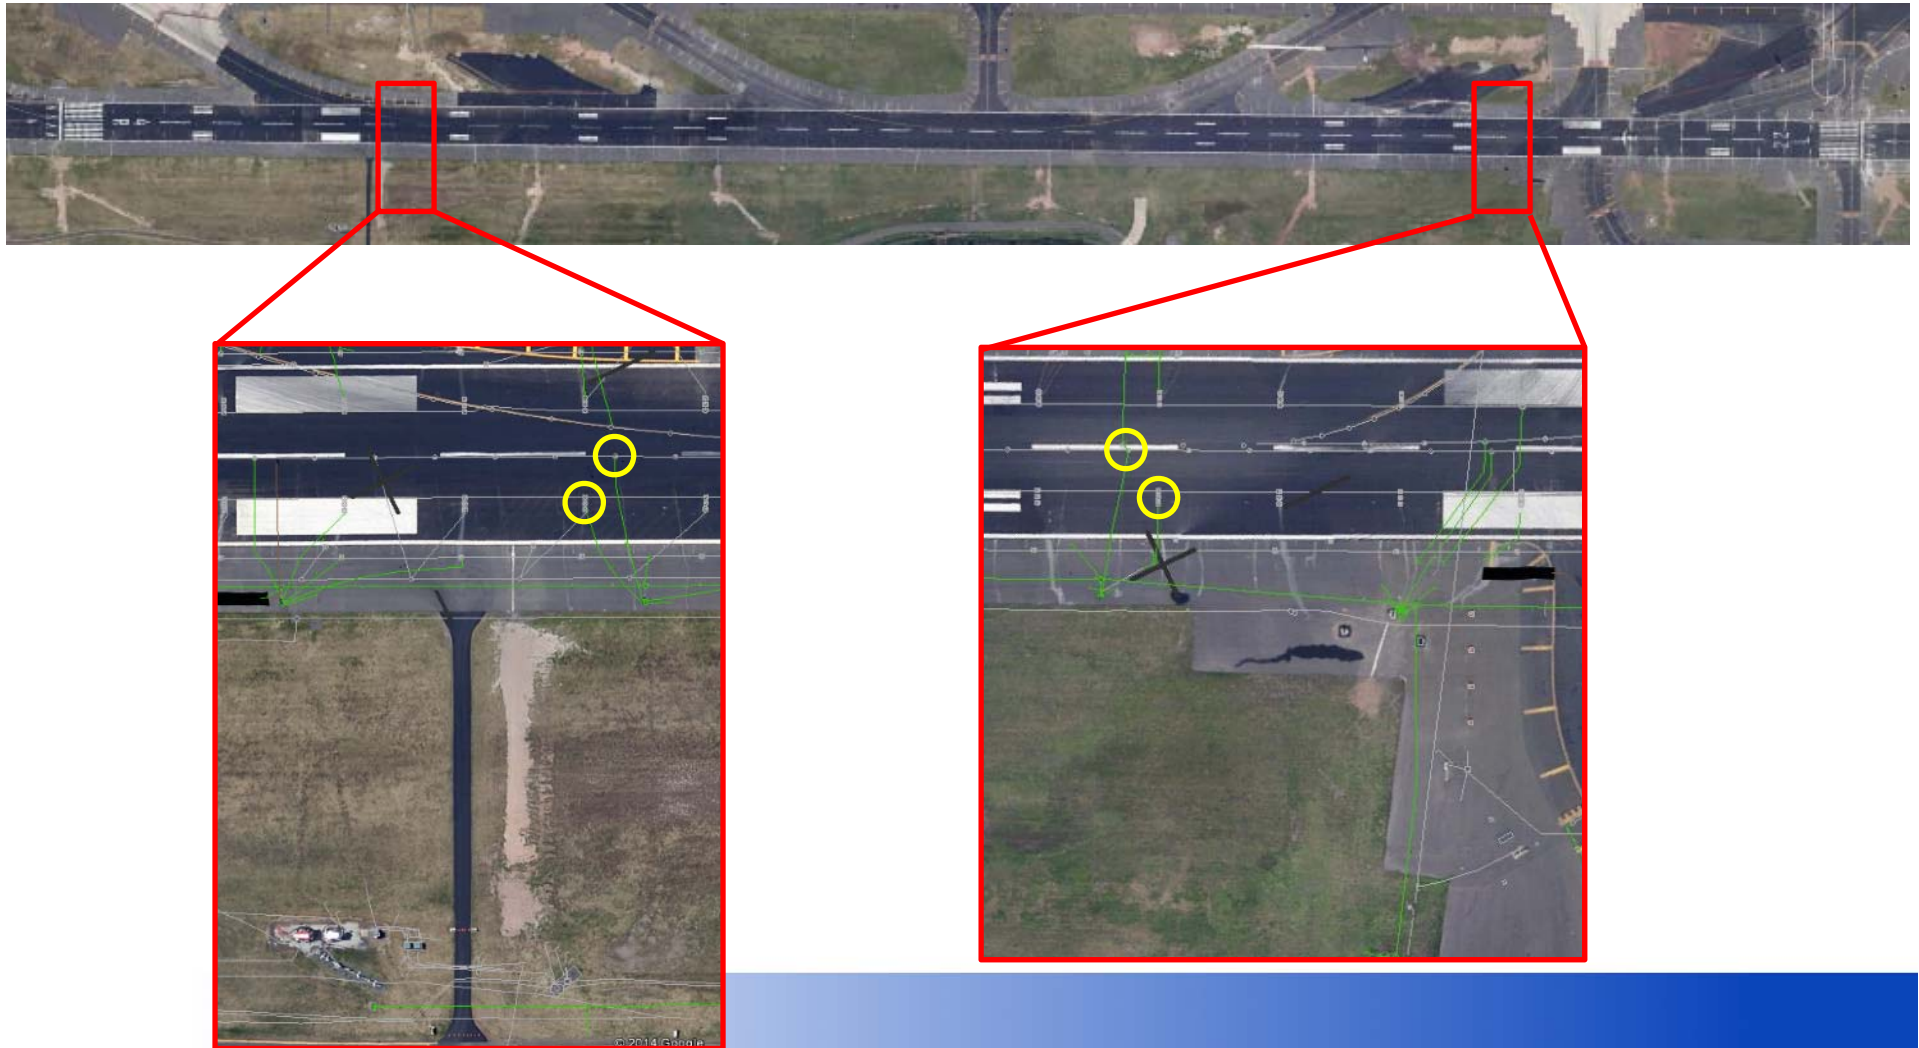
# Instrumentation and Analysis

- Bolts repeatedly experience significant relaxation/unloading
- Results indicate aircraft **does not** have to contact light fixture in order to induce cyclic strain response
  - No indication of direct impact, but good results obtained from “rolling end” of runway

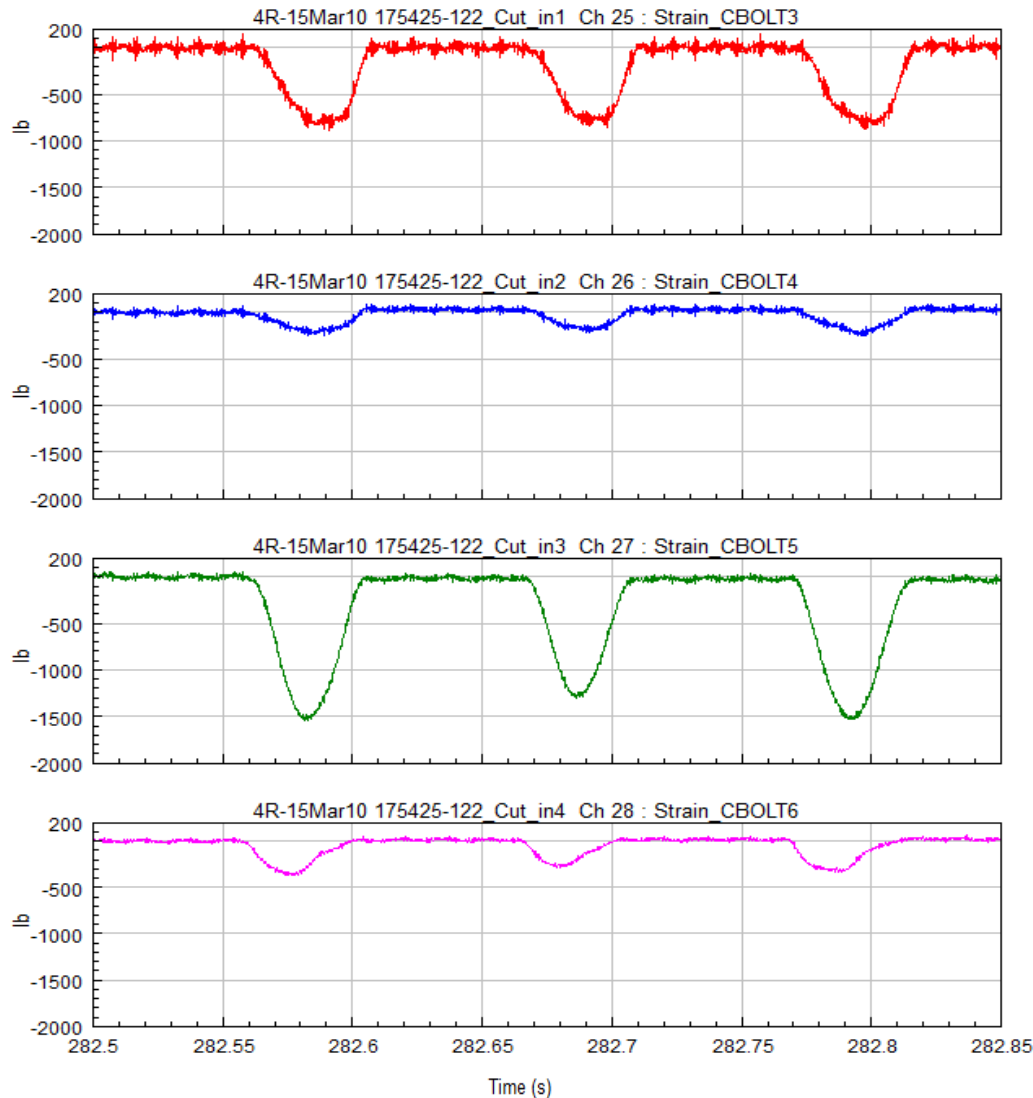
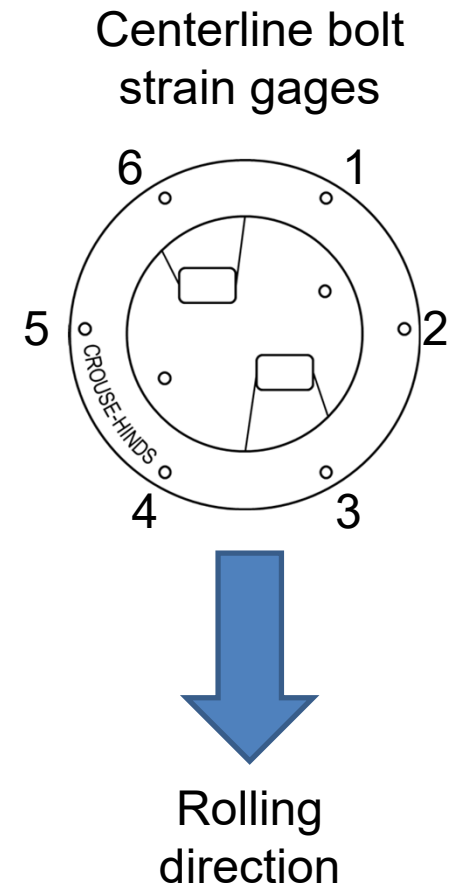
# Instrumentation and Analysis

- 777 after landing (all wheels down)

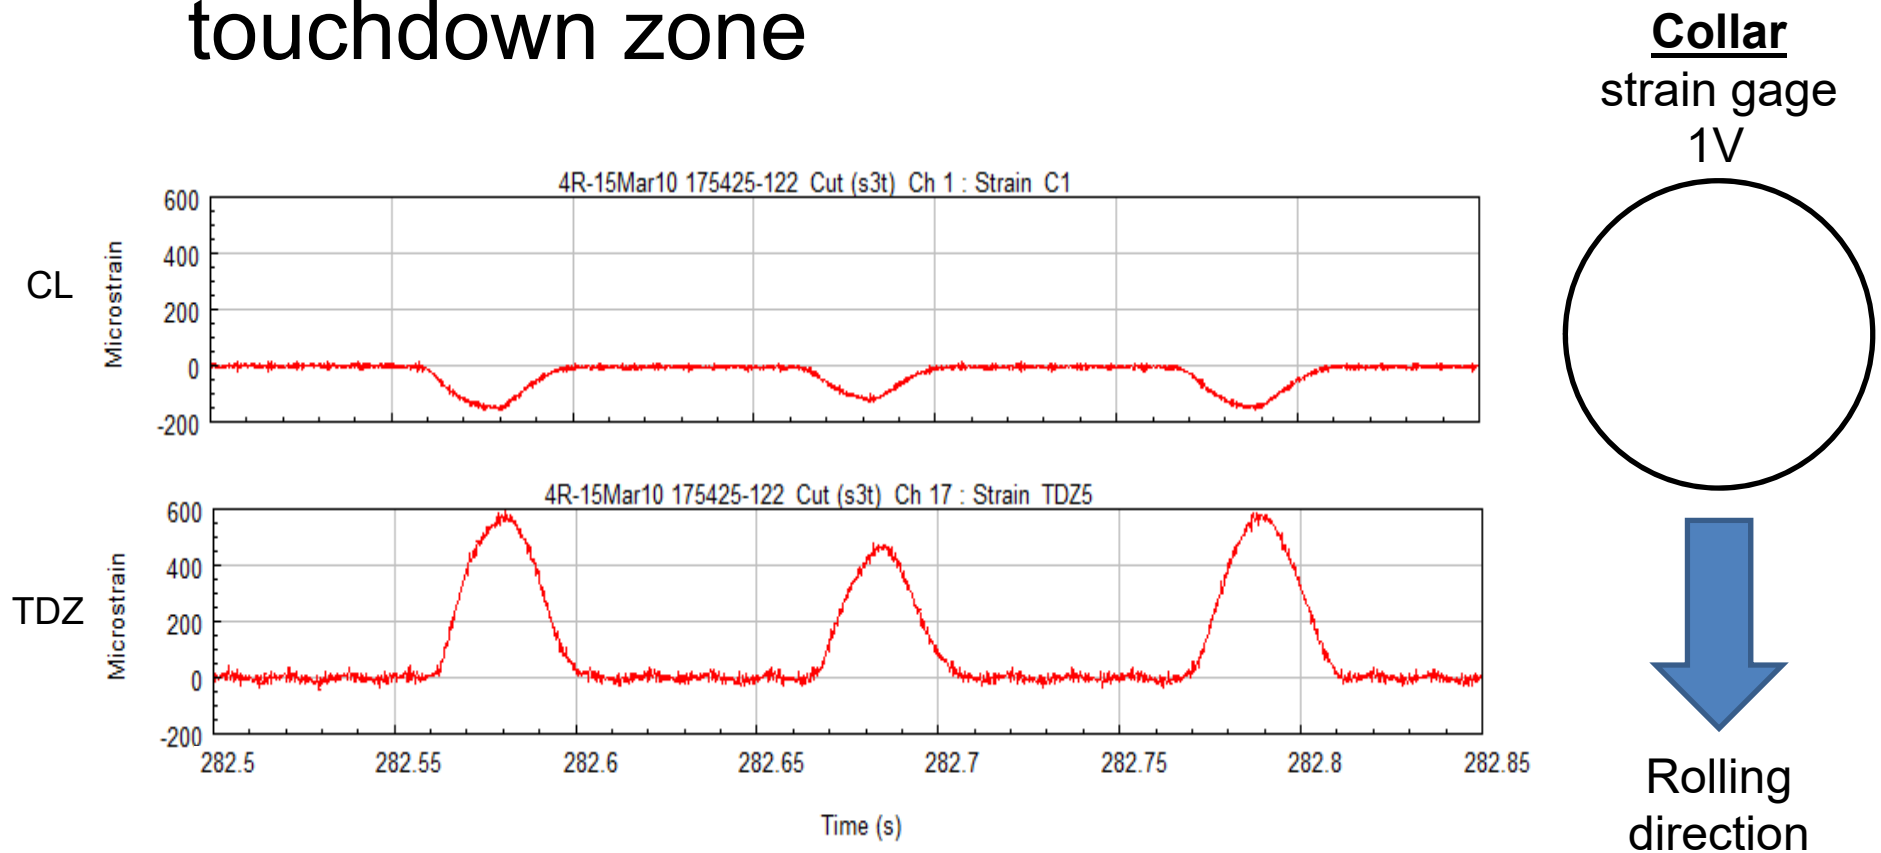
# Instrumentation and Analysis

- Simultaneous response at centerline and touchdown zone

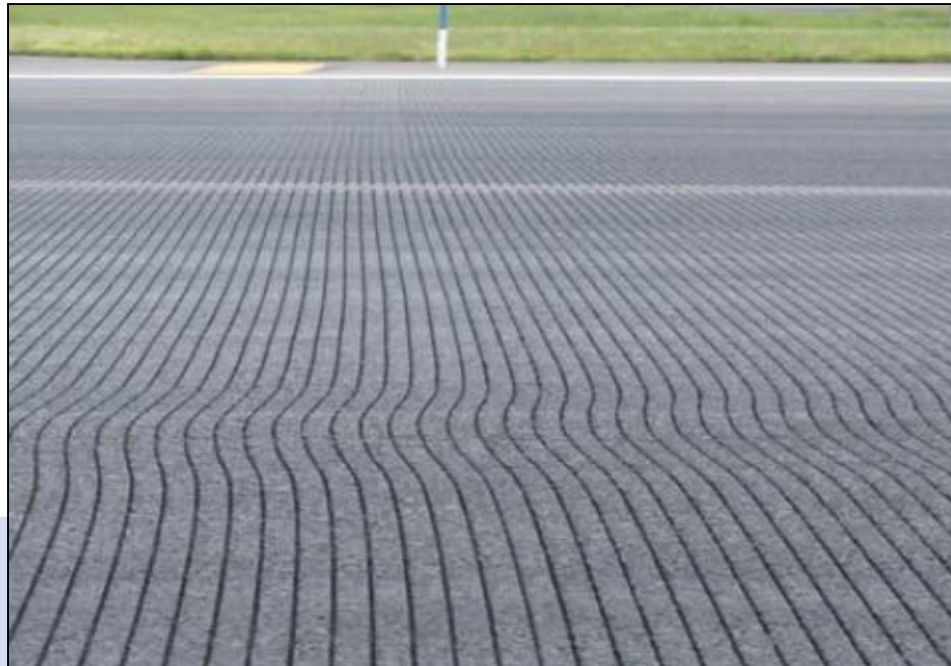
# High-speed Turn-off Analysis

- Additional type of incident highlighting influence of pavement / light fixture interaction
- High-speed turn-off fixtures experience braking forces and lateral turning forces

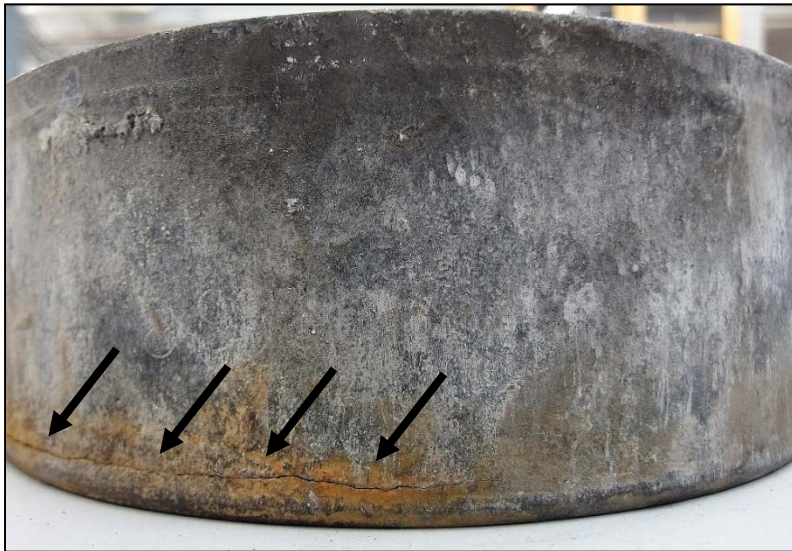
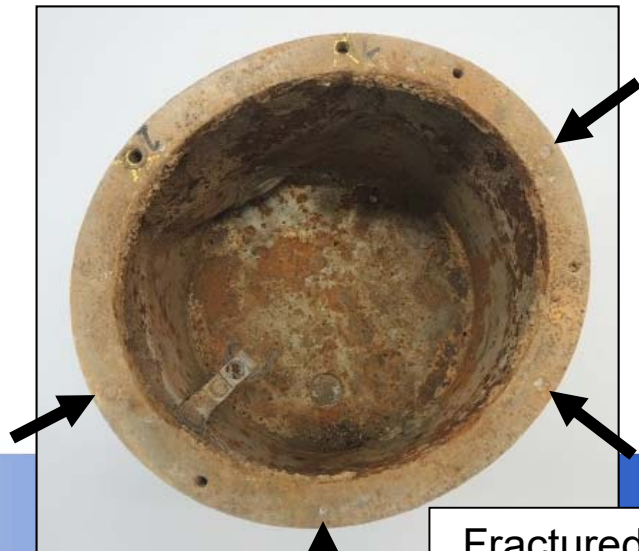
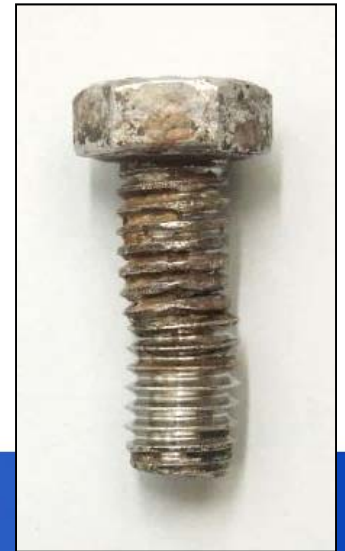
# High-speed Turn-off Analysis

- Numerous lead-off light fixture assemblies for high-speed taxiways discovered with:
  - Cracked / fractured extension collars
  - Ovalized base cans
  - Severely deformed / cracked / fractured bolts

Fractured bolts

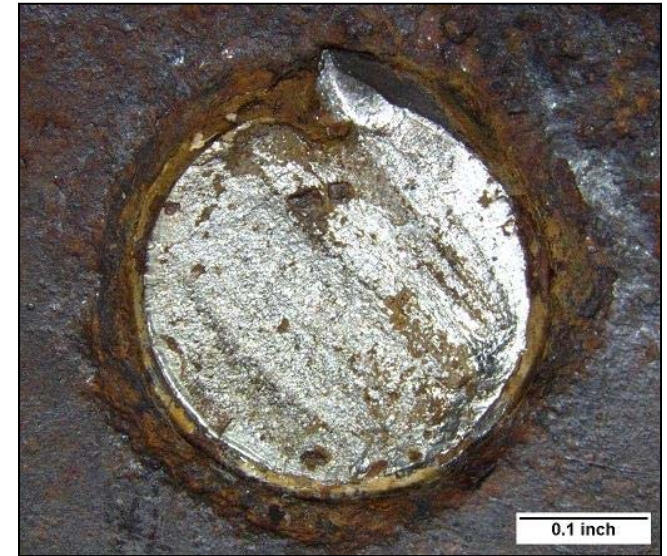
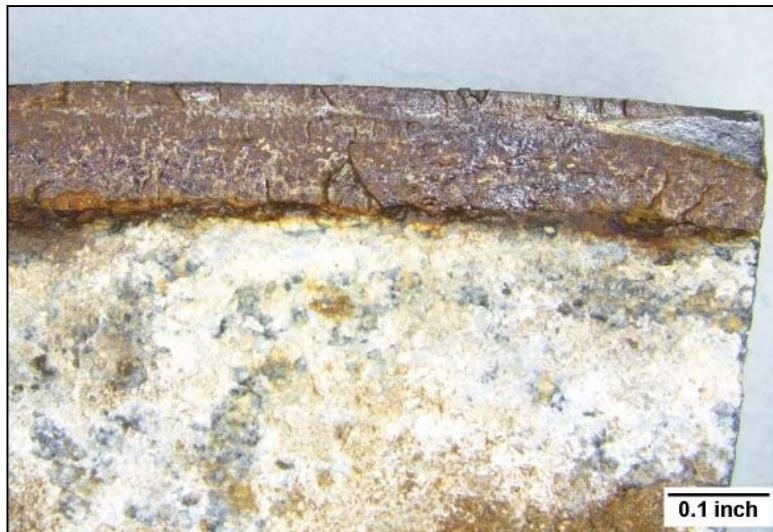
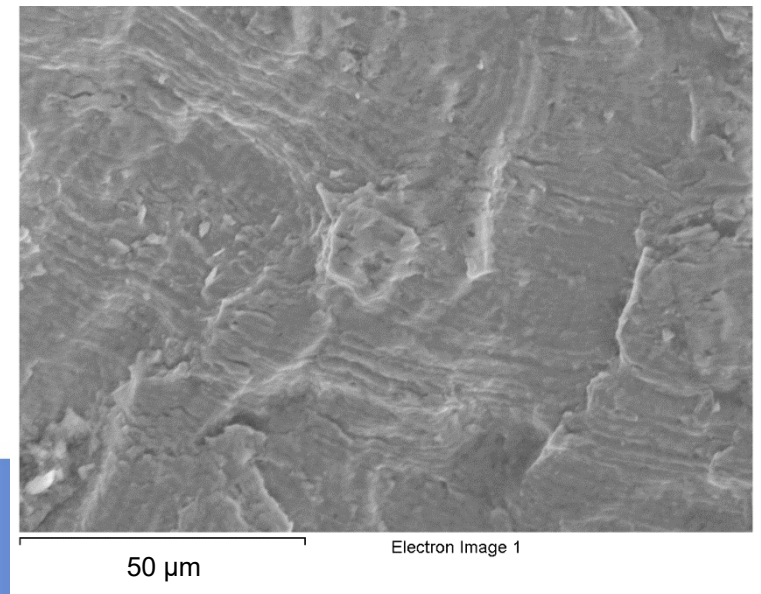
# High-speed Turn-off Analysis

- Extension collar exhibited evidence of fatigue cracking at lower flange
- Bolt segments in base can exhibit evidence of bending fatigue

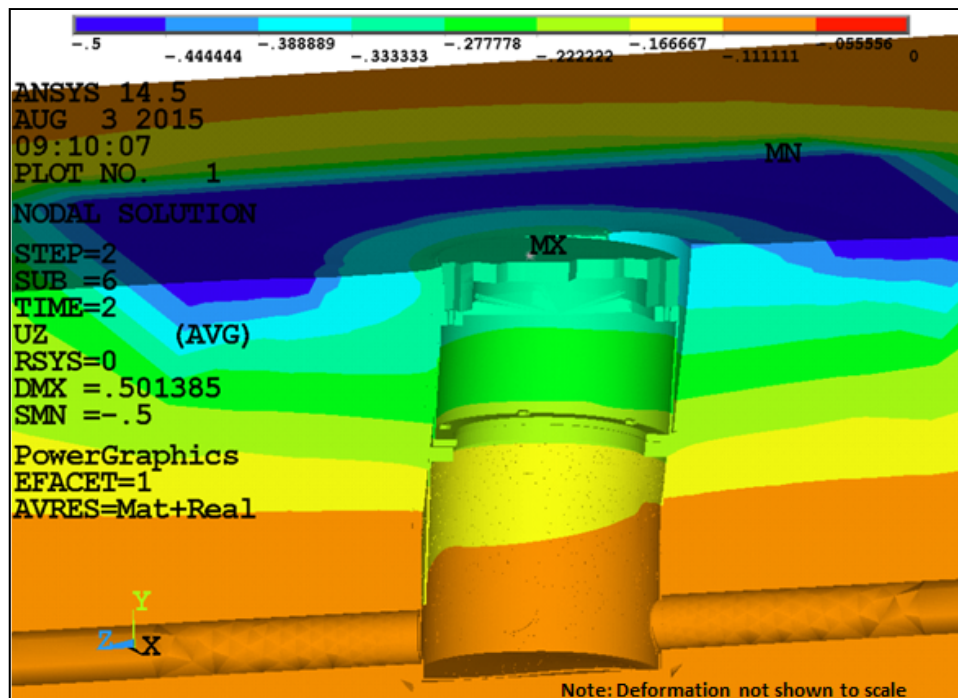
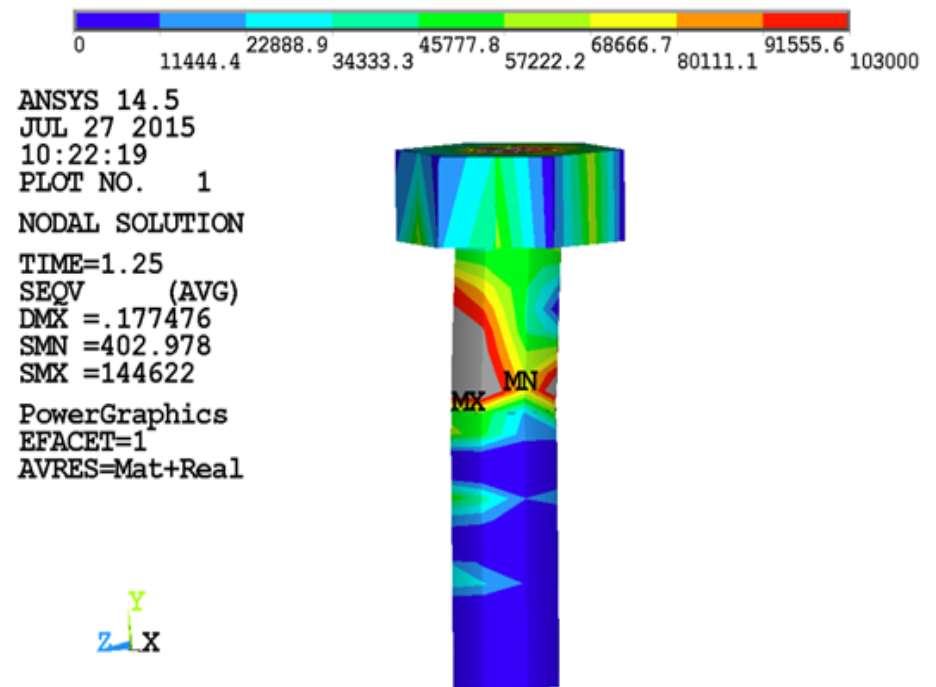
# High-speed Turn-off Analysis

- Finite element analysis validated findings under scenarios of asphalt pavement displacement

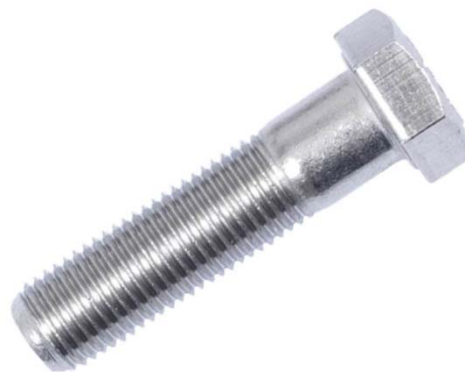
*Are six 3/8" 18-8 bolts sufficient?*

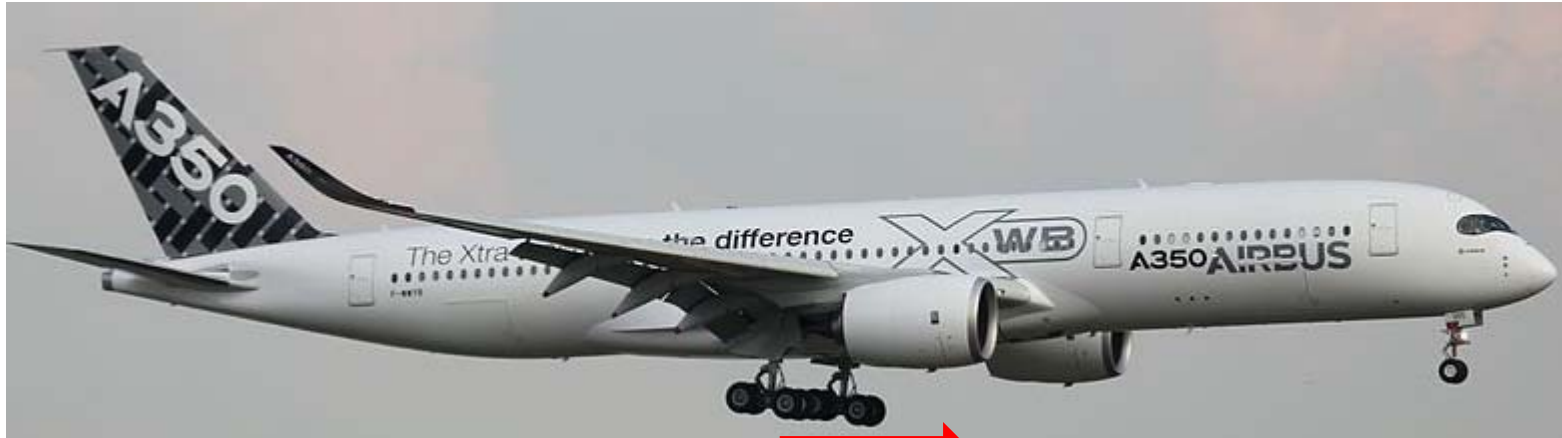
# A350-900 Main Strut Data (each)<sup>[2]</sup>

Max Static Load (lbs)	Instantaneous Braking Force (lbs)
277,700	222,150

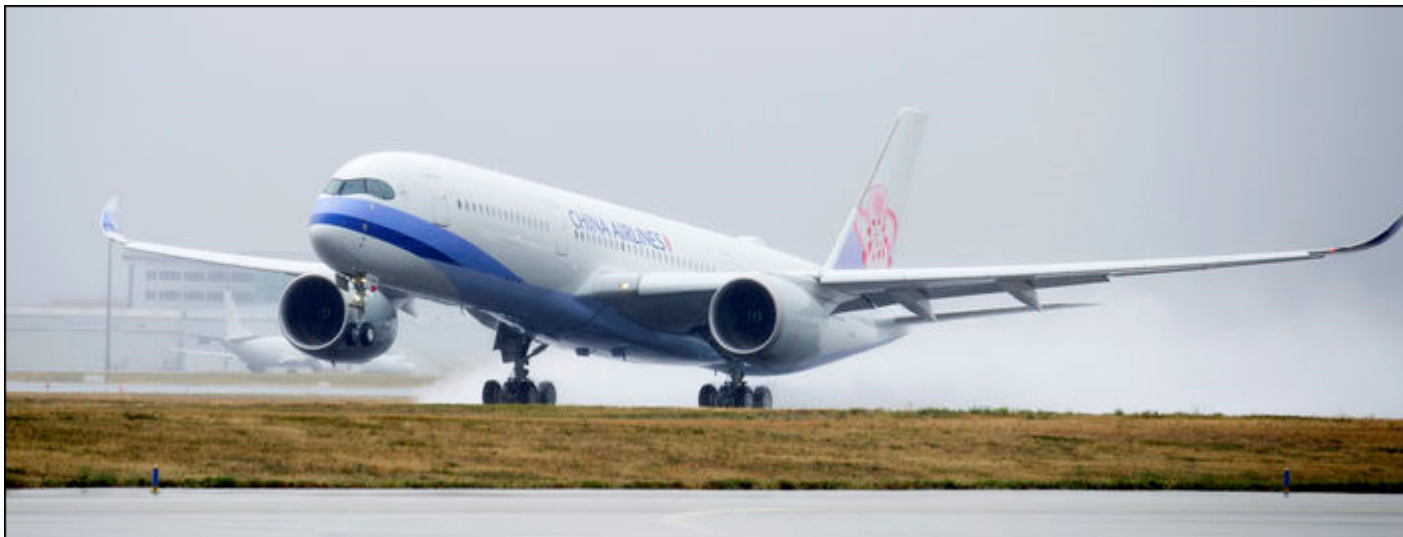
[13]

55,600 lb horizontal (shear) force per tire

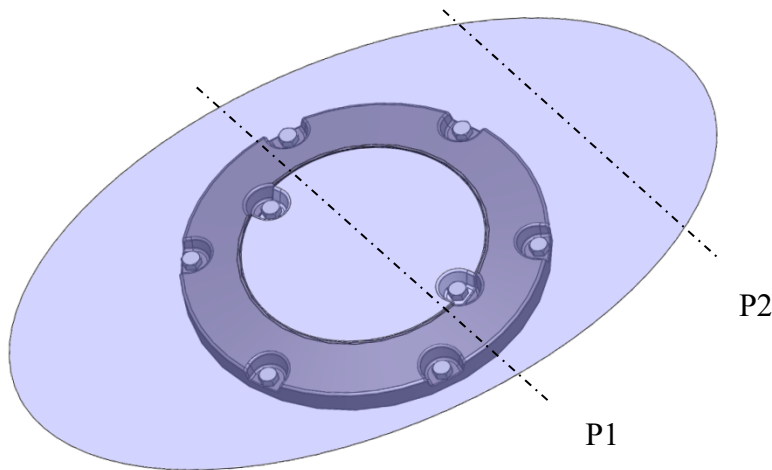
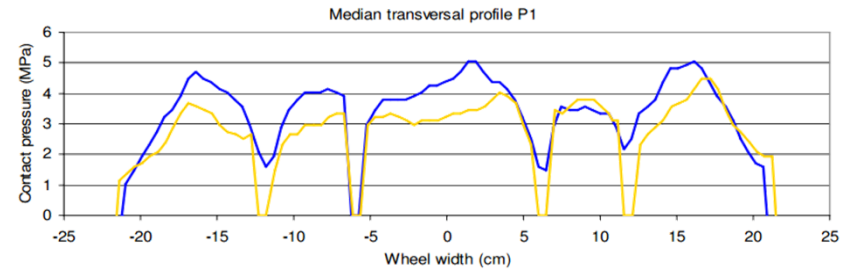
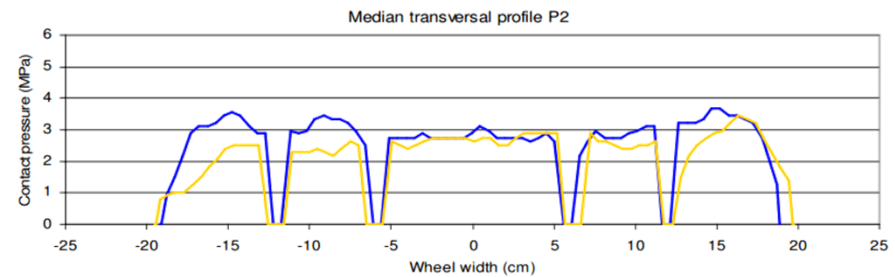
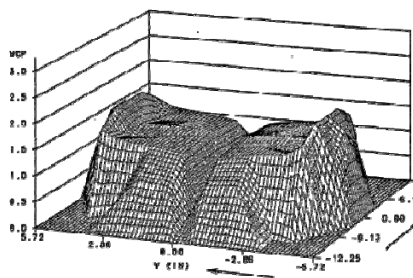
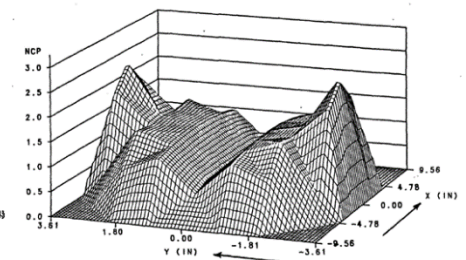
# Assumption: 150% x average loading

Normalized contact pressure - C-5B tire  
(13500 LB LOAD, 175 PSI INFLATION)  
(NORMALIZED TO INFLATION PRESSURE)

Normalized contact pressure - B-1B tire  
(13500 LB LOAD, 200 PSI INFLATION)  
(NORMALIZED TO INFLATION PRESSURE)

Normalized contact pressure - C-130 tire  
(14500 LB LOAD, 175 PSI INFLATION)  
(NORMALIZED TO INFLATION PRESSURE)

Normalized contact pressure - F-15E tire  
(12500 LB LOAD, 305 PSI INFLATION)  
(NORMALIZED TO INFLATION PRESSURE)

Boeing and Airforce test data<sup>[5] [6]</sup> (above) shows uneven contact pressure distribution across the length of an aircraft tire patch

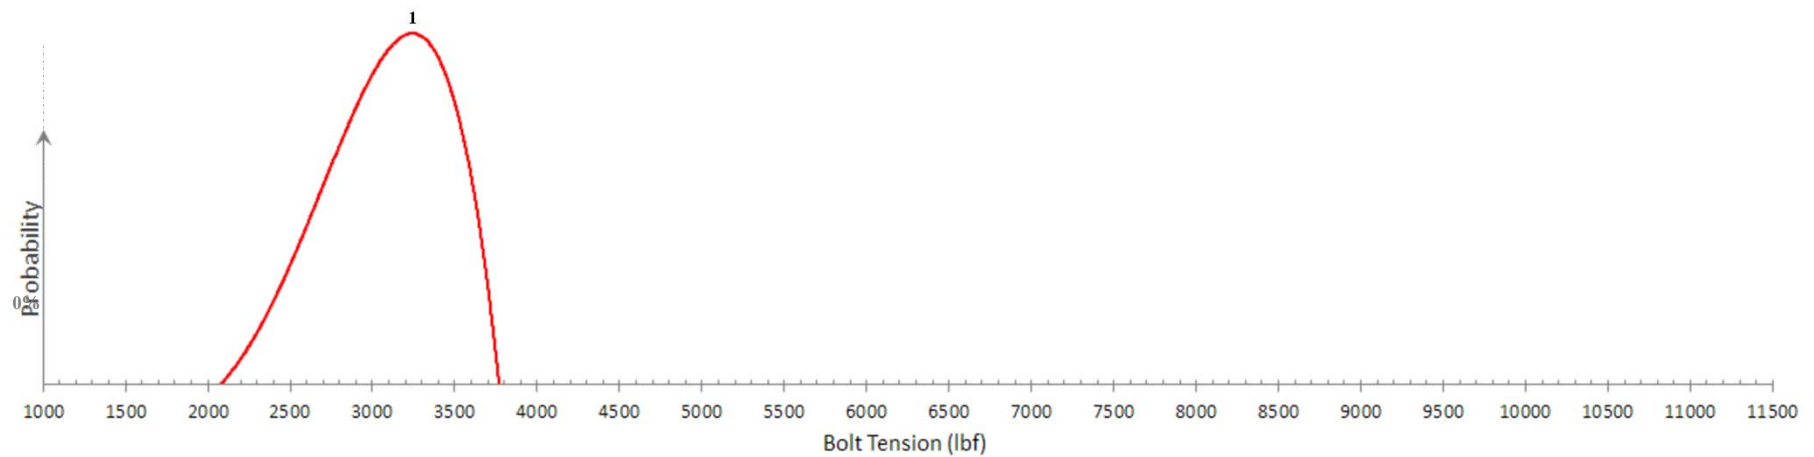
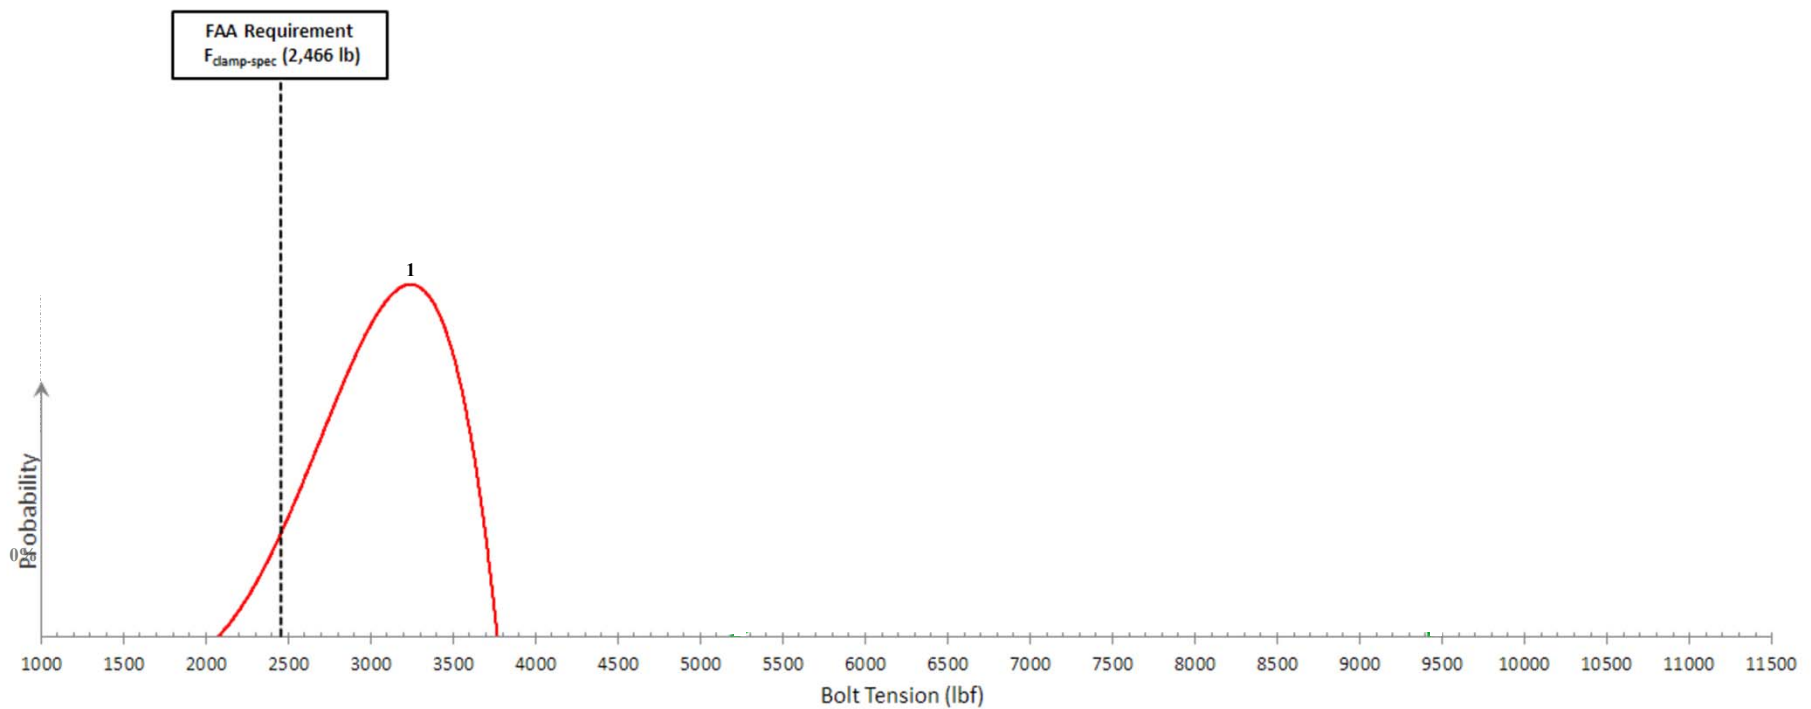
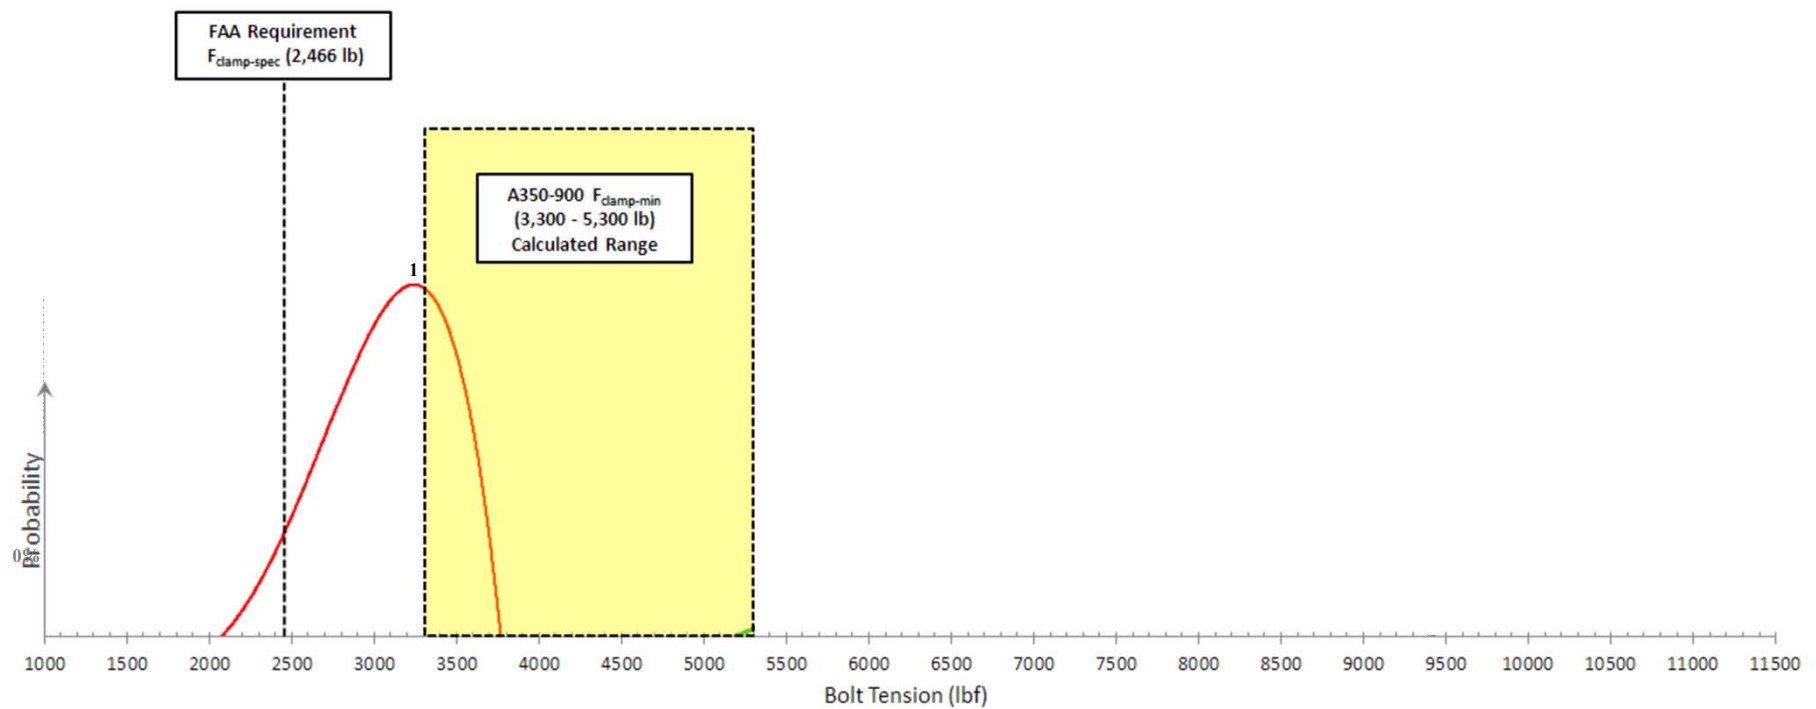
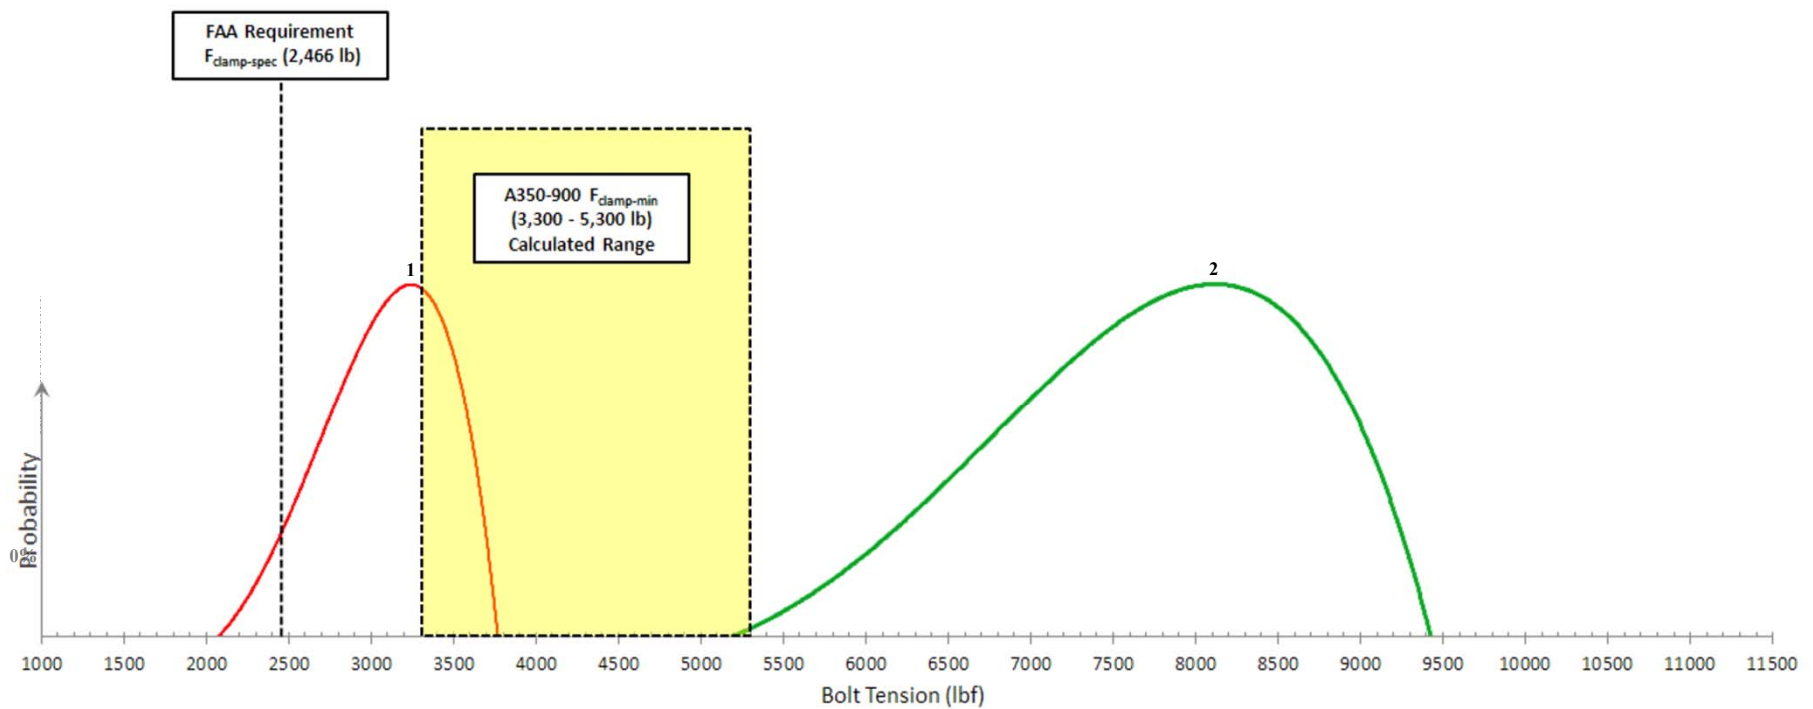
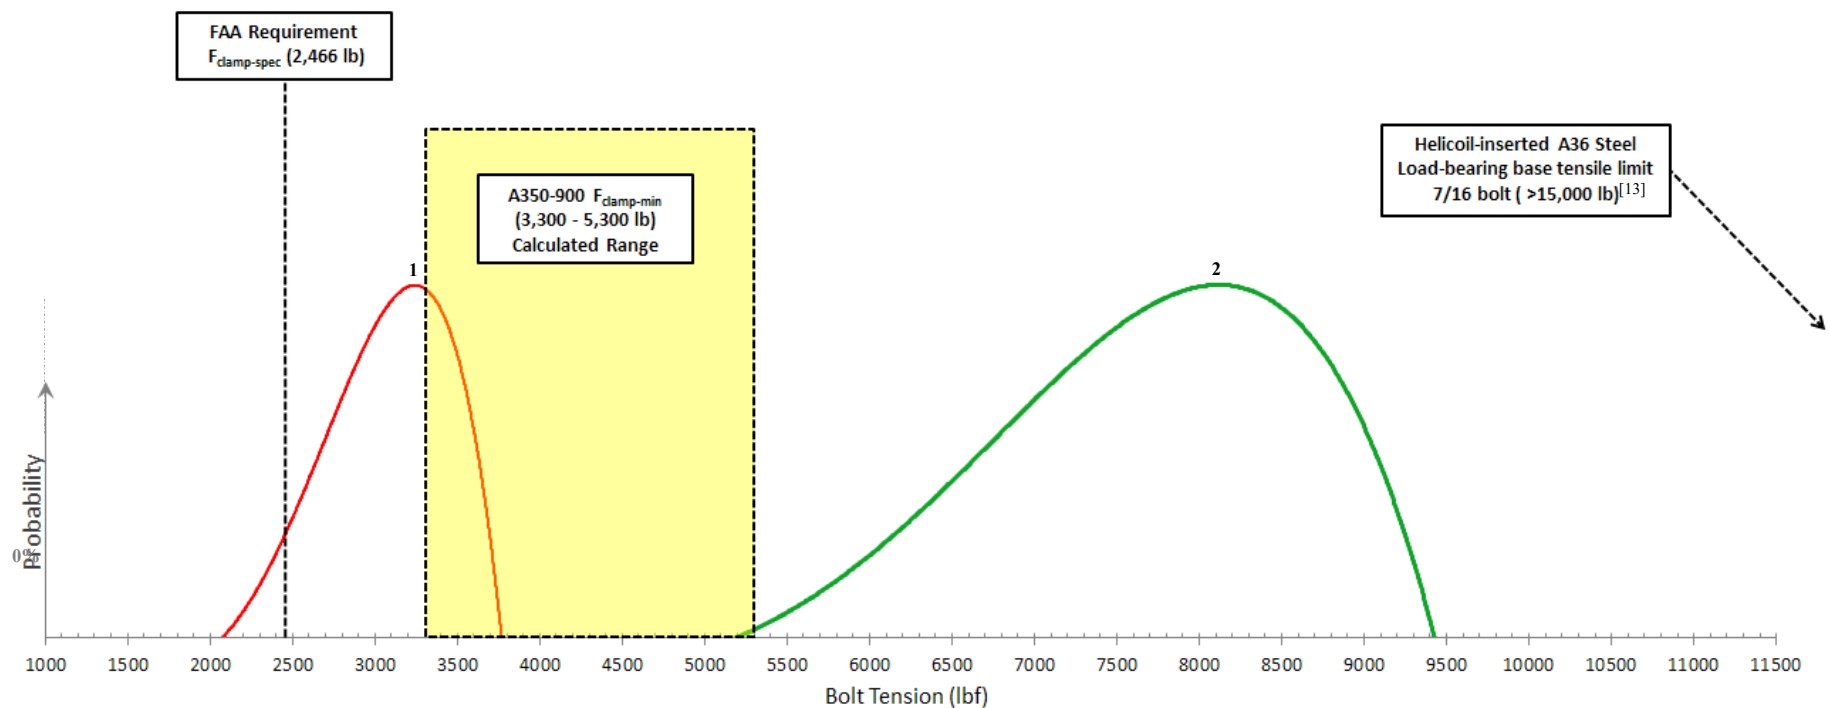
# Torque & Probable Bolt Tension<sup>[8]</sup>, $K=.18$ <sup>[10]</sup>

1 — Poly. (3/8-16 bolt @ 185 in-lb (15.4 ft-lb), FAA spec)

- 1 — Poly. (3/8-16 bolt @ 185 in-lb (15.4 ft-lb), FAA spec)
- 2 — Poly. (7/16-14 bolt @ 540 in-lb (45.0 ft-lb), HT spec)

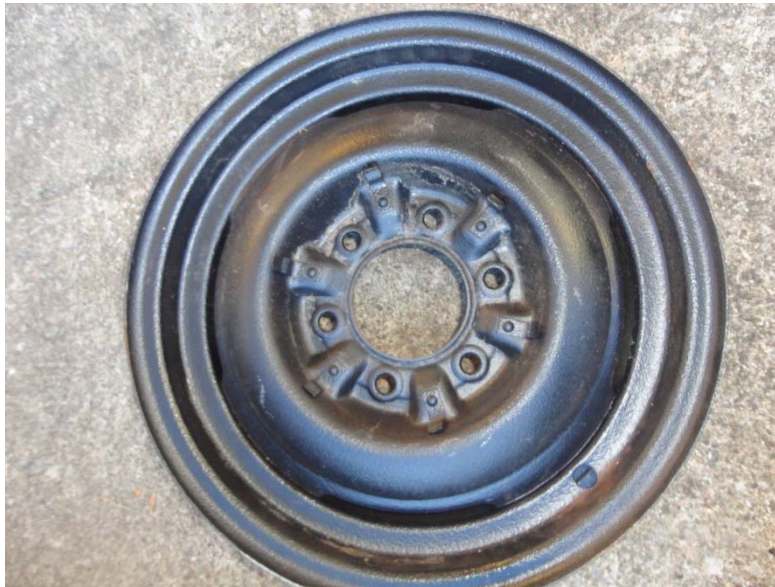
1/2 Ton Chevy Truck → Six 7/16" Lugs

Inputs		
Calculated		
		units
Curb Weight =	3300	lb
Load capacity =	0.5	ton
# of wheels =	4	n/a
# of bolts per wheel =	5	n/a
Acceleration/Deceleration =	3	g
Shear force per wheel =	3225	lbf
Shear force per bolt =	645	
COF =	0.45	n/a
Min required clamping force =	1433.3	lbf/bolt
Typical 7/16 lug nut torque =	85	ft-lb
Min 7/16 lug nut clamp =	8000	lbf
Clamp Factor of Safety =	5.6

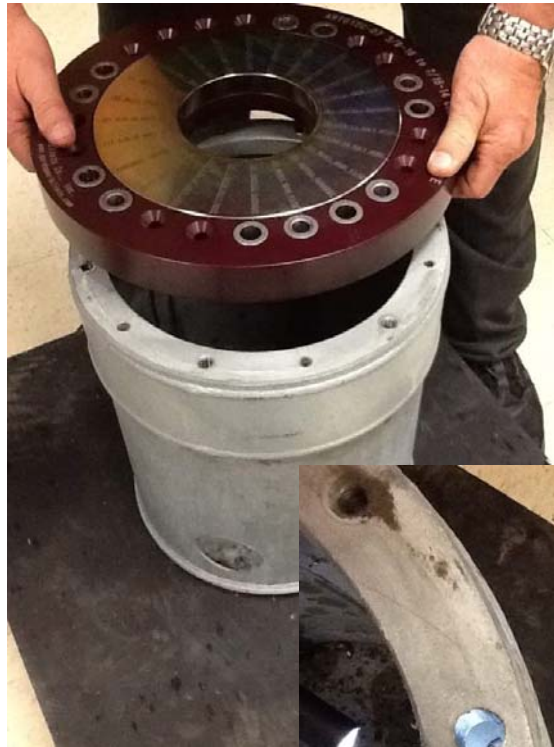
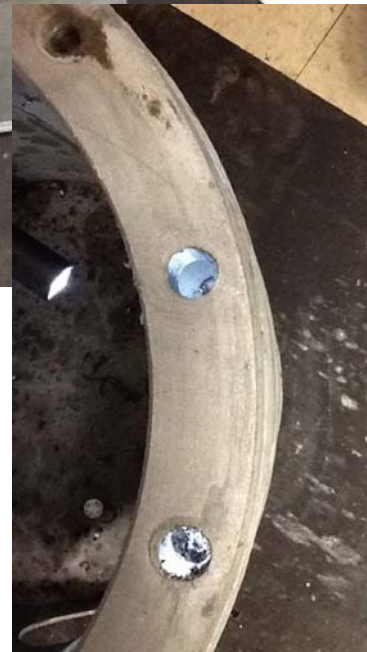
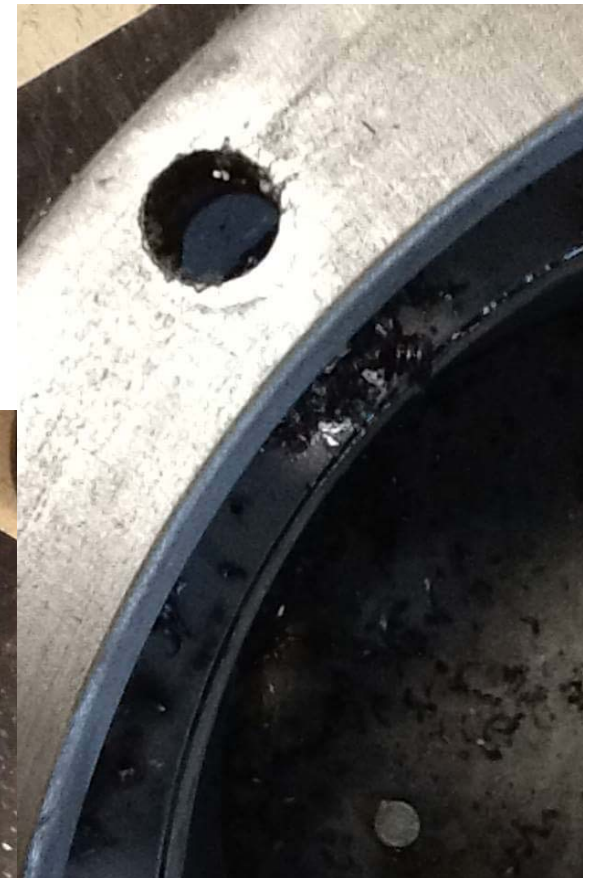
Replacement of the extension collar with 3/8" bolt holes on the bottom flange and 7/16" bolt holes on the top.

Modification of the base can or extension collar in place will require a tool to drill out existing bolt holes.
