Runway Incursions and Airfield Lighting

NTSB Aviation Accident Investigation

*2019 IES Aviation Lighting Committee
Technology Meeting
Monterey, CA*

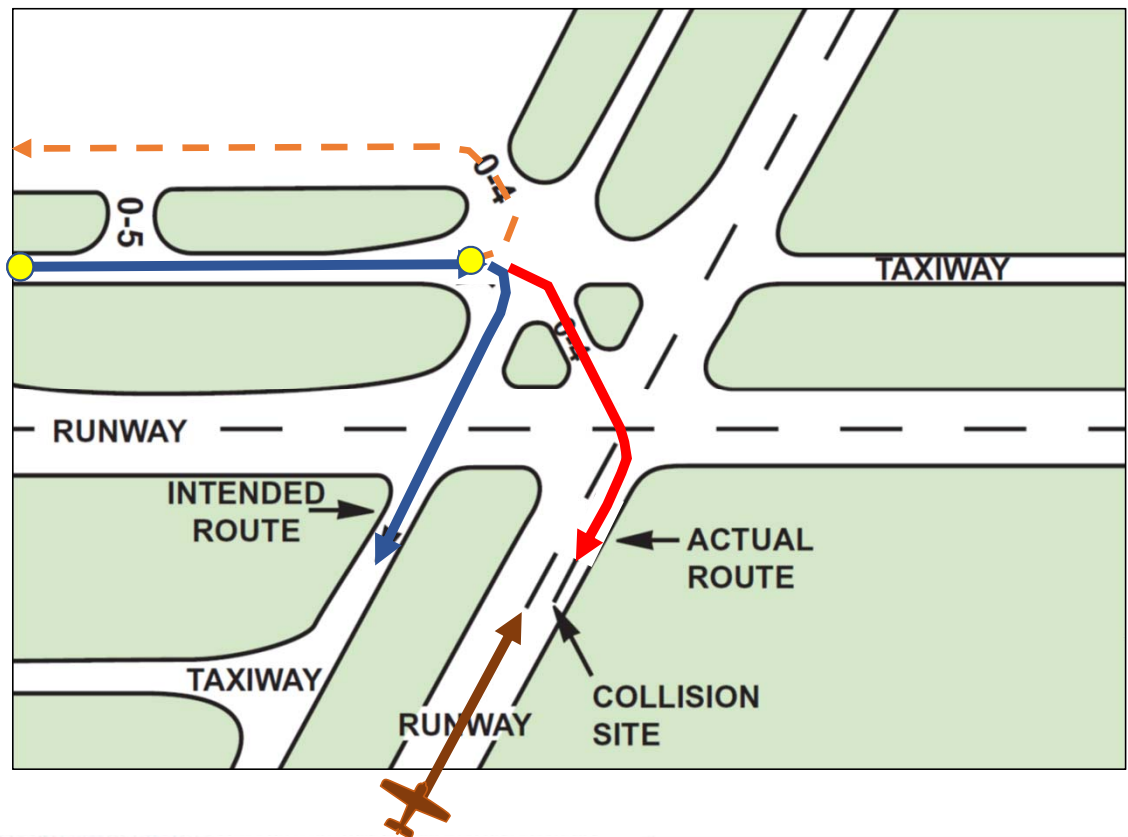
Key Findings

- Complex Intersection / Airfield Geometry (1990)
 - HSE into Apron
 - Open Spans of Pavement
 - Small Islands
 - Undefined Area
 - Direct Access Taxiway

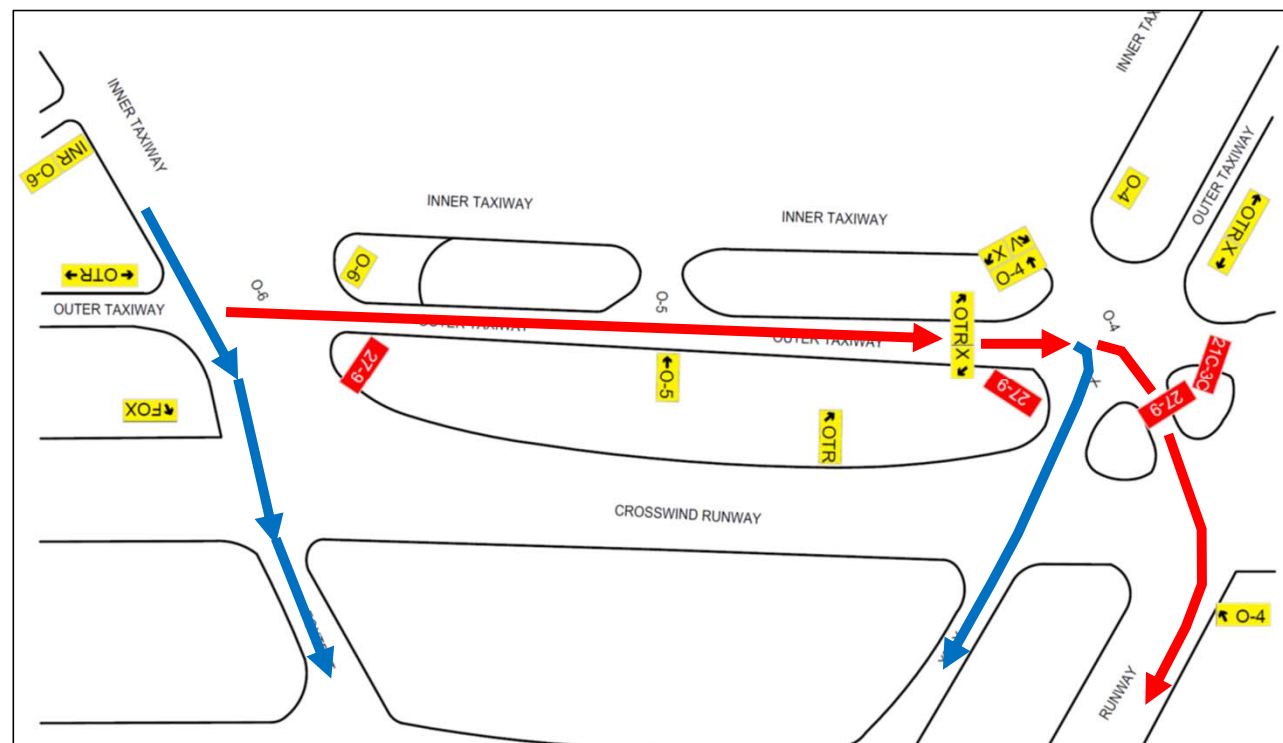
Airfield Lighting and Signage

Runway Centerline Lights

- Centerline Lights were not operable?
- Rotary Switch needed Replacement

Missing Runway Edge Lights

- No Inpavement lights Through Crosswind RW
- “Wig Wag”
 - No L-804 FAA specification
 - New Technology in 1990
 - Not required by FAA Criteria

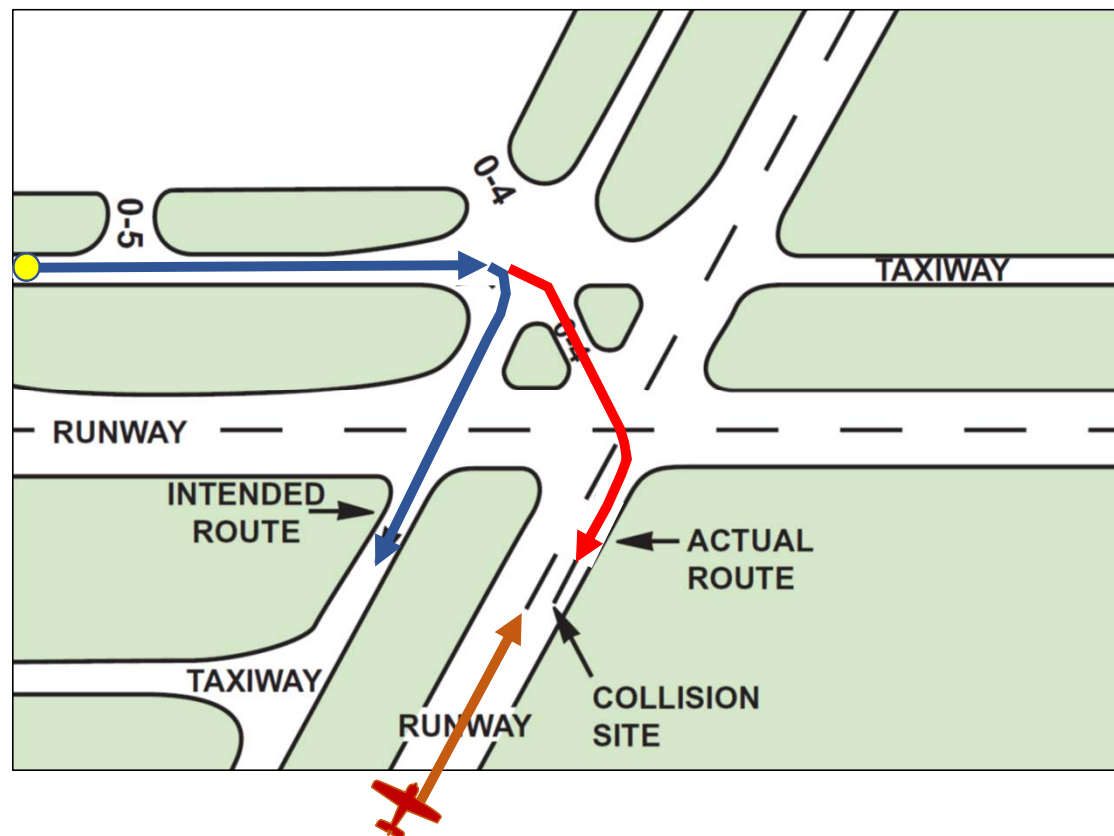
Probable Cause

- Lack of Crew Coordination
- Role Reversal

Contributing Cause

- Failure of Ground Controllers to act Quickly
- Need for improved Signage
- Inoperative runway centerline lights
- Failure of tailcone release mechanism

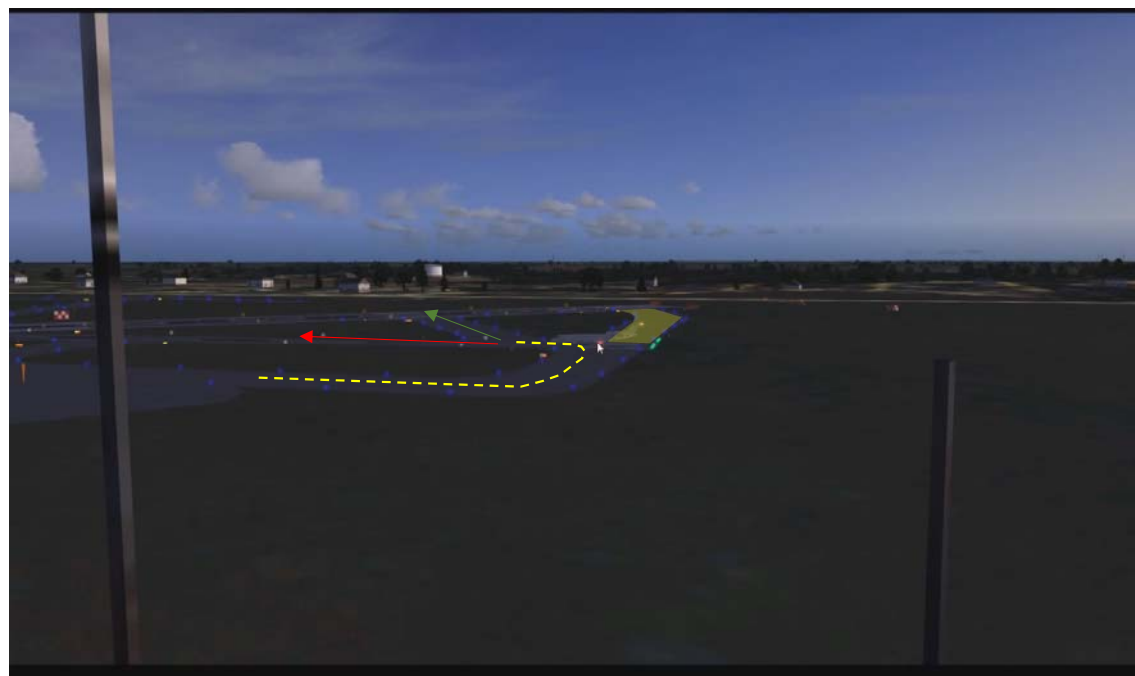
ATCT View

- Aircraft Clearly Visible on TW A
- RW 26
 - Threshold - difficult to Discern which RW Aircraft was on
 - Initial Rollout – More Discernable Aircraft was on RW 26
 - Final Rollout – Difficult to Discern if aircraft was on RW 26 or parallel TW A
- Runway 22
 - RW 22 hold position (and taxi) – easily discernable aircraft on RW 22

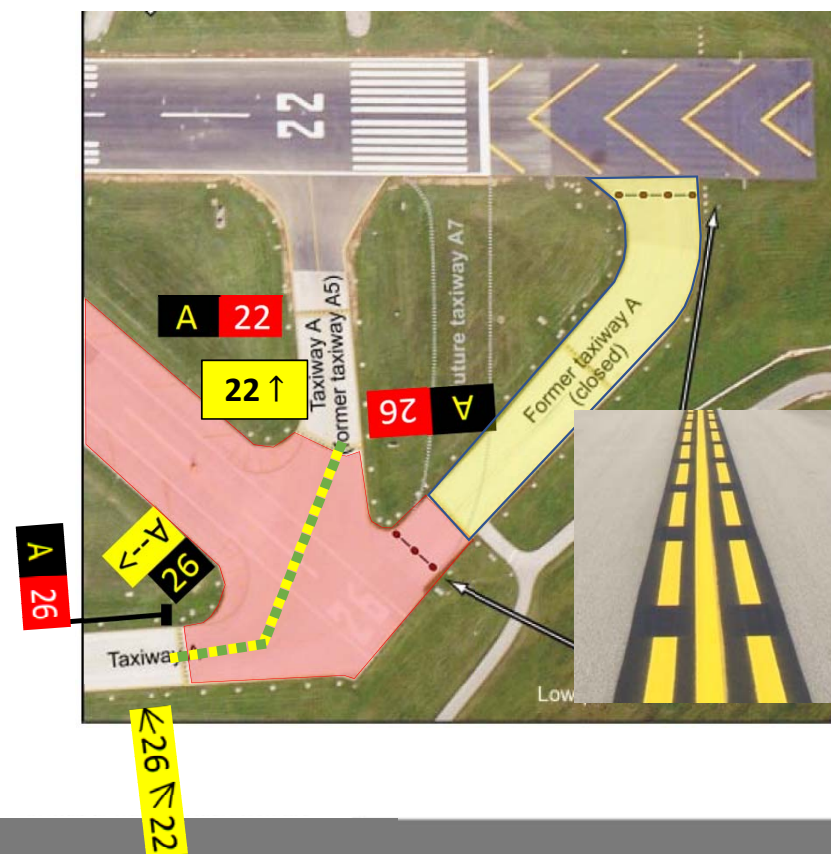
- No Findings Pertaining to Lighting and Signage
- Generally meet FAA AC Criteria
- In Retrospect:
 - Signage Enhancements
 - Add RW Location Sign
 - Outbound Destination Signs
 - Taxiway Centerline Lights

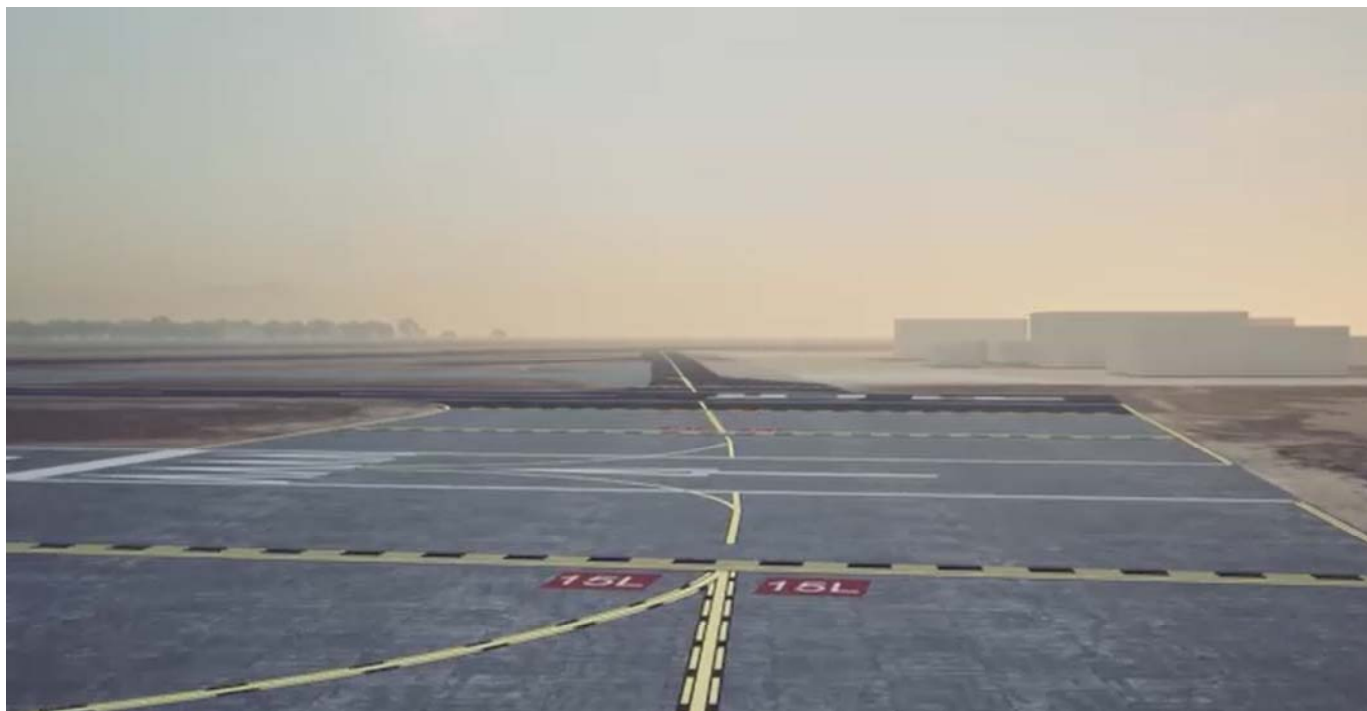
Pilot View

- Nine Runway Incursions in 6 Years
- Challenges
 - Wide Expanse of Taxiway near a Runway
 - Short Taxiway Stubs between Runways
 - Non-Standard Marking and Signage

- Install Runway Guard Lights
