2019 IES Aviation Lighting Committee  
Technology Meeting  
Monterey, CA

## ***Apron Floodlighting Updates***

Ms Mai Yeung, *Bechtel Corporation*

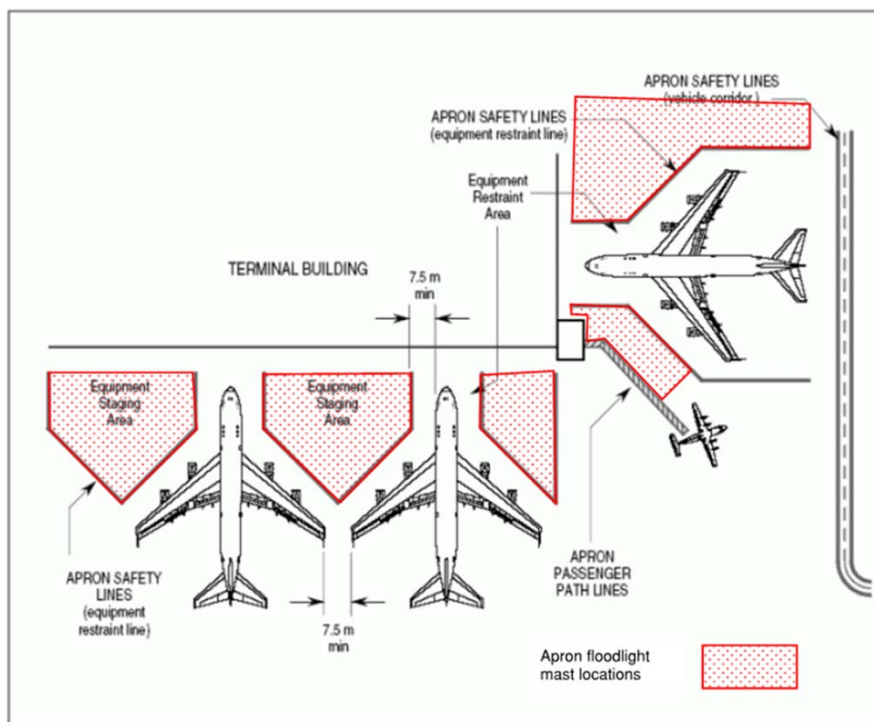
## Location of masts

- Masts located outside the separation distance
- Generally within the GSE area

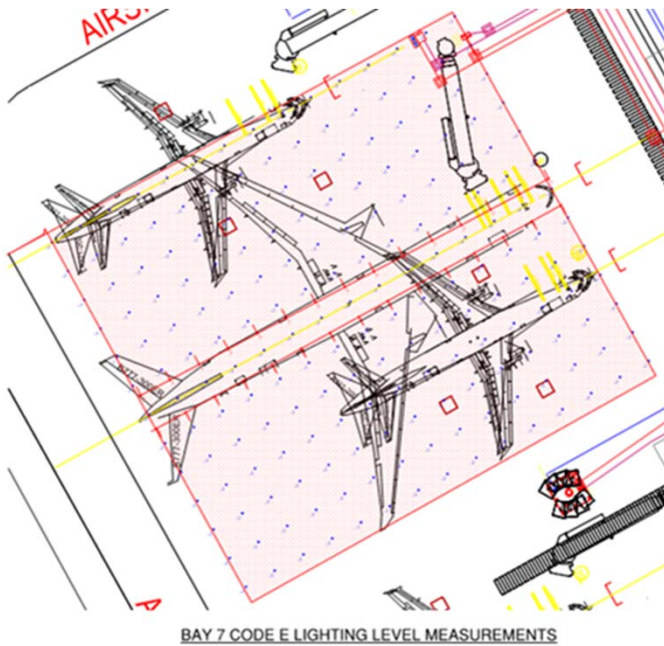
## Code E Parking (MARS)

## Match measurement points with calculation points

- - Horizontal lighting level measurement points
- - Vertical lighting level measurement points 2m above ground level, light meter photocell facing parallel and away from centerline of fuselage

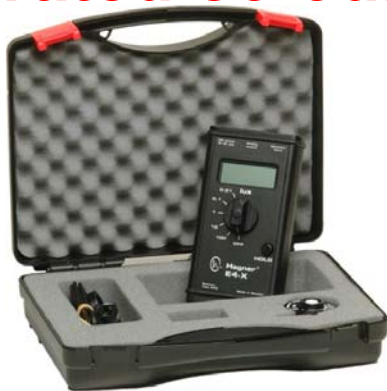
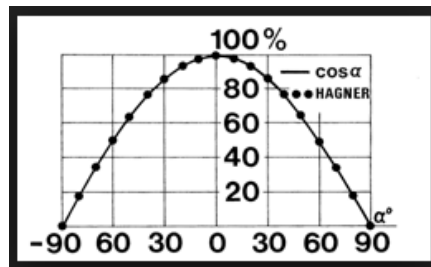
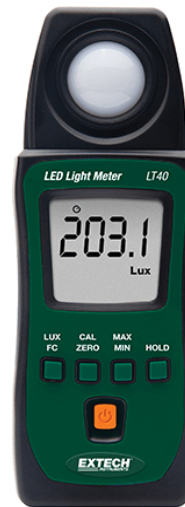
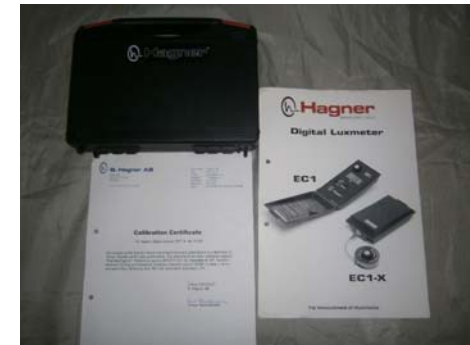
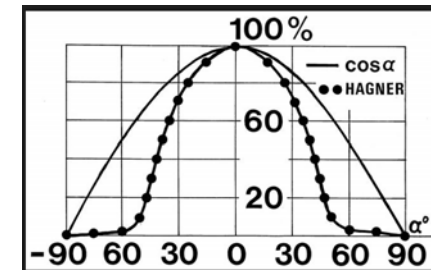
## Calibrated colour & cosine corrected light meter

Cosine corrected measurement
